HERITAGE IMPACT ASSESSMENT

372 Crawley Road
Part of Lot 14, Concession 7
Geographic Township of Puslinch
City of Guelph, Wellington County, Ontario

**CLASS ENVIRONMENTAL ASSESSMENT STUDY
NISKA ROAD IMPROVEMENTS
CITY OF GUELPH, ONTARIO**

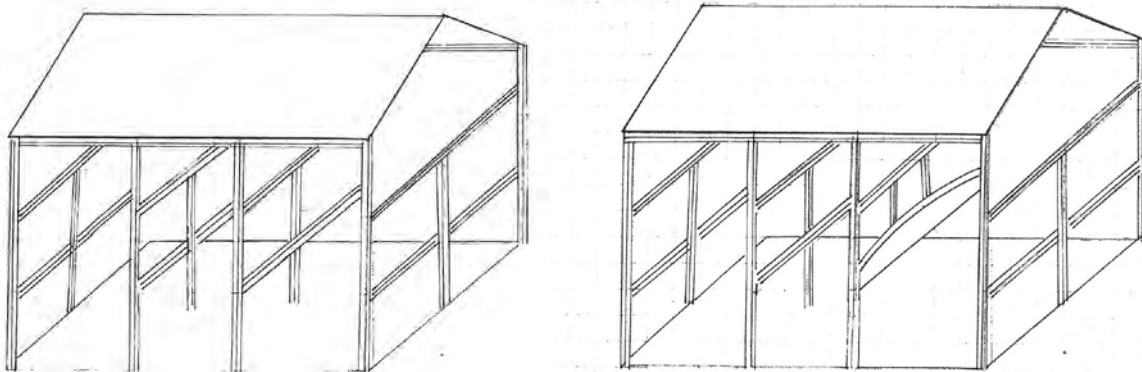
Plate 4: Sketches of typical English barn framing layouts without swing beam (left) and with swing beam (right)

The English barn was typically modified for North American use. The most distinct change was the mid-19th century introduction of a large single beam, known as a swing beam that replaced two short span beams. The beam extended the width of the barn and permitted a larger unobstructed threshing floor. These beams were typically one to two feet in width and were large enough to support the hay mows above. Typically square holes were cut into the swing beam in order to house joists to create a loft space for hay storage above. The beam allowed for the removal of a vertical post to allow a wagon to enter the barn, and provide enough room for it to swing around without interference.

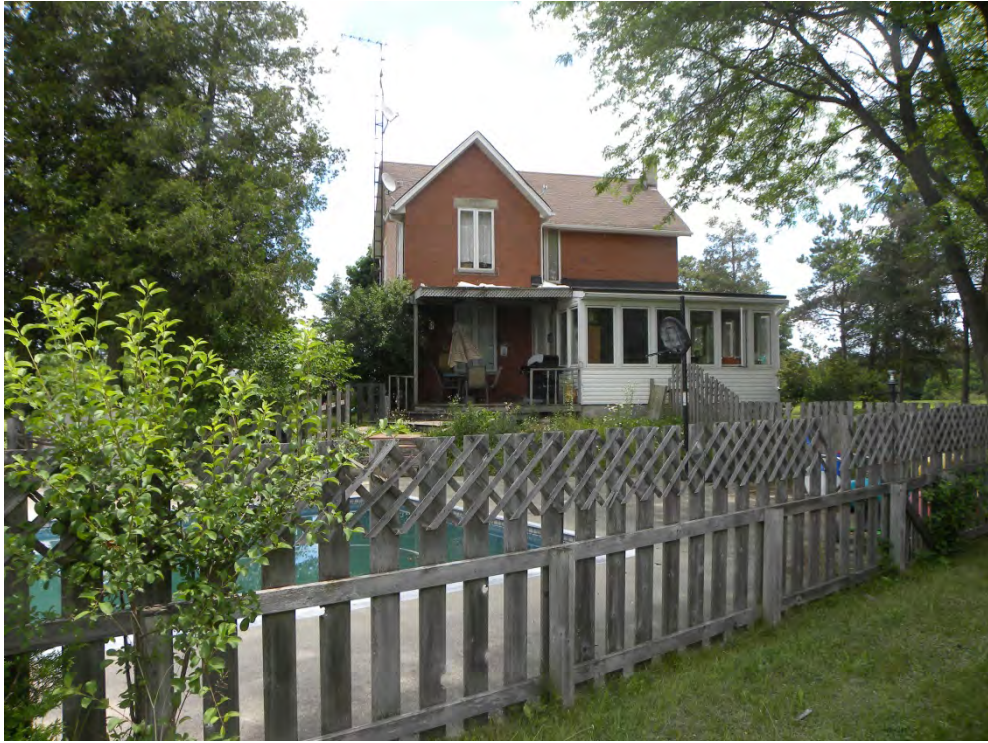
Plate 8: South façade of house showing gable, sunroom and porch. A pool is located in front of the house

The house has two later additions. A one-story sunroom on a concrete foundation is located on the south façade of the house. The exterior is sided with synthetic siding and consists of mostly windows. A small porch is located adjacent to the front addition. A one-story addition has been added to the rear of the house to allow a mudroom and rear living room addition. This addition is also on a concrete foundation and has a bay window and rear entrance on the north façade.

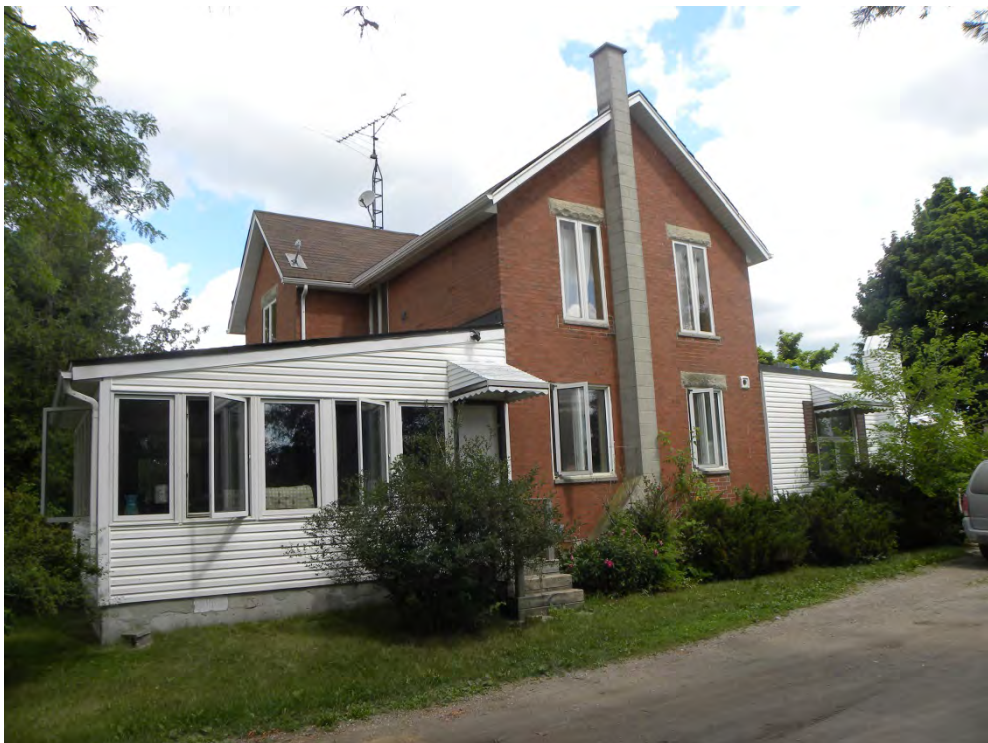
Plate 9: East façade of the house showing window arrangement, concrete chimney, and front and rear additions

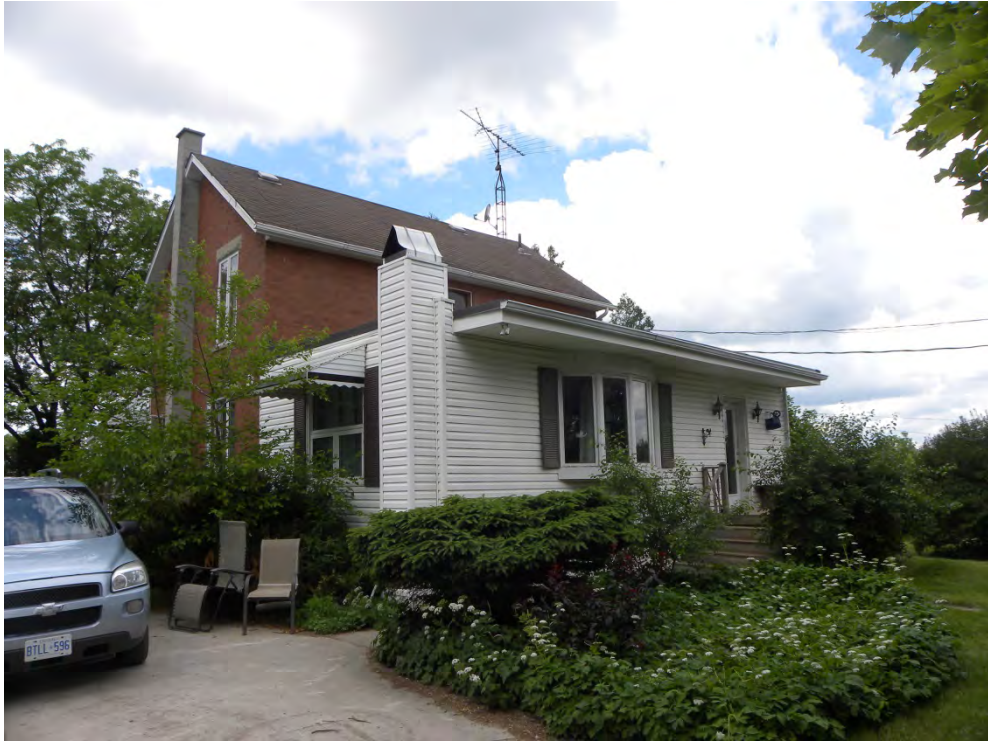
Plate 10: North façade of the house showing one-storey addition to rear of house

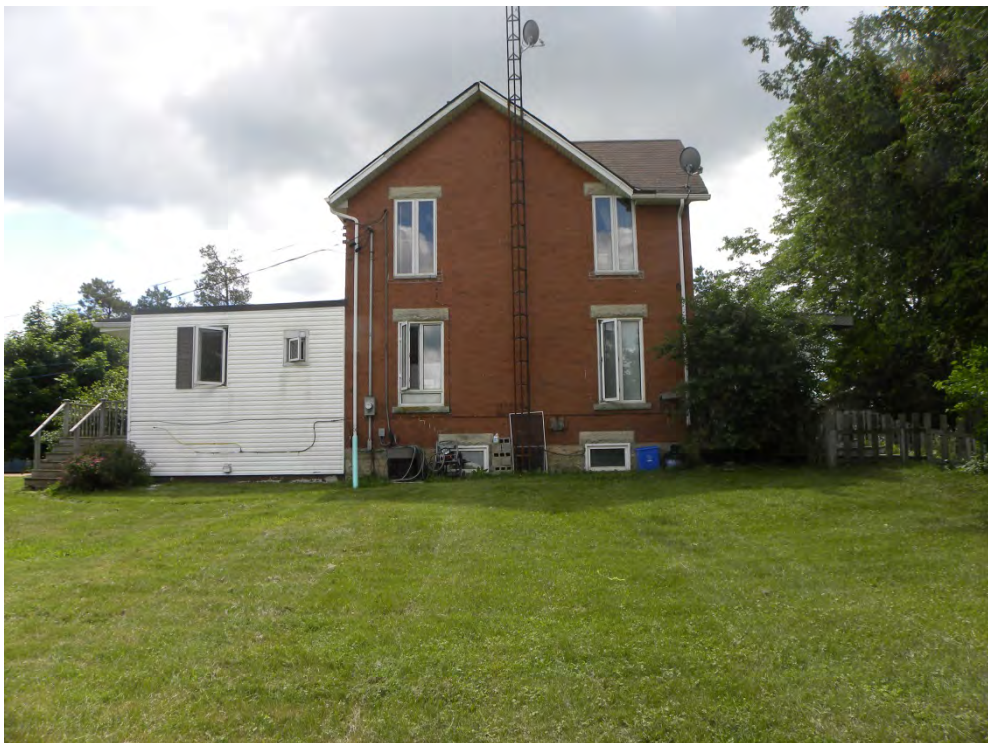
Plate 11: West façade of house showing stone foundation, brick construction, and rear addition. The window sills on the ground floor are constructed of stone, while the second floor sills have been replaced with concrete

The original windows have been replaced with modern vinyl windows. Most of the windows have large stone lintels, but most of the stone sills have been replaced with thin concrete sills. The change in sill material is most notable by the difference in size of the stone and concrete sills from the first and second floor windows on the west façade.

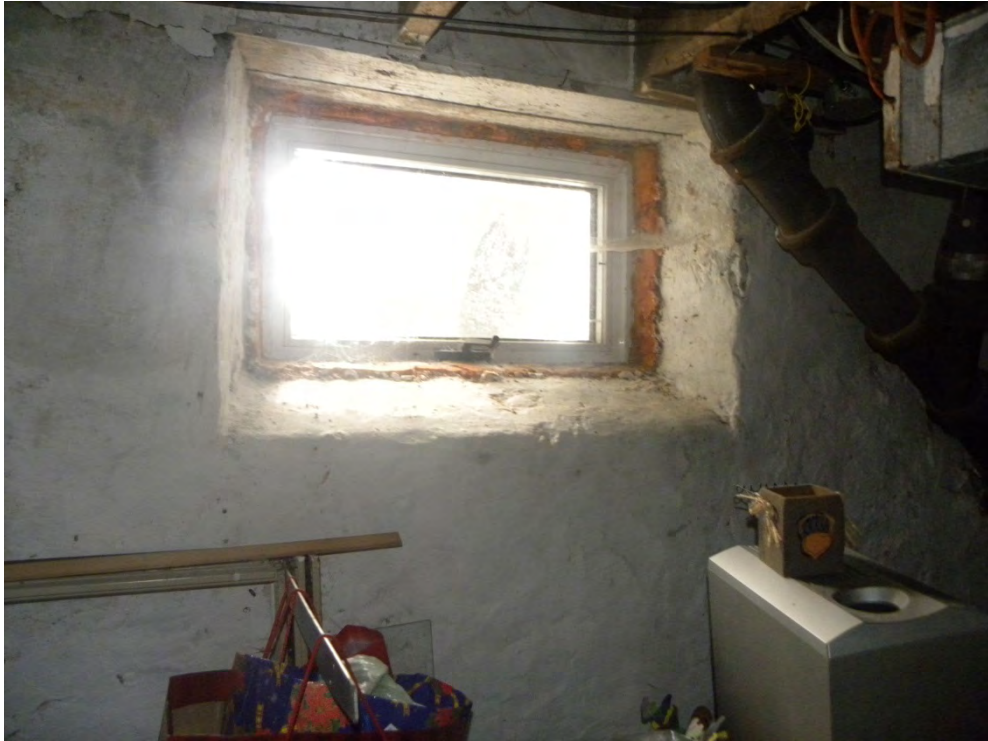
Plate 12: Basement wall showing parged stone finish, and modern vinyl window

The basement is constructed of stone and is accessible from a staircase in the first floor kitchen. The basement has been parged and the windows have been replaced with modern vinyl windows. Remnants of machine cut lath are visible in a wall opening found in the stairway to the basement.

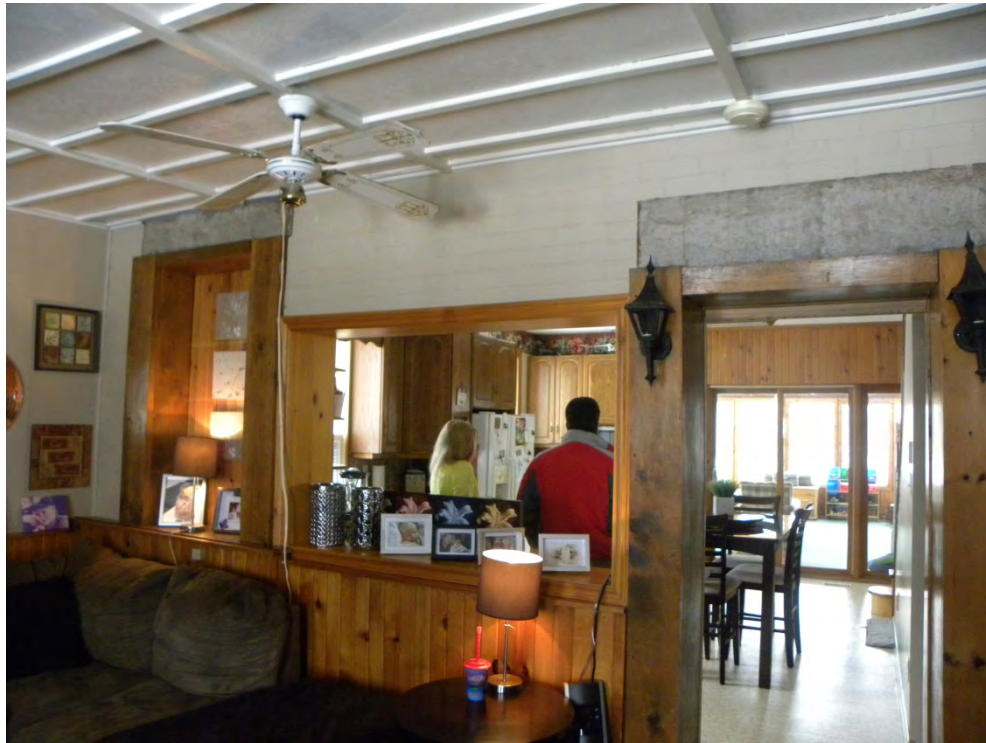
Plate 14: Interior of rear addition, looking south towards kitchen showing exposed brick wall and former exterior sills above door and window opening

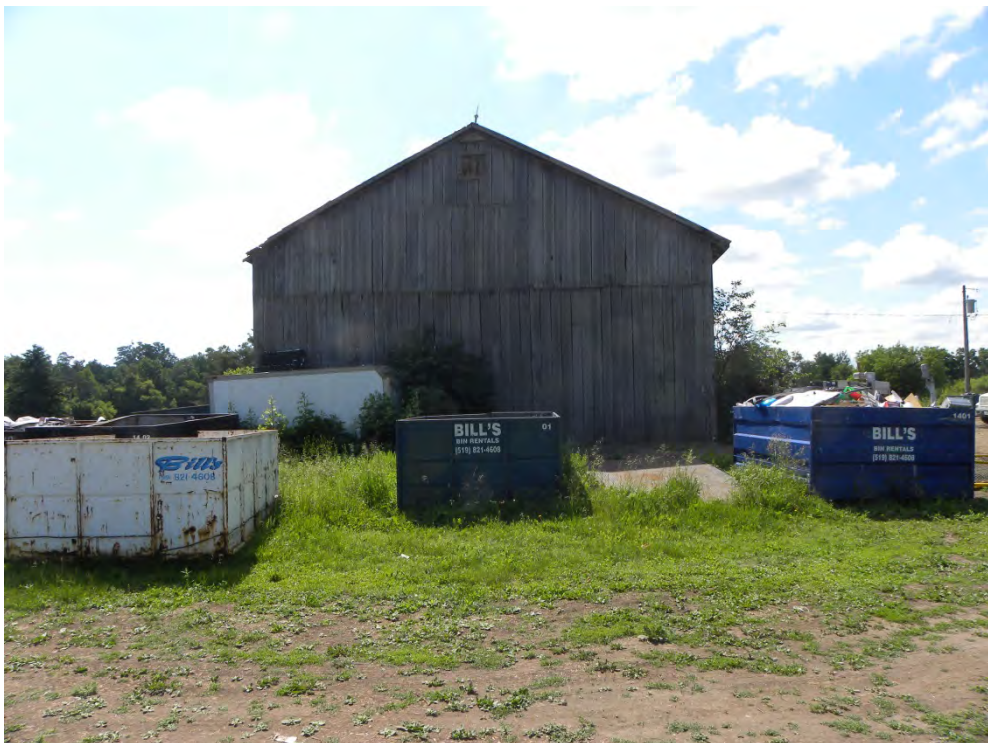
Plate 17: West façade of barn showing vertical pine plank siding, and low-pitched gable roof

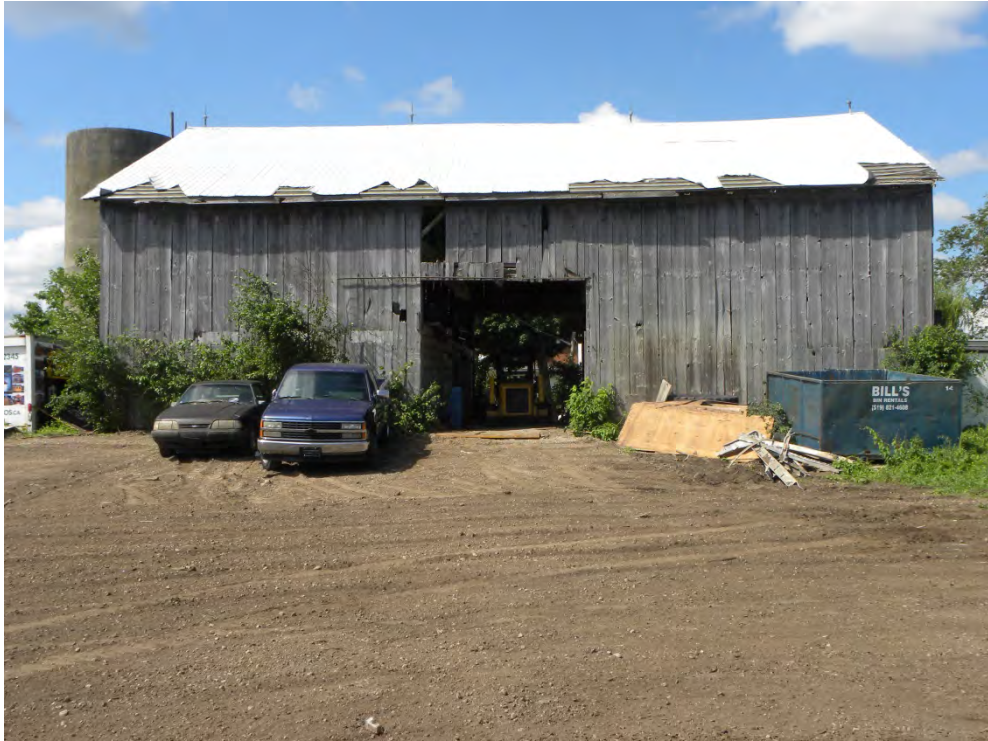
Plate 18: North façade of the barn showing three-bay arrangement of façade, with centered opening for wagon access

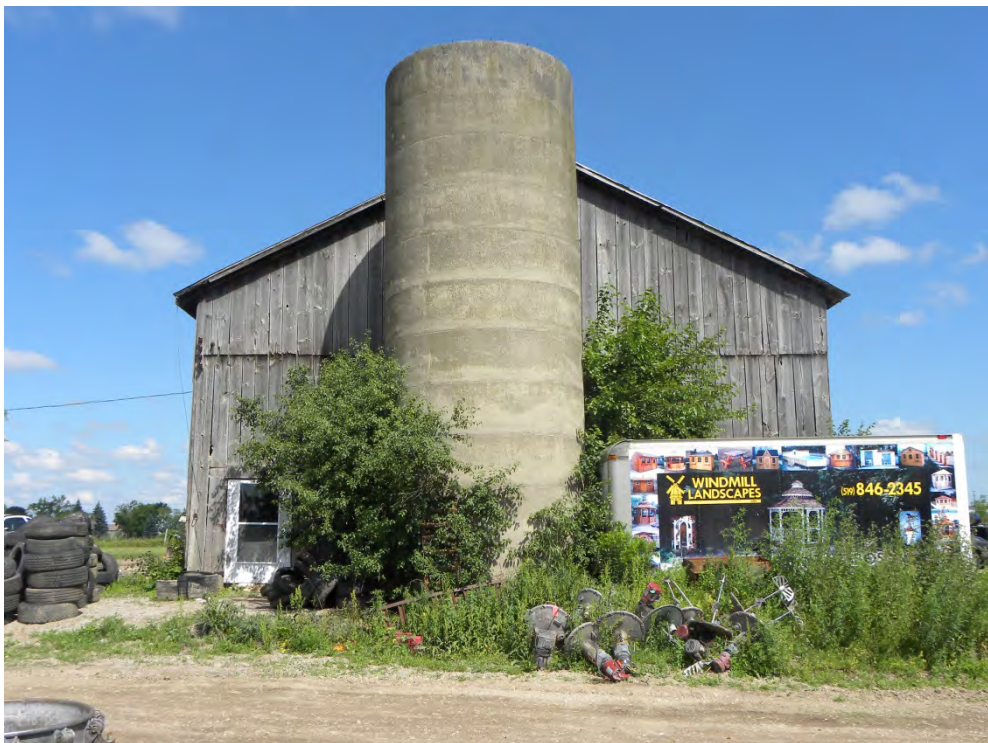
Plate 19: East façade of barn showing concrete silo

On the east of the barn is the remains of a concrete silo. The silo is no longer in use and based on its concrete construction was likely built between 1900 and 1950 when poured concrete silos were most commonly built.⁹

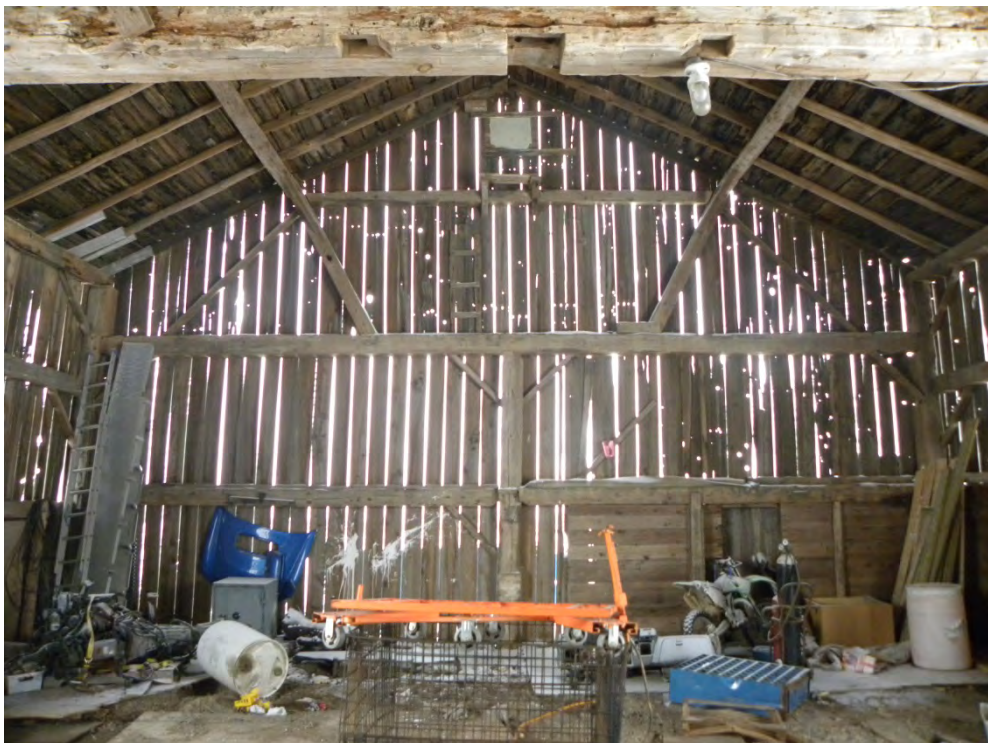
Plate 21: Interior west wall showing a typical timber-frame bent used as an end wall for barn construction. Two horizontal cross beams are located on this bent supported by a central vertical post. The lower cross beam consists of two short spans

The barn is approximately 58 feet by 39 feet and has twelve foot openings located on the middle of the long side of the barn. The structural frame consists of four bents. The bents at the end of the barn consist of two end posts, and a centered vertical posts, and horizontal cross beams that together form the massing of the barns exterior walls. The middle bents also have two end posts, but only have one horizontal cross beam and no centered vertical post. Most of the connections use mortise and tenon joinery held by pegs. Modern lumber has been used to replace some of the diagonal cross bracing in some corners. Hewing marks are evident on some of the timbers.

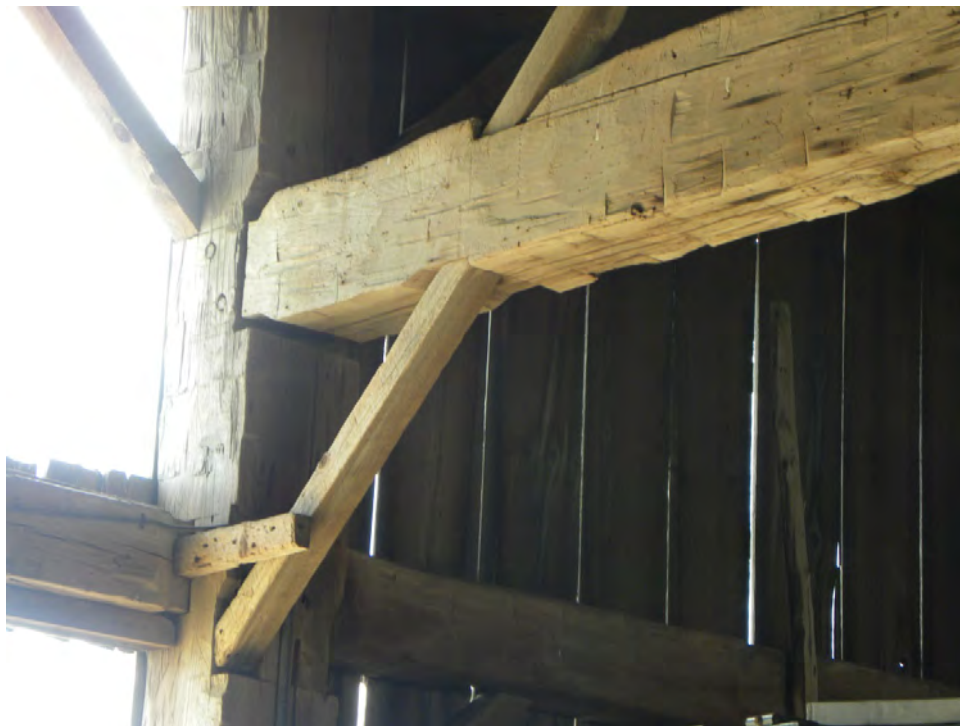
Plate 23: Tapered end of the swing beam that has been joined to the vertical posts using mortise and tenon joinery. The diagonal cross bracings have been replaced with modern dimensional lumber. Hewing marks are visible on the beam.

One of the horizontal timbers is distinctive and was observed during the field assessment to have been a swing beam. As a heavy timber beam, the swing beam consists of a continual span of approximately 39 feet across the barn. The beam has a slight camber at its end and is not supported by any vertical posts unlike the beams used on the ends of the barn. The beam has seven square holes cut into it, which would have previously housed joists that would have been connected to another cross beam to support a hay loft above.

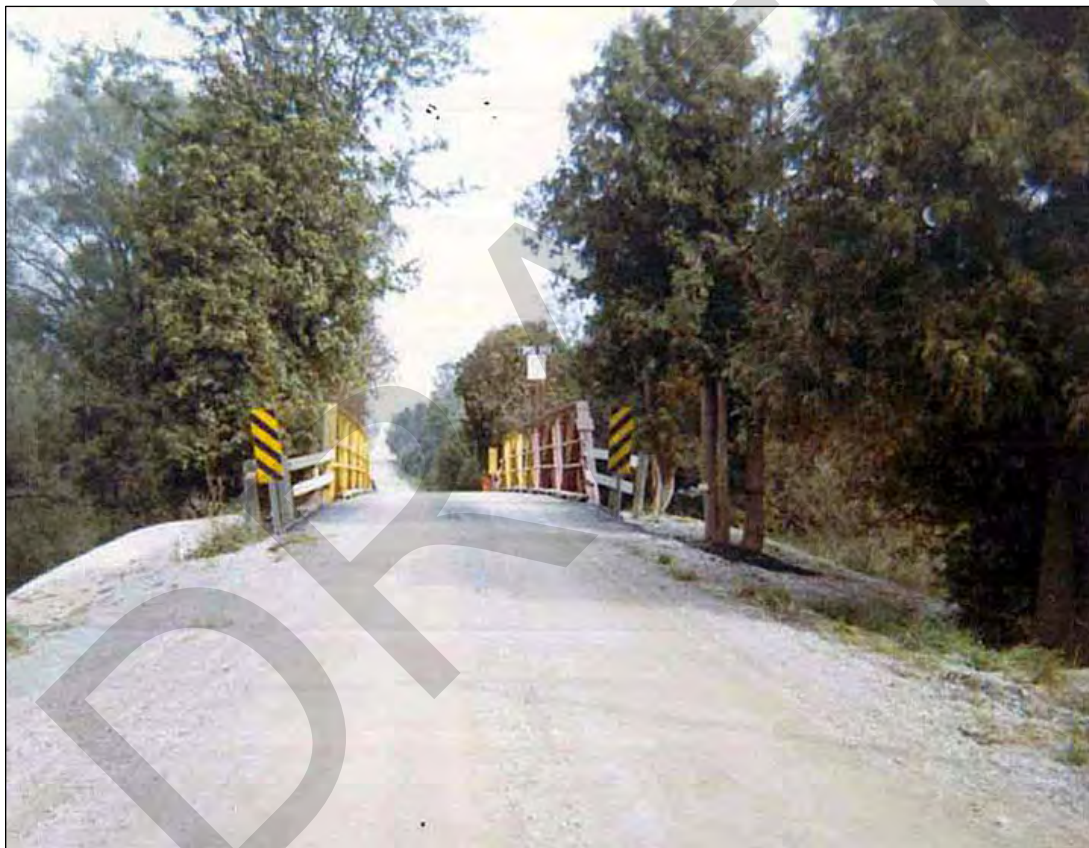
Figure 2. A view along the former Kortright Road shows the steel pony truss structure over the Speed River, September 20, 1971 [City of Guelph].

The Township of Puslinch was responsible for the construction of a steel pony truss bridge over the Speed River on Lot 12, Concessions 5 and 6 (**Figure 2**). Known as the Kortright Road Bridge, it was probably constructed in the first part of the 20th century, although, a review of the Township of Puslinch Council Minutes from 1897 to 1931 does not make reference to a new bridge at this location.¹¹ The National Topographic Series (NTS) map 40 P/9 Guelph (1935) depicts a bridge at this location; however, it is noted as a masonry bridge rather than a metal structure.

The one-span Kortright Road Bridge extended approximately 80-ft. (24 m) over the Speed River. The pony truss superstructure used a Warren truss design with parallel top and bottom chords. Triangular in outline, the diagonals carry both compressive and tensile forces. A true Warren truss uses equilateral triangles. The trusses were made up of five panels each. The deck comprised a transverse wood plank wearing surface and curbs. No sidewalk was provided on the bridge. Historic photographs suggest at least one nameplate was installed on the bridge (**Appendix A**). The structure became the responsibility of the City of Guelph in 1966 as part of an annexation of land from the Township of Puslinch.

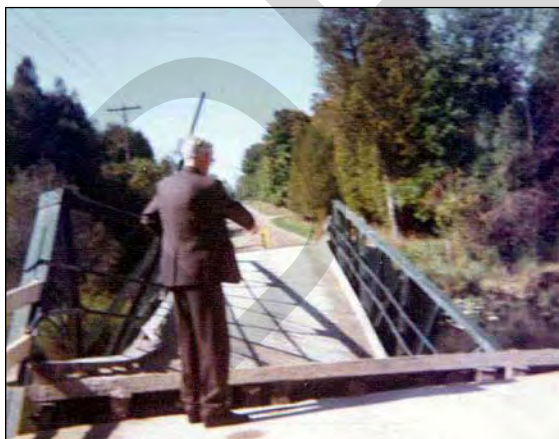
Figure 3. A view west depicts the collapsed Kortright Road Bridge, September 26, 1974 [City of Guelph].

The Kortright Road Bridge collapsed at midday on Monday, September 23, 1974 (*Figures 3 and 4*).¹² An anonymous telephone call alerted City officials to the bridge failure. The bridge was posted with a weight limit of 5 tons and newspaper reports speculated an overweight vehicle might have contributed to the collapse. Investigations revealed the structure could not be repaired and had to be replaced.

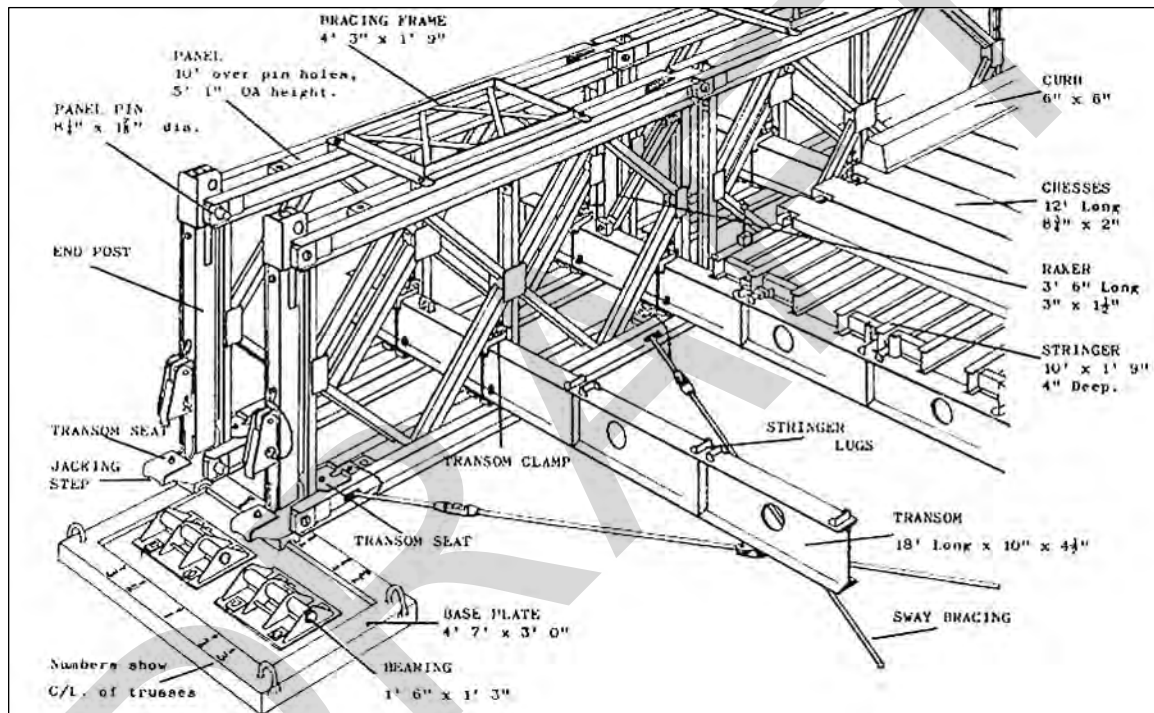
Figure 6. An isometric drawing of a double truss, single storey (DS) Bailey panel illustrates the arrangement of metal components [Sir Donald Bailey's Bridge²¹].

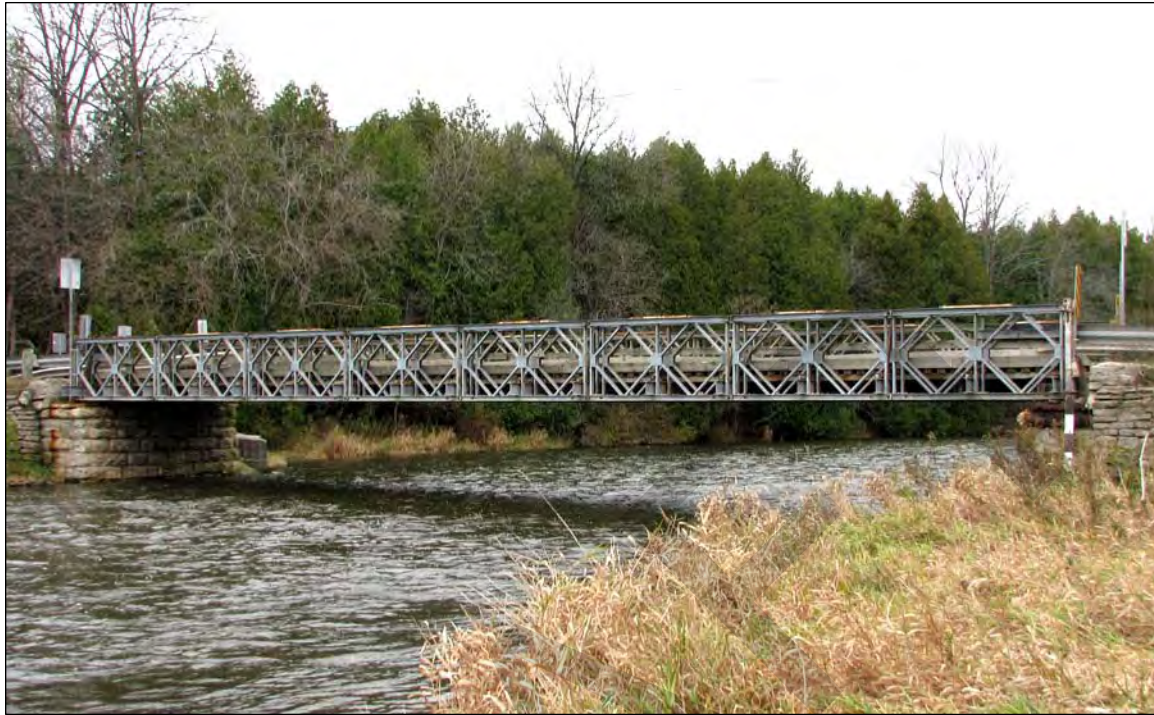
Figure 8. A view of the south elevation of the Niska Road Bridge depicts the Bailey bridge with stone abutments.

The east and west abutments are faced in dressed and coursed limestone blocks and constitute the oldest elements of the structure. The exposed sections of the abutments above the waterline contain six courses of stone mortared in place. The top blocks at the outer corners of the bridge project slightly over the wall to shed water. Retaining walls comprised of concrete rubble laid in a random pattern are located at the four corners of the bridge. These appear to be of later construction than the abutments.

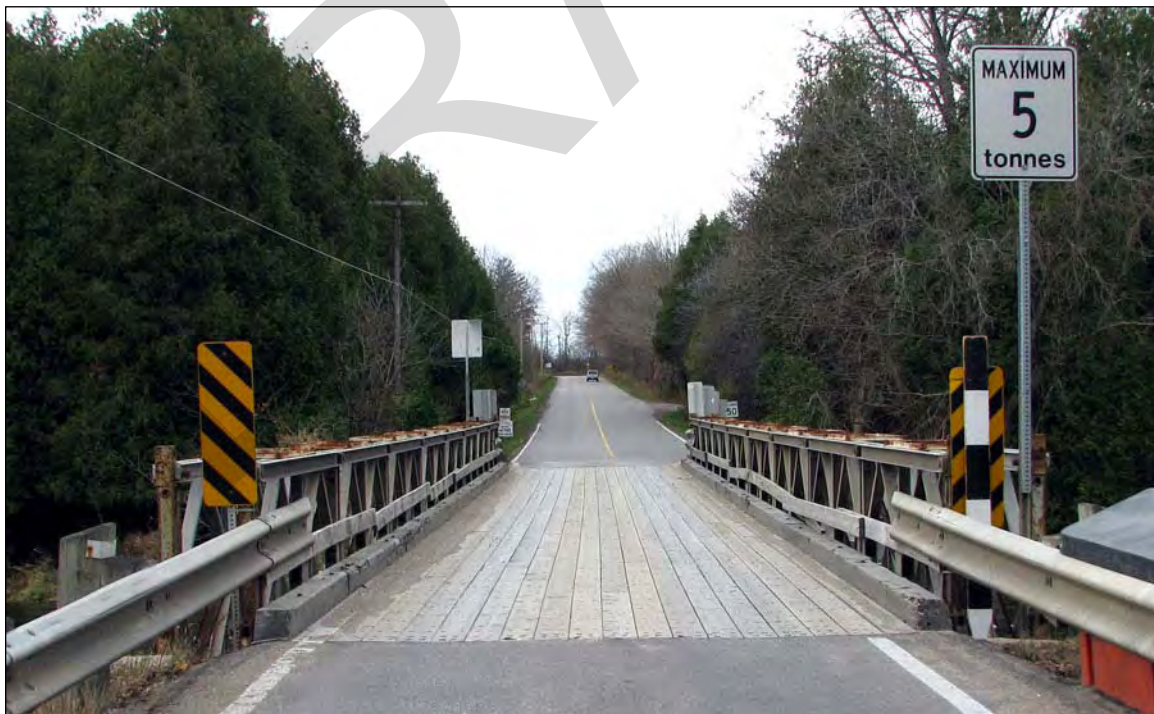
Figure 9. A view north shows the one-lane bridge with timber deck.

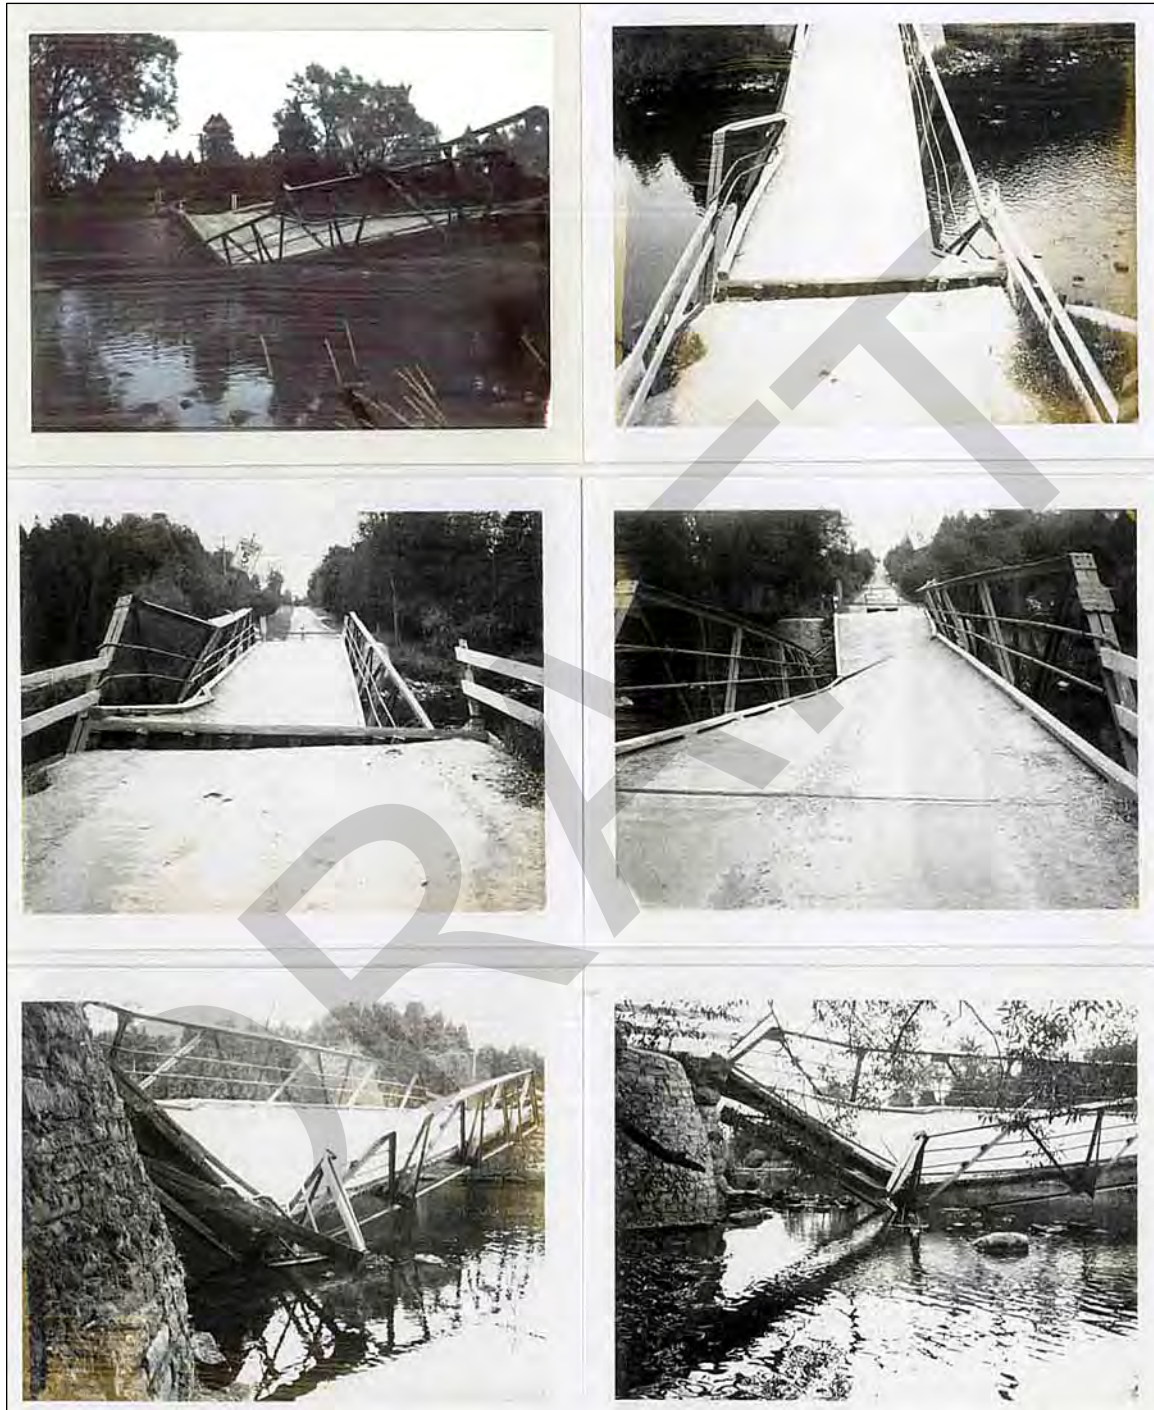
A series of photographs document the Niska Road Bridge after its collapse on September 23, 1974 [City of Guelph]. The middle photograph on the right shows a nameplate on the west end chord.

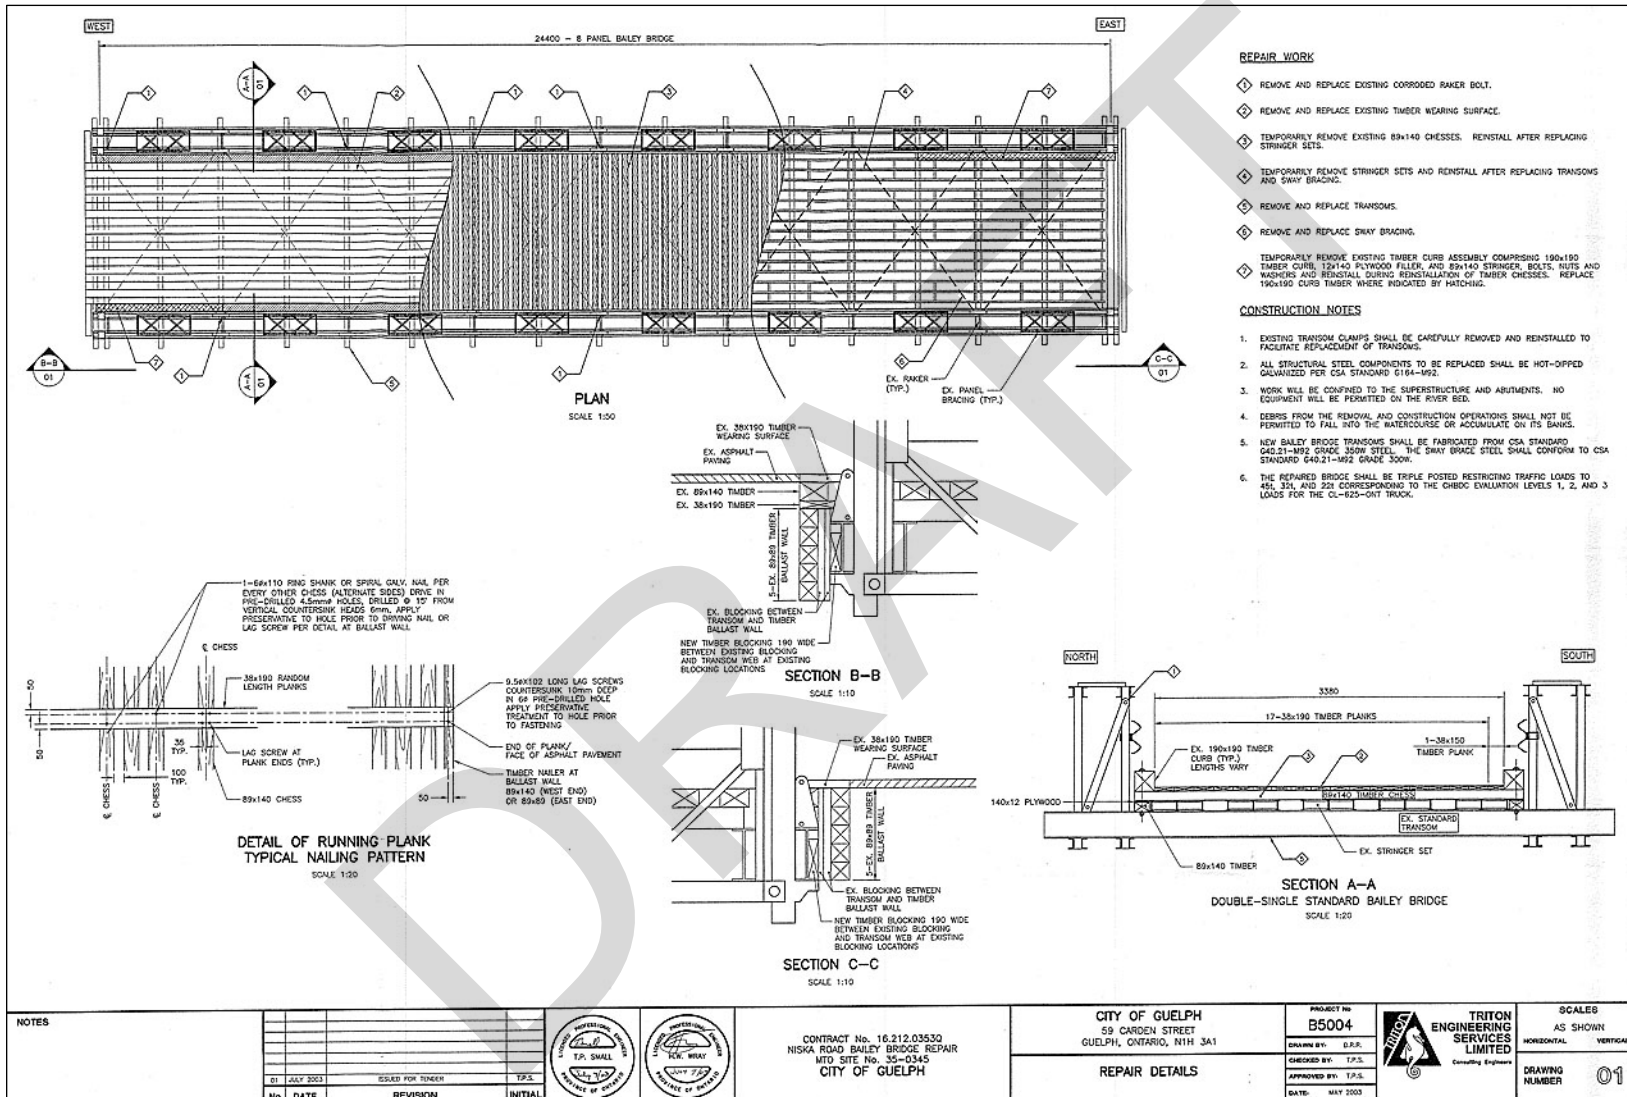
Triton Engineering Services Limited, Consulting Engineers prepared a Repair Details drawing for the Niska Road Bridge that is dated May 2003.
