City of Guelph

Ward to Downtown Bridges

FINAL REPORT

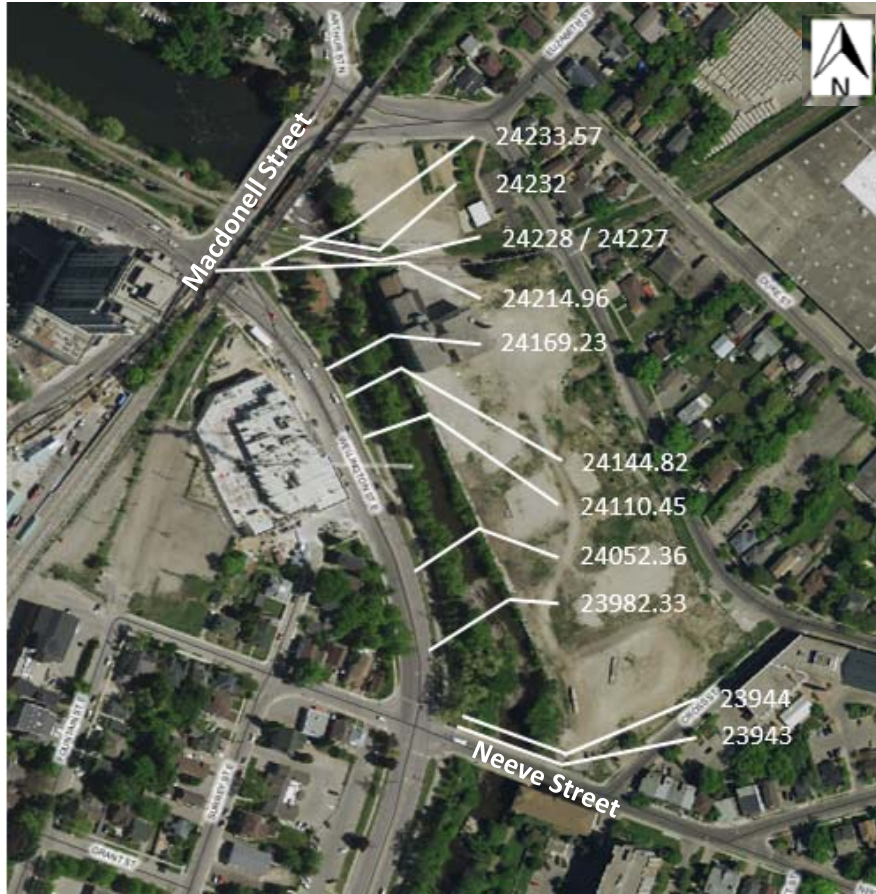
Figure 3-3. Location of HEC-RAS sections (airphoto from Google Maps extracted 2017)

The model was updated with field surveyed cross-sections to gain an understanding of the hydraulic conditions that occur in the study area and to serve as the basis for further analyses pertaining to the proposed pedestrian bridge crossings. The cross-sections representing the Macdonell Street crossing, the railway bridge, the GJR Bridge and the Neeve Street crossing were not updated in the model since field site conditions at, or in proximity to the crossings appeared to be well represented by the model. **Figure 3-3** illustrates the location of the existing and updated cross sections through the study area.

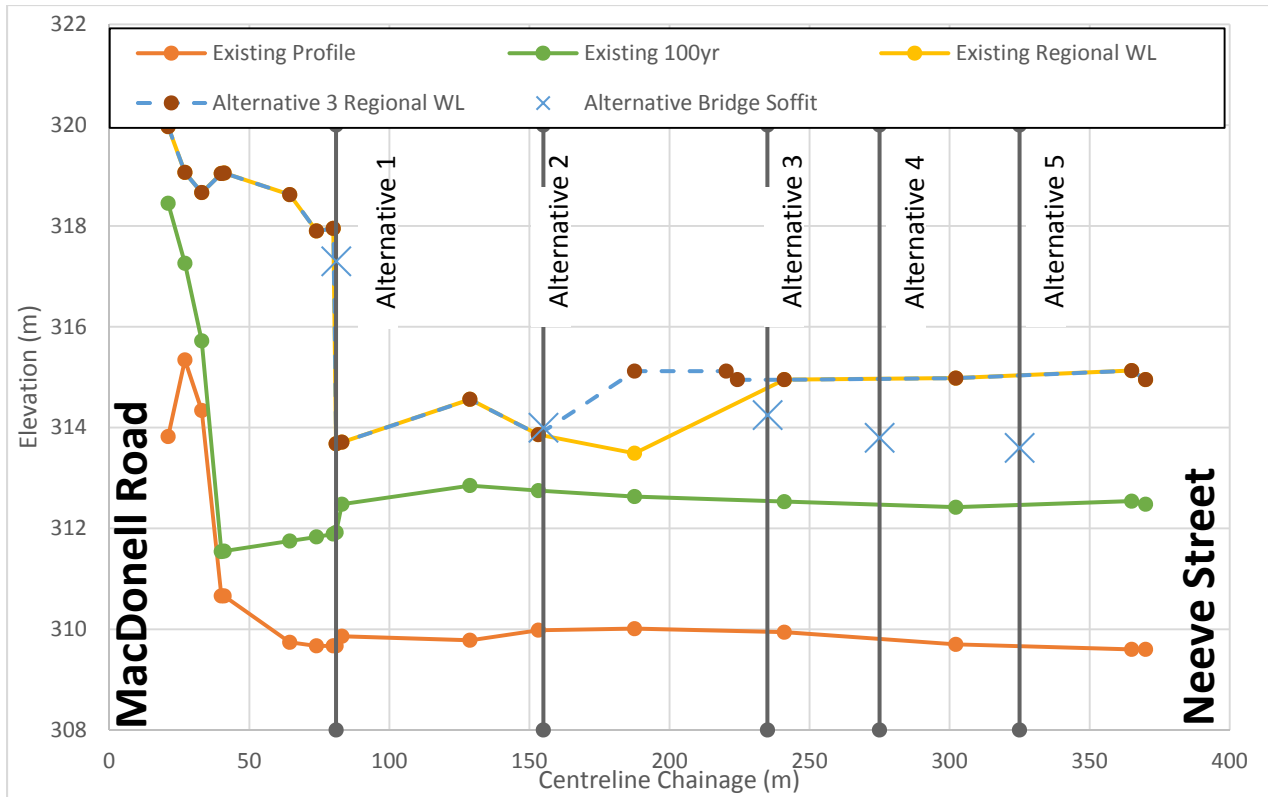
Figure 4-2. Comparison of regional water level between existing conditions and the proposed Alternative 3 bridge crossing. The location of all other alternatives is for general spatial reference only. The proposed bridge soffit for all alternatives is shown in relation to the existing regional flood levels.

Given that Alternative 3 occurred in a transition zone from supercritical to subcritical flow (based on existing conditions modelling), this alternative was modeled to better examine implications for the 100 year and regional flood elevation and the corresponding hydraulic conditions. (**Figure 4-2**). More specifically, the potential of Alternative 3 to increase regional flood elevations to the east of the river was examined through modeling. The implication of all other proposed alternatives on regional flood elevations and hydraulic conditions was inferred through review of data only and is presented in **Table 4-1**.

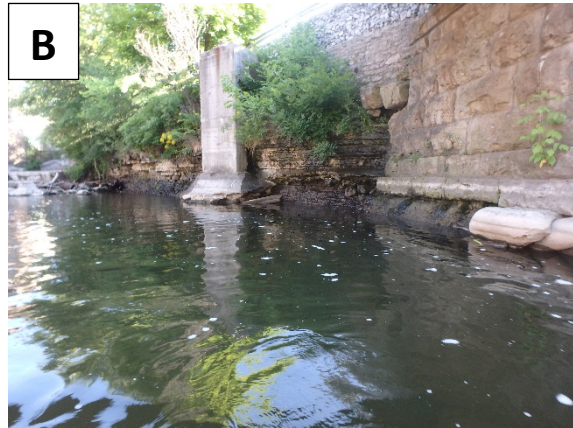
Sewer manhole structure situated along the east bank, between the CNR and GJR railway bridges; note the exposed bedrock surrounding the structure (interbedded shale and limestone/siltstone formations)

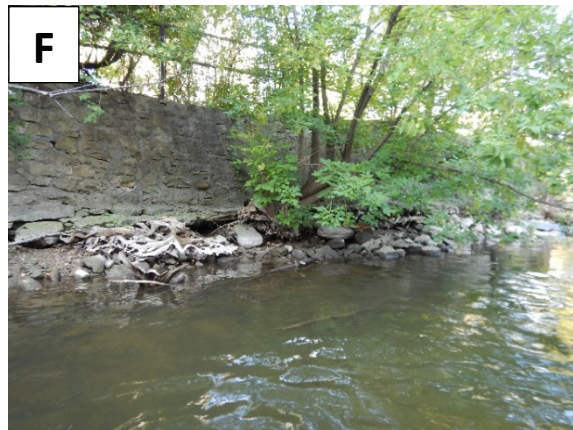
Looking at west bank where a tree was growing out of the retaining wall; this coincides with an approximately 2.4 m deep undercut.

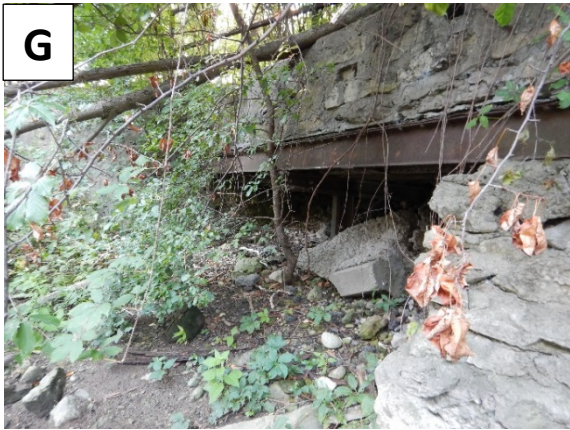
G
Section of failed retaining wall and some potential retroactive structural stabilization (west bank)

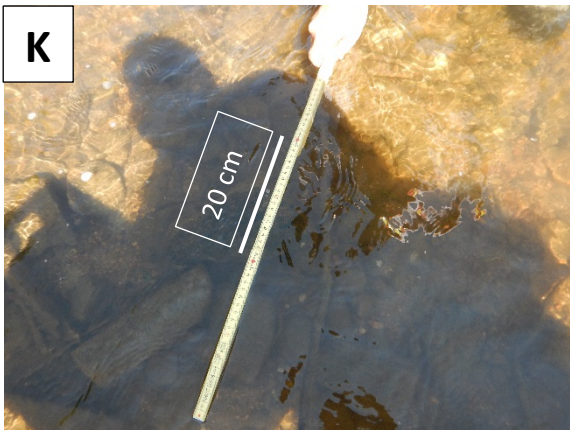
K
Photo of bed material immediately upstream of sewer crossing

- **Bed materials** – the substrate material was characterized by coarse particles typically ranging from 5 mm to 300 mm (D_{50} of 65 mm); larger particles (500+ mm) were present at the upstream limit of the reach. Small pockets of medium to coarse sands were present on the channel bed between larger clasts/rocks. The channel bed is classified as a cobble bed (Bunte and Abt, 2001).

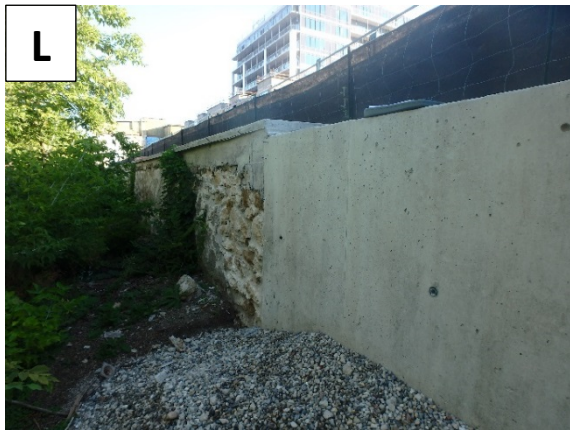
L
Transition between old (repaired) and new (replaced) retaining wall on east bank upstream of sewer crossing.

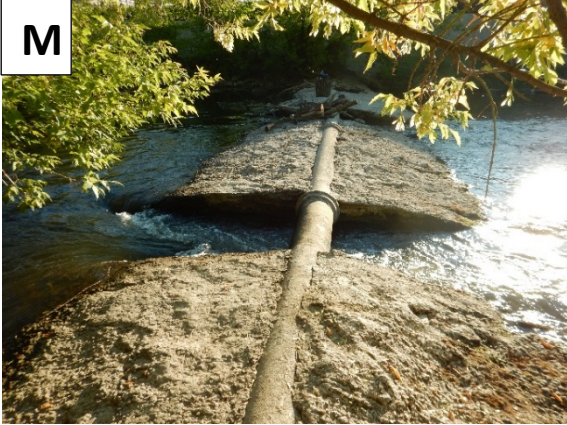
M

Looking east along sewer crossing; exposed pipe.

- **Exposed Sanitary Sewer** – a metal sanitary sewer pipe was observed on the channel bed. This pipe was secured to the channel bed with poured concrete (0+280). In three (3) locations, the sanitary sewer was unsupported/unprotected by concrete and water flow occurred under the pipe. In general, the sanitary sewer contributed to backwater conditions in the upstream portion of the reach.

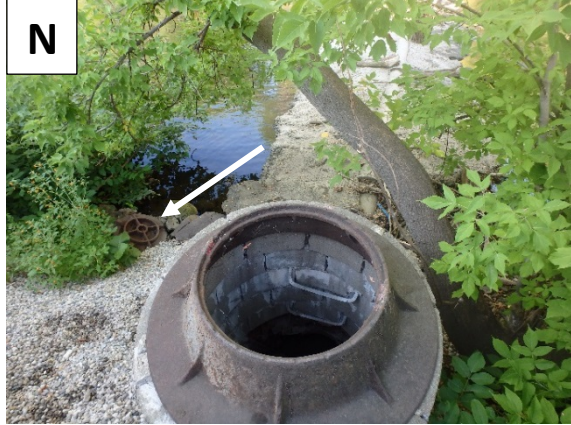
N

Sewer manhole at location of sewer crossing; note the manhole lid had been displaced. The lid was subsequently replaced by City staff.

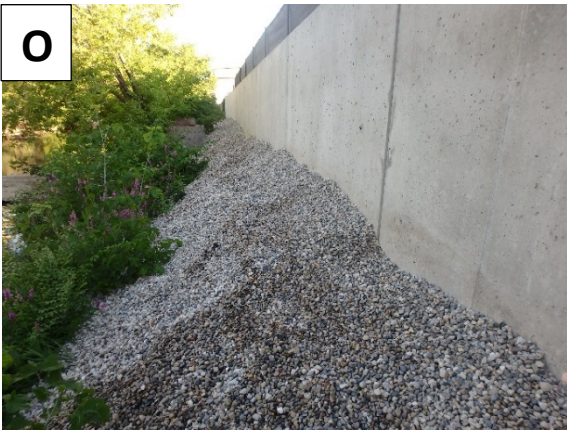
O

Section of east bank at sewer crossing. Gravel appears to have been placed at the toe of the recently constructed concrete wall.

- **Bank materials (east bank)** – Immediately upstream of Neeve Street, the (stone and mortar) retaining wall along the east bank was in disrepair (undercut, fractured, stone in places with minimal mortar remaining). Near the sanitary sewer crossing (See **Figure 3-4**), the east bank wall appeared to have been recently replaced/repared with a concrete wall; small gravel extended from the concrete wall to the river's edge.

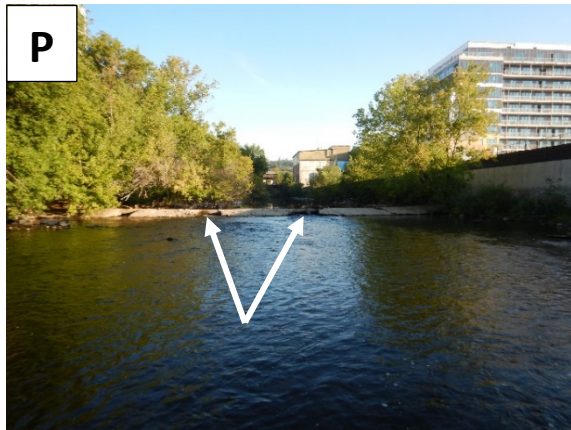
P

Looking upstream at the existing sewer crossing and pointing to the gaps between the concrete.

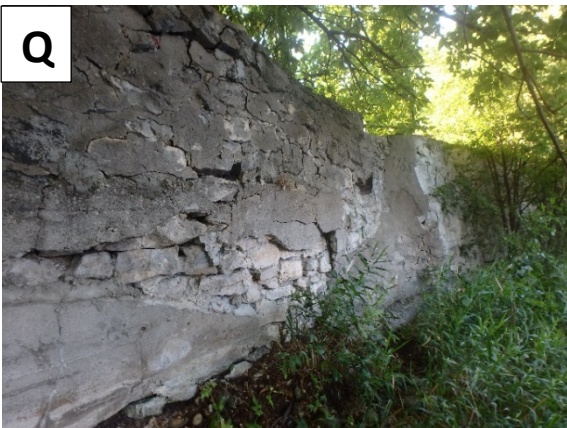
Q

Condition of the existing east bank retaining wall upstream of Neeve Street
