# Environmental Impact Study (EIS)

York Road Environmental Design

City of Guelph

March, 2017

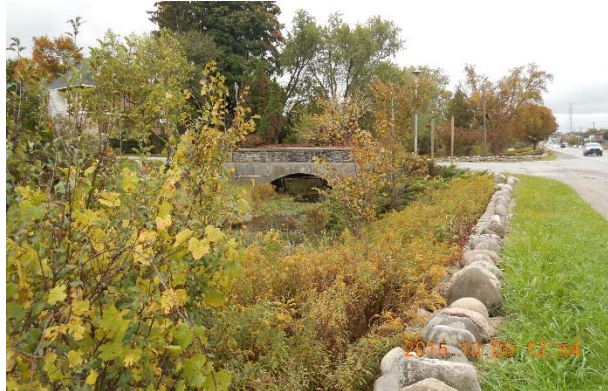
### Reformatory Entranceway

This feature includes hand-laid stone walls, bridge, weirs and circular wall terminus structures. As with the other features on the Reformatory property, these features were built by inmates and help to tell the story of the site.

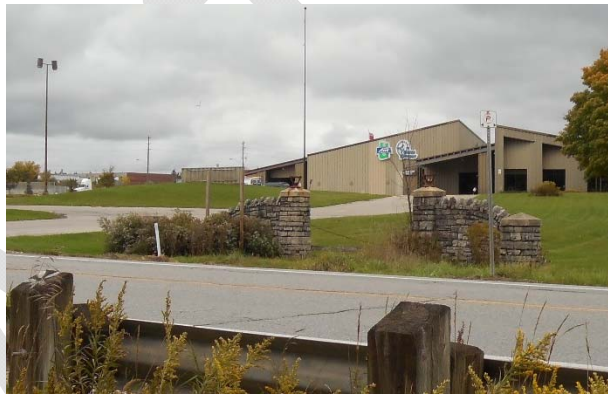
### Gateway

This high-integrity hand-laid stone gateway is located at the east extent of the York District (Reformatory) property.

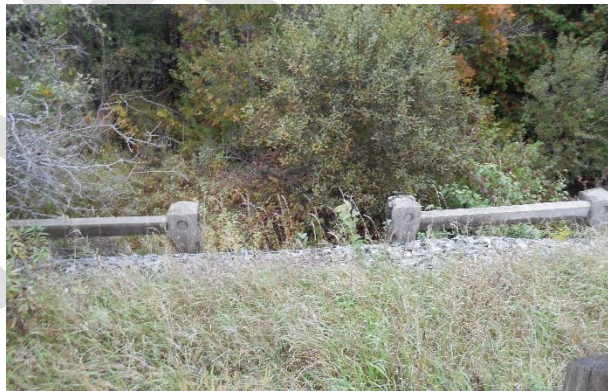
### Bridge Railing

Although currently partially embedded within a gabion basket wall, an existing bridge railing located on the north side of the culvert immediately east of 850 York Road, holds heritage value as it bears the mark of an architect who was instrumental in forming the City of Guelph. As this culvert will require resizing, this railing will require relocation.

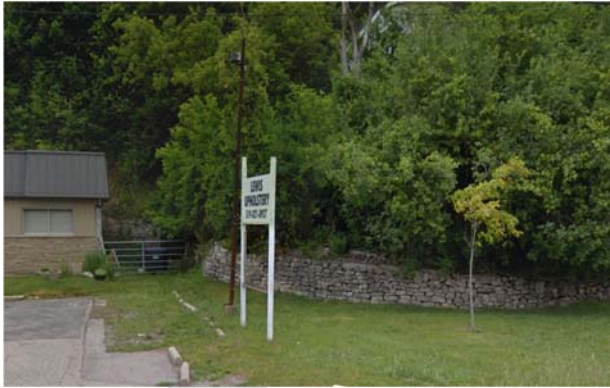
<p><b>Stone Retaining Wall</b></p> <p>A stone wall with identified heritage value is located immediately east of the Publix Variety/Lewis Upholstery complex located at 804 York Road.</p>

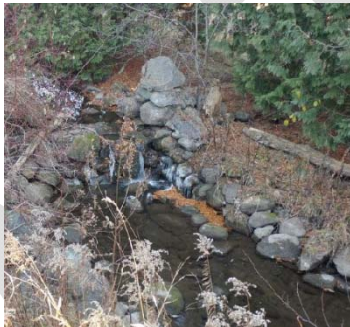
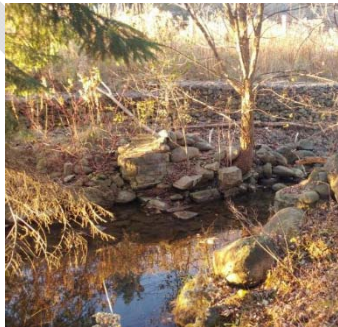
<p><b>In-Water Features</b></p> <p>Preservation of two weirs located in close proximity to the proposed roadway are to potentially be maintained through the use of retained soil systems (RSS). These two features are located approximately midway between the Reformatory Entrance and the eastern limits of the Reformatory property.</p>
