APPENDIX A

HERITAGE IMPACT ASSESSMENT York Road Environmental Design Study	
Location of the Study Area	
PROJECT N°:	TP115100
DATE:	07 Mar 2017
Amec Foster Wheeler Environment and Infrastructure 505 Woodward Ave., Hamilton, ON L8H 6N6 tel: 905-312-0700 www.amec.com	
FIGURE:	1

APPENDIX B - PHOTOGRAPHIC RECORD

PROJECT NO. TP115100
PROJECT HIA York Rd. Environmental Design Study
LOCATION Guelph, Ontario

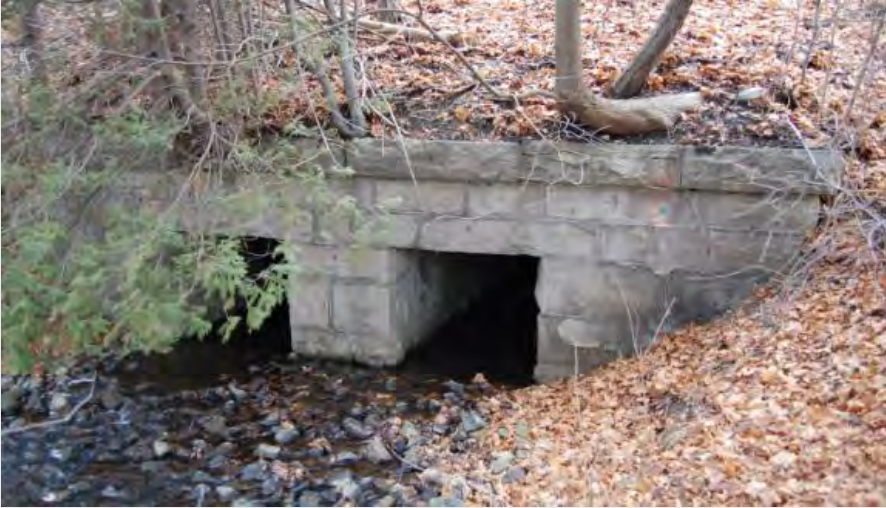
<table border="1"><tr><td>PHOTOGRAPH</td><td>1</td></tr></table>	PHOTOGRAPH	1				
PHOTOGRAPH	1						
<table border="1"><thead><tr><th colspan="2">Description</th></tr></thead><tbody><tr><td colspan="2">Ashlar Stone Culvert</td></tr><tr><td colspan="2">Potential BHR</td></tr></tbody></table>		Description		Ashlar Stone Culvert		Potential BHR	
Description							
Ashlar Stone Culvert							
Potential BHR

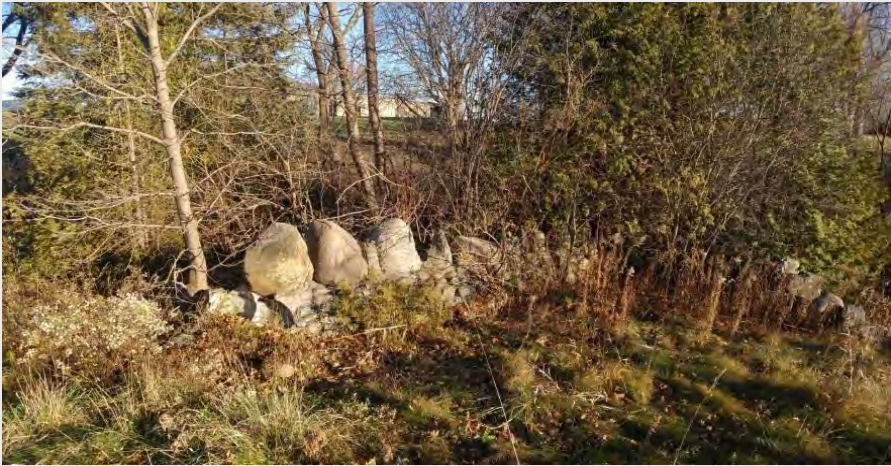
PHOTOGRAPH	3c
	Description Fieldstone sentinel stones Listed, non-designated

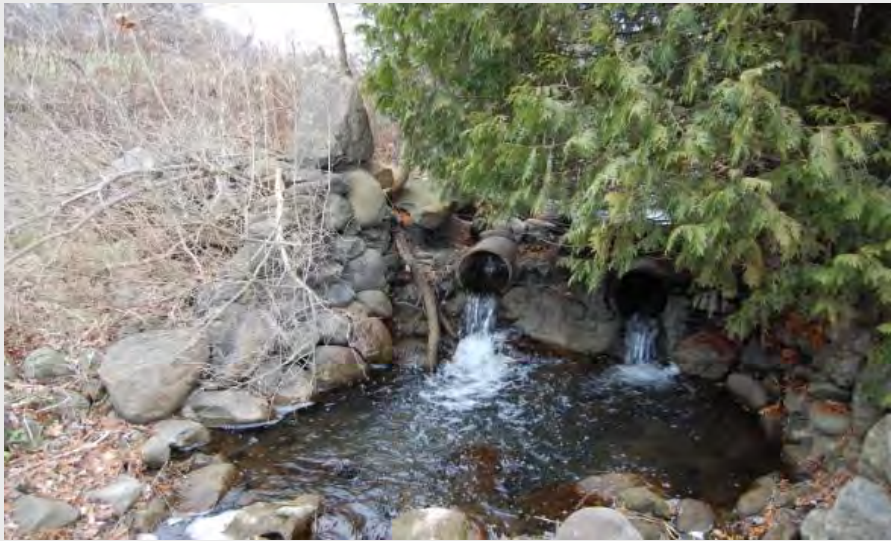
PHOTOGRAPH	5
Description	
Fieldstone weir Listed, non-designated

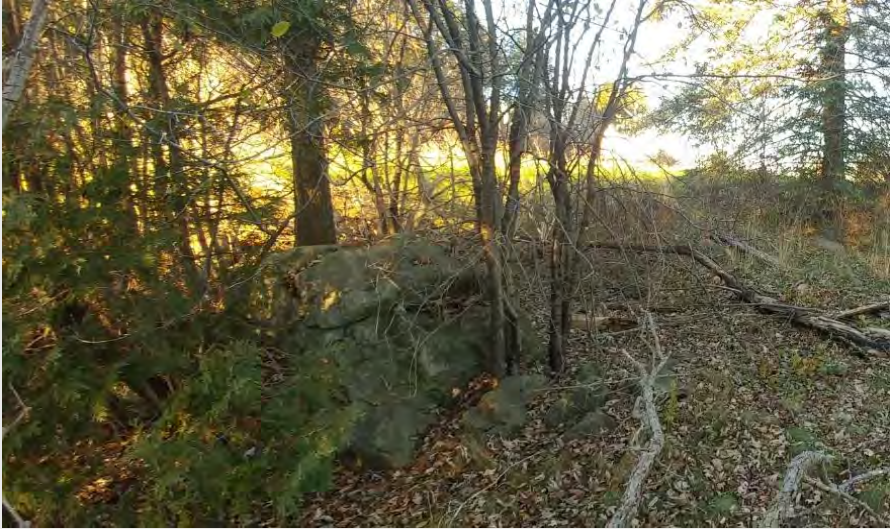
PHOTOGRAPH	7
Description	
Large boulder Potential BHR

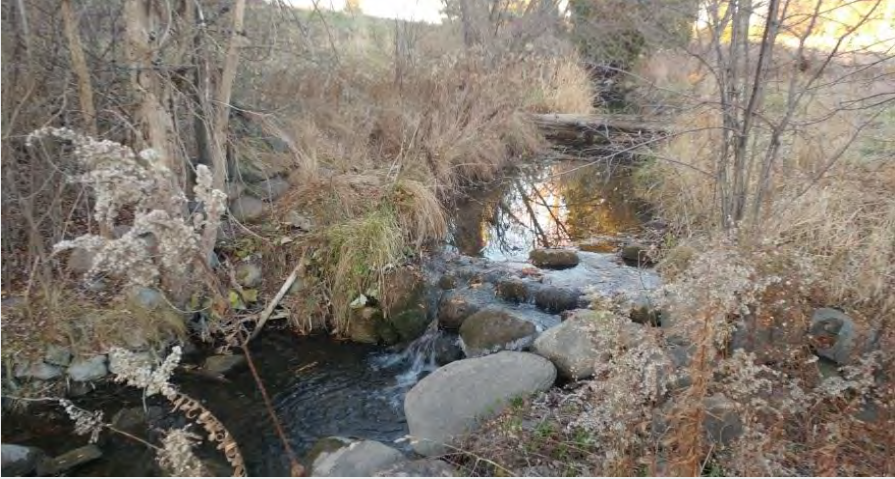
PHOTOGRAPH	8
Description	
Fieldstone weir Listed, non-designated

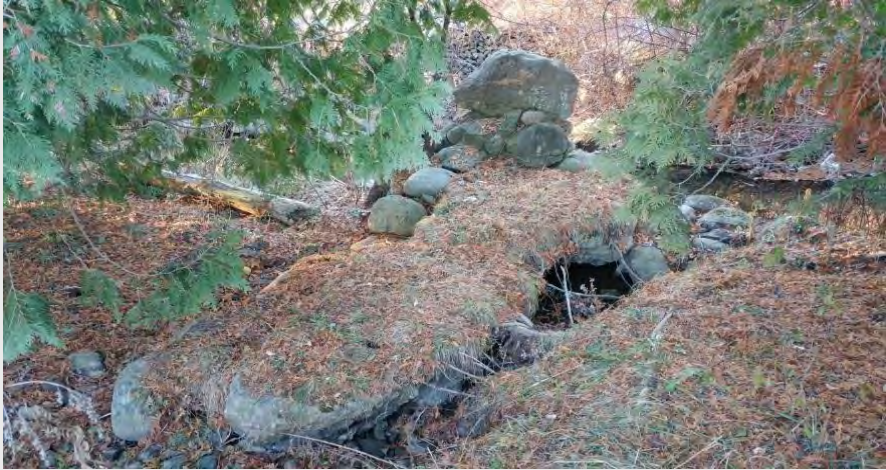
<table border="1"><tr><td>PHOTOGRAPH</td><td>9c</td></tr></table>	PHOTOGRAPH	9c
PHOTOGRAPH	9c		
<table border="1"><thead><tr><th>Description</th></tr></thead><tbody><tr><td>Fieldstone weir Listed, non-designated</td></tr></tbody></table>		Description	Fieldstone weir Listed, non-designated
Description			
Fieldstone weir Listed, non-designated

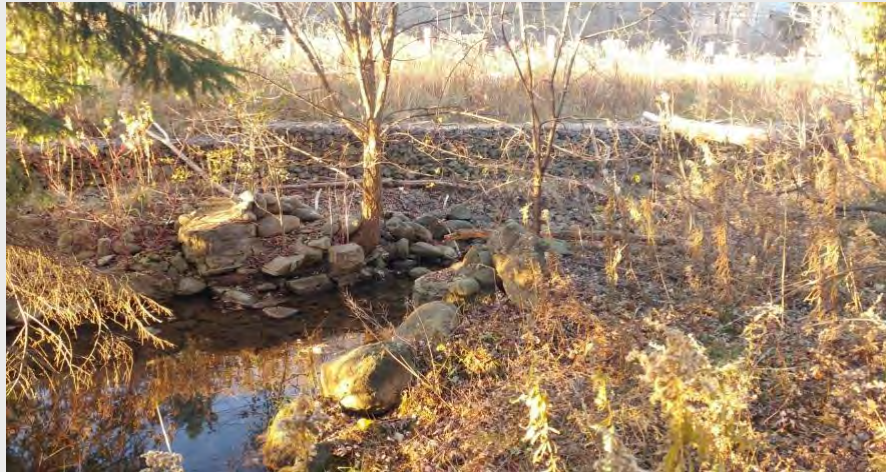
<table border="1"><tr><td>PHOTOGRAPH</td><td>10</td></tr></table>	PHOTOGRAPH	10
PHOTOGRAPH	10		
<table border="1"><thead><tr><th>Description</th></tr></thead><tbody><tr><td>Fieldstone weir beside gambion baskets Listed, non-designated</td></tr></tbody></table>		Description	Fieldstone weir beside gambion baskets Listed, non-designated
Description			
Fieldstone weir beside gambion baskets Listed, non-designated

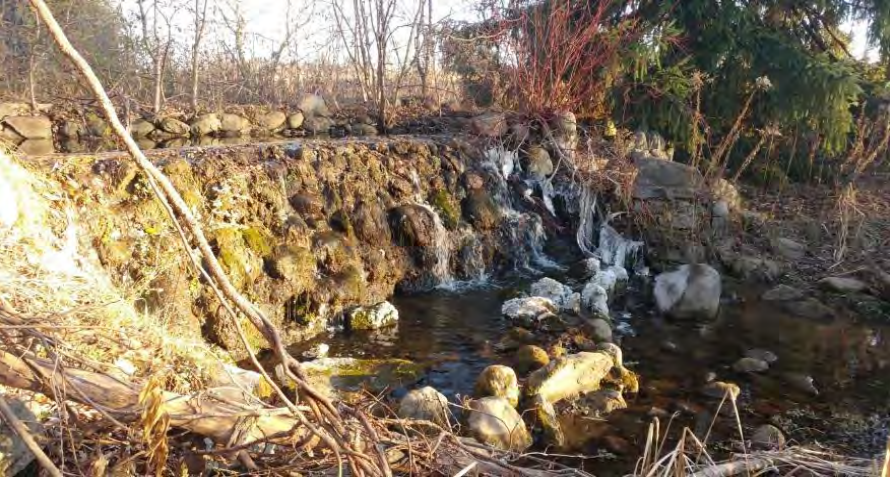
PHOTOGRAPH	11a
	Description Fieldstone weir, steps and ashlar stone terrace wall Listed, non-designated

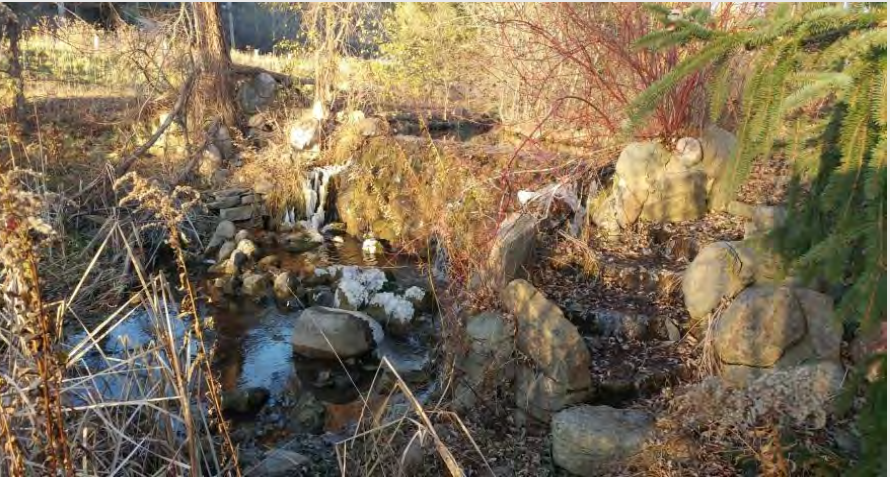
PHOTOGRAPH	11b
	Description Fieldstone weir, steps and ashlar stone terrace wall Listed, non-designated

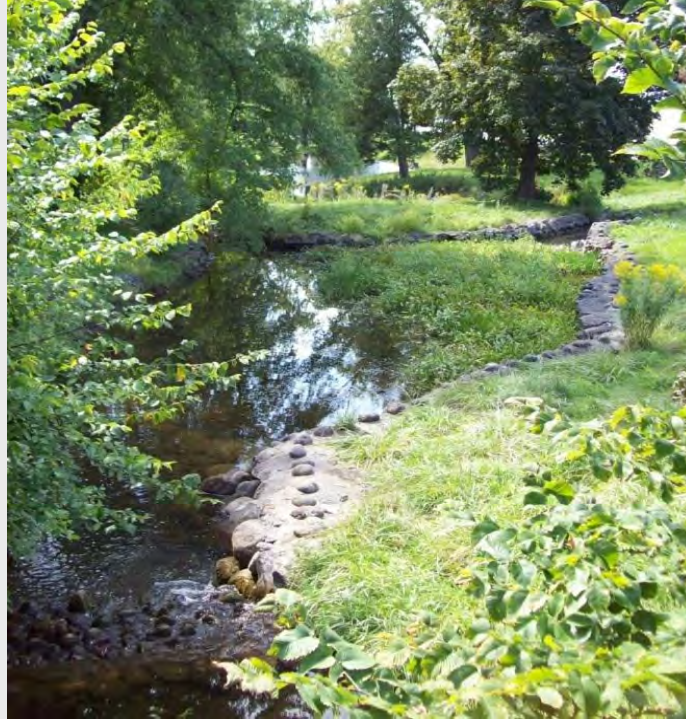
PHOTOGRAPH	23a
------------	-----

Description
Fieldstone weir and culvert Listed, non-designated

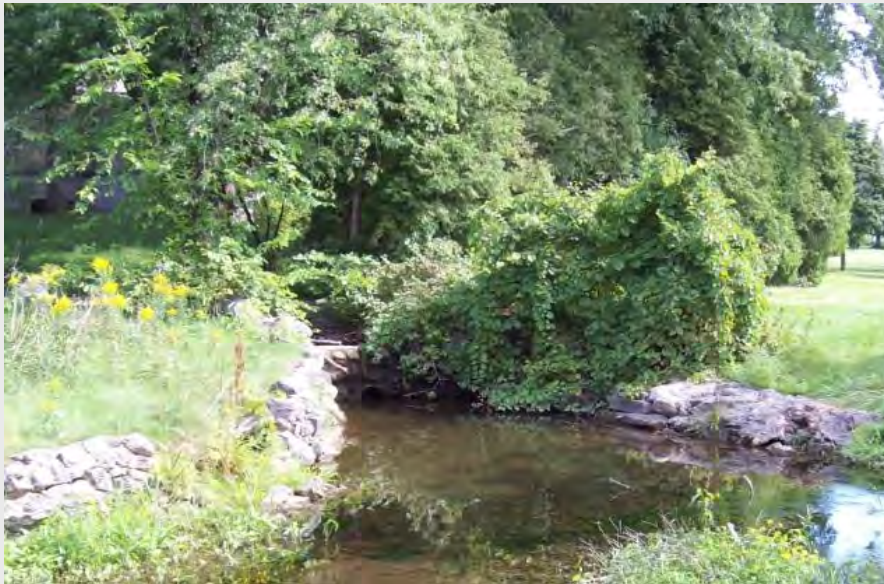
PHOTOGRAPH	23b
------------	-----

Description
Fieldstone weir and culvert Listed, non-designated

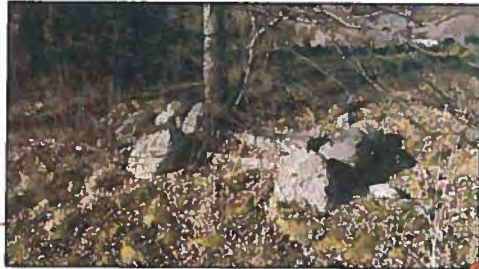
Feature #6: Fieldstone steps (listed, non-designated significant feature). No impact to feature anticipated.

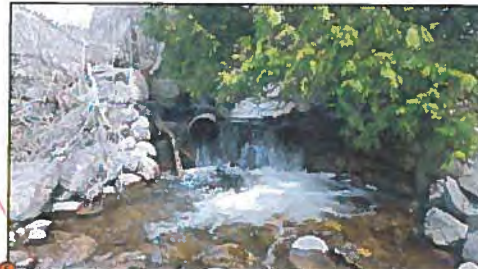
Feature #5: Fieldstone weir with clay pipes (listed, non-designated significant feature). No impact to feature anticipated. Feature is a substantial barrier to fish passage and limiting factor in overall channel function and health. Feature to be taken off-line/disconnected from active flow as a result of channel realignment. Feature will be maintained in landscape but will be impacted by loss of flow.

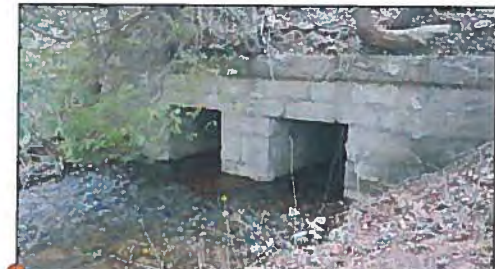
Feature #1: Aahar stone culvert (potential significance). No impact to feature anticipated.

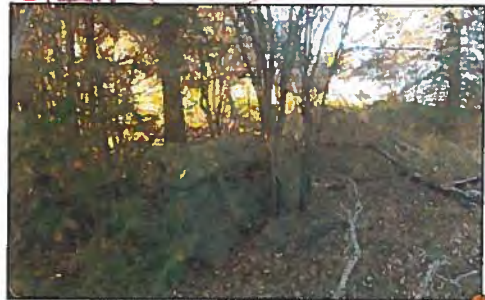
Feature #7: Large boulder or bedrock outcrop (potential significance). No impact to feature anticipated.

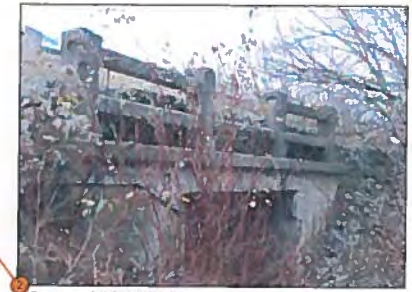
Feature #2: Reinforced concrete road bridge railing (potential significance). Feature to be modified to accommodate road widening works.

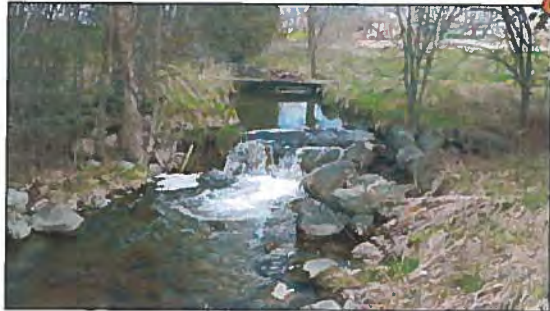
Feature #8: Fieldstone weir (listed, non-designated significant feature). No impact to feature anticipated. Feature is a substantial barrier to fish passage and limiting factor in overall channel function and health. Feature to be taken off-line/disconnected from active flow as a result of channel realignment. Feature will be maintained in landscape but will be impacted by loss of flow.

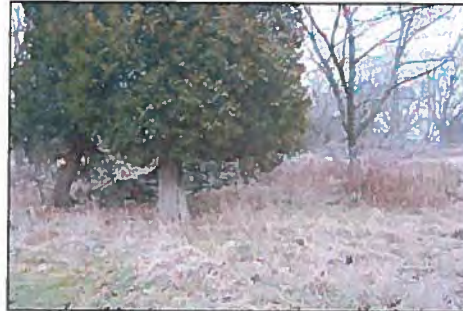
Feature #4: Fieldstone garden wall with sentinels (listed, non-designated significant feature). No impact to feature anticipated.

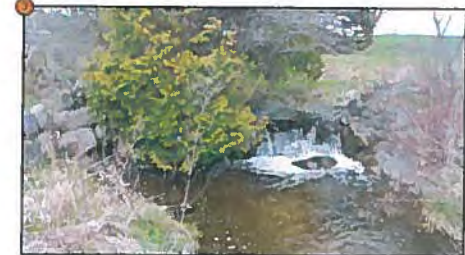
Feature #3: Fieldstone weir with steps and sentinel stones (listed, non-designated significant feature). Feature is a substantial barrier to fish passage and limiting factor in overall channel function and health. Feature to be taken off-line/disconnected from active flow as a result of channel realignment. Feature will be maintained in landscape but will be impacted by loss of flow.

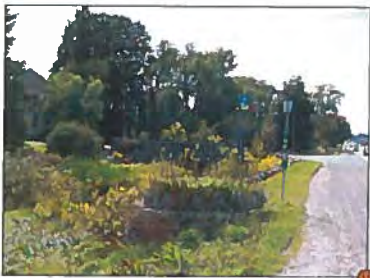
Feature #15: Fieldstone east entrance wall with sentinel stones (listed, non-designated significant feature). No impact to feature anticipated

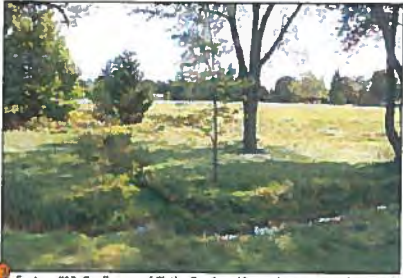
Feature #13: Confluence of Clythe Creek and intermittent stream (potential significance). Feature to be taken off-line/disconnected from active flow as a result of channel realignment. Tributary connection to Existing Clythe Creek will be filled. Existing groundwater draw to be incorporated and maintained within proposed re-alignment.

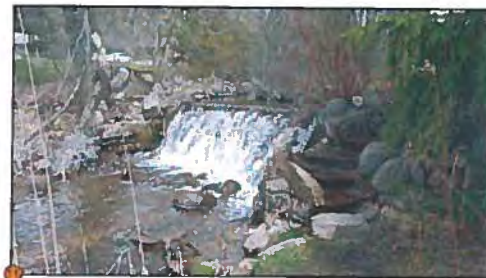
Feature #11: Fieldstone weir with steps and ashlar stone terrace wall (listed, non-designated significant feature). Feature is a substantial barrier to fish passage and limiting factor in overall channel function and health. Feature to be taken off-line/disconnected from active flow as a result of channel realignment. Feature will be maintained in landscape but will be impacted by loss of flow

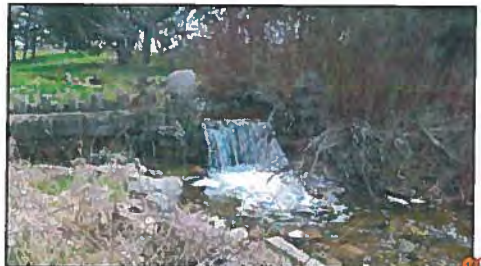
Feature #14: Fieldstone weir with cut stone terrace wall (listed, non-designated significant feature). Feature is a substantial barrier to fish passage and limiting factor in overall channel function and health. Feature to be taken off-line/disconnected from active flow as a result of channel realignment and maintained within landscape. Potential for overflow channel to reconnect during times of high-flow

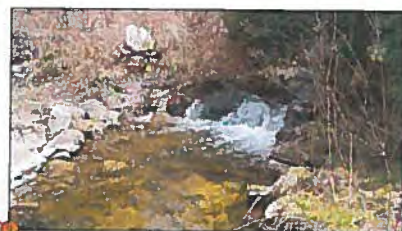
Feature #9: Fieldstone weir (listed, non-designated significant feature). No impact to feature anticipated. Feature is a substantial barrier to fish passage and limiting factor in overall channel function and health. Feature to be taken off-line as a result of channel realignment. Feature will be maintained in landscape but will be impacted by loss of flow

RETAINING WALL + EXCAVATION TO
 HAVE IMPACTS ON FEATURES #9 + 10.
 NEED TO STATE WHAT THOSE IMPACTS
 ARE. WHAT ALTERATIONS ARE BEING

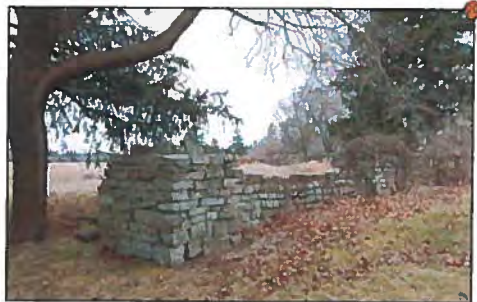
Feature #20: Ashlar dry stone wall (listed, non-designated significant feature). No impact to feature anticipated

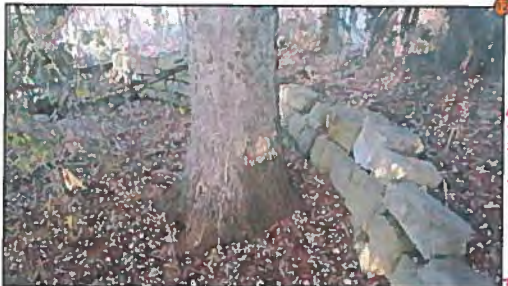
* Feature #12: Ashlar limestone wall (listed, non-designated significant feature). Part of feature impacted by proposed creek realignment.

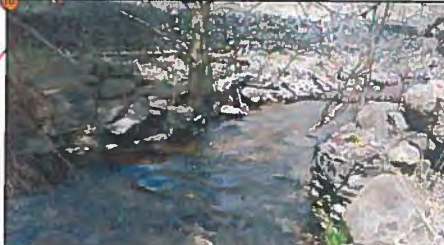
Feature #10: Fieldstone weir (listed, non-designated significant feature). No impact to feature anticipated. Feature is a substantial barrier to fish passage and limiting factor in overall channel function and health. Feature to be taken off-line/disconnected from active flow as a result of channel realignment. Feature will be maintained in landscape but will be impacted by loss of flow
