**HERITAGE IMPACT ASSESSMENT:  
YORK ROAD ENVIRONMENTAL DESIGN STUDY,  
GUELPH, ONTARIO**

**PROJECT NUMBER: TP115100**

**Revised August 2019**

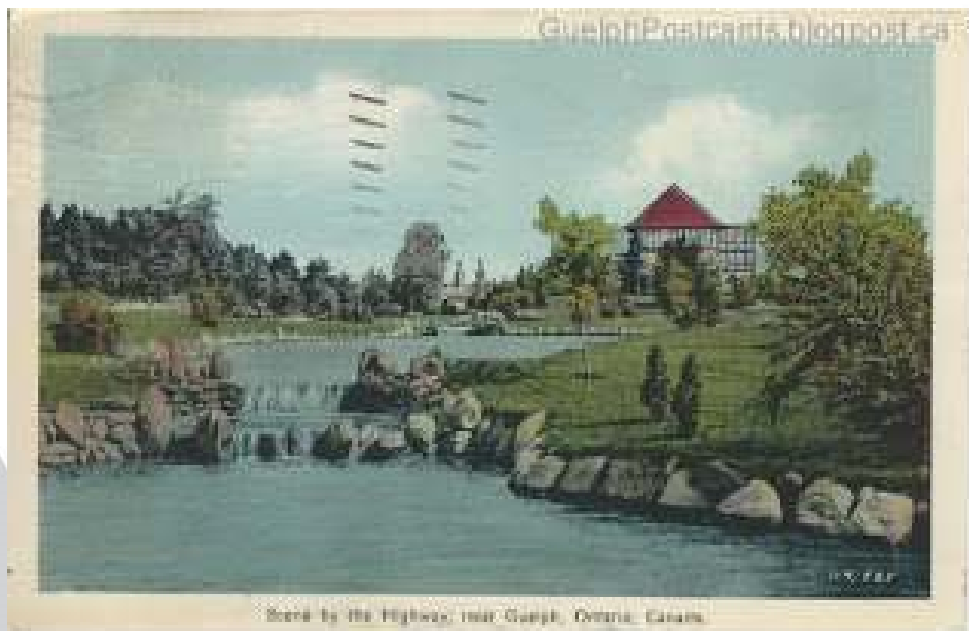
**Photograph 2: 1935 Postcard Showing Water Falling over Weirs:**  
<http://guelphpostcards.blogspot.ca/search/label/Guelph%20Correctional%20Centre>

This circa 1935 postcard is entitled: "Scene by the Highway, near Guelph, Ontario, Canada. " There is no mention of the Guelph Correctional Centre.

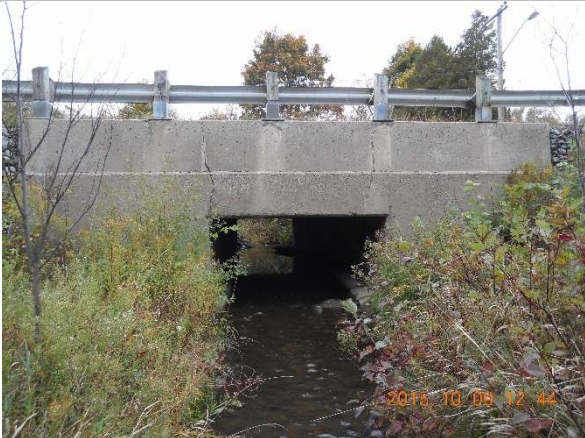
<p>Bridge shown from the south side of York Road. Clythe Creek passes through the culvert under the road at this location.<sup>3</sup></p>	<p><b>Relocation or Removal:</b>            Bridge/culvert would be removed and replaced with a wider arched culvert for the road widening.</p>	<p>No mitigation</p>
2

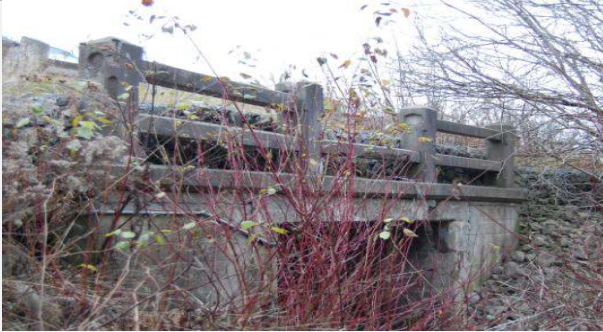
<p>Reinforced concrete road bridge railing (remnant) circa 1920 on the north side of York Road.</p>	<p><b>Relocation or Removal:</b>            This feature would be removed due to road widening and multi-use path.</p>	<p>If possible, relocation within the GCC or to other parts of Guelph in order to better accommodate conservation and adaptive reuse. The appropriate context of the resource must be considered in relocation. Partial salvage, documentation through measured drawings and high-resolution digital photographs, and/or historical plaquing.</p>

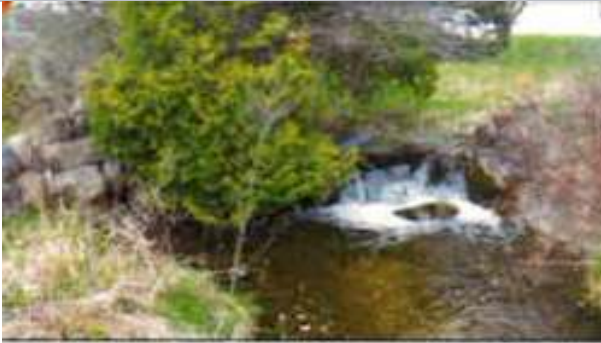
<p>Fieldstone weir with steps and sentinel stones. This is a barrier to fish passage.</p>	<p><b>Maintained in situ:</b> This feature would be maintained in landscape but will be impacted by loss of flow as a result of channel realignment.</p>	<p>May require repairs. This would be decided during the preparation of a Conservation Plan by a qualified heritage consultant. Where possible, creek realignment design should incorporate the 'high-flow' channel to convey higher flows over the weir structure.</p>
4

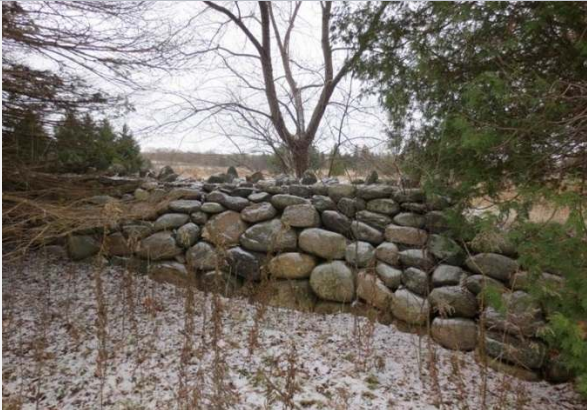
<p>Fieldstone garden wall with sentinel stones.</p>	<p><b>No Impact:</b> Wall to remain in existing condition</p>	<p>May require repairs. This would be decided during the preparation of a Conservation Plan by a qualified heritage consultant.</p>
5

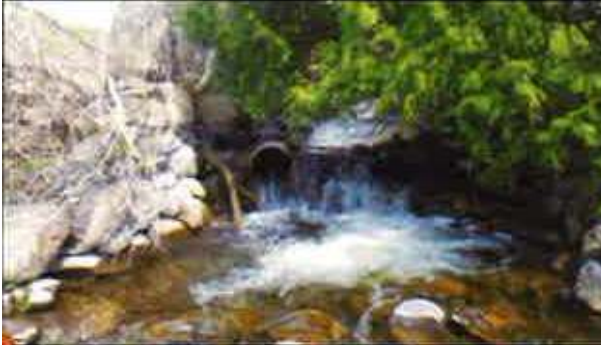
<p>Fieldstone weir with clay pipes. This is a barrier to fish passage.</p>	<p><b>Maintained in situ:</b> This feature would be maintained in landscape but would be impacted by loss of flow as a result of channel realignment</p>	<p>May require repairs. This would be decided during the preparation of a Conservation Plan by a qualified heritage consultant. Where possible, creek realignment design should incorporate the 'high-flow' channel to convey higher flows over the weir structure.</p>

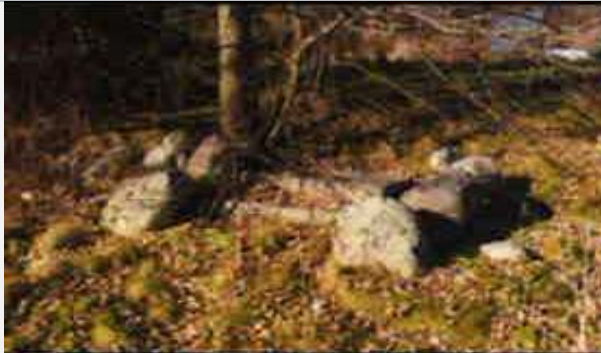
<p data-bbox="298 674 493 705">Fieldstone steps.</p>	<p data-bbox="911 317 1045 380"><b>Potentially impacted:</b></p> <p data-bbox="911 380 1143 499">The steps may be covered by grading for road and pathway.</p>	<p data-bbox="1170 317 1419 926">If possible, relocation within the GCC or to other parts of Guelph in order to better accommodate conservation and adaptive reuse. The appropriate context of the resource must be considered in relocation. Partial salvage, documentation through measured drawings and high-resolution digital photographs, and/or historical plaquing.</p>
7

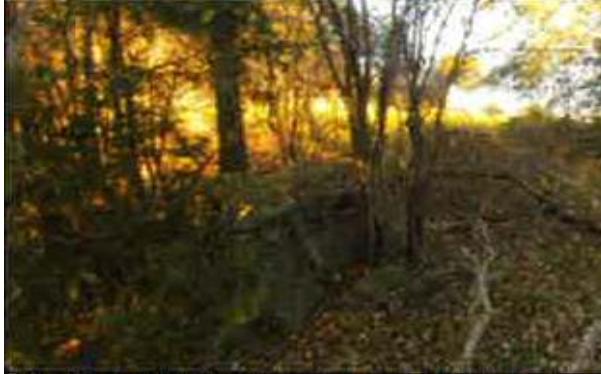
<p data-bbox="298 1346 704 1377">Large Boulder or bedrock outcrop.</p>	<p data-bbox="911 968 1045 1031"><b>Potentially impacted:</b></p> <p data-bbox="911 1031 1110 1150">This feature may be covered by grading for road and pathway</p>	<p data-bbox="1170 968 1419 1577">If possible, relocation within the GCC or to other parts of Guelph in order to better accommodate conservation and adaptive reuse. The appropriate context of the resource must be considered in relocation. Partial salvage, documentation through measured drawings and high-resolution digital photographs, and/or historical plaquing.</p>

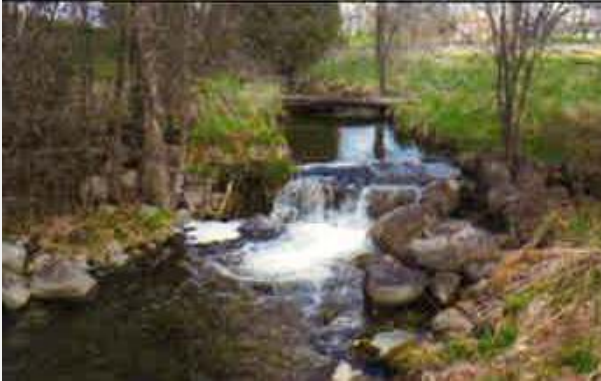
<p>Fieldstone weir. This is a barrier to fish passage</p>	<p><b>Maintained in situ:</b> The weir would be maintained in landscape but would be impacted by loss of flow as a result of channel realignment.</p>	<p>May require repairs. This would be decided during the preparation of a Conservation Plan by a qualified heritage consultant. Where possible, creek realignment design should incorporate the 'high-flow' channel to convey higher flows over the weir structure.</p>
9

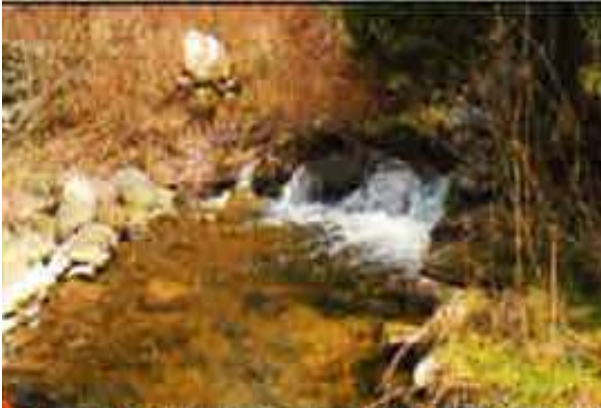
<p>Fieldstone weir beside gabion baskets. (Gabion baskets are not part of listed heritage resource).</p>	<p><b>Removal or possibly maintained in situ:</b> This feature would be removed due to grading for road widening and multi-use path. If a proposed retaining wall is built it could be maintained in the landscape but will be impacted by loss of flow.</p>	<p>If possible, relocation within the GCC or to other parts of Guelph in order to better accommodate conservation and adaptive reuse. The appropriate context of the resource must be considered in relocation. Partial salvage, documentation through measured drawings and high-resolution digital photographs, and/or historical plaquing.</p>

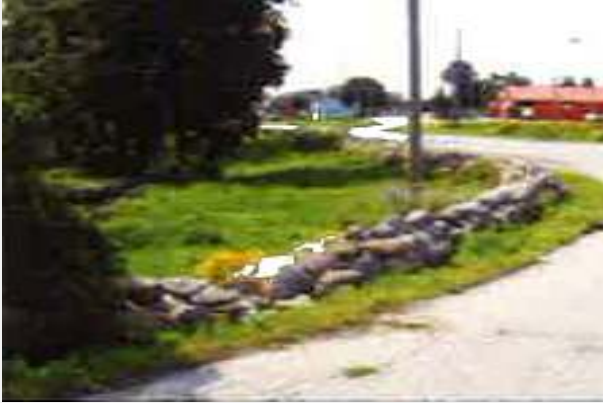
<p data-bbox="300 724 868 808">Roughly squared stones cut from the limestone quarry and fieldstone west entrance wall, curved with sentinel stones.</p>	<p><b>Relocation:</b> This feature would be removed due to grading needed for road widening and multi-use path.</p>	<p>This structure would be removed and reconstructed back further from the road by skilled heritage masons. The details of the reconstruction would be decided during the preparation of a Conservation Plan by a qualified heritage consultant. See Drawing 1 on page 4.</p>
17

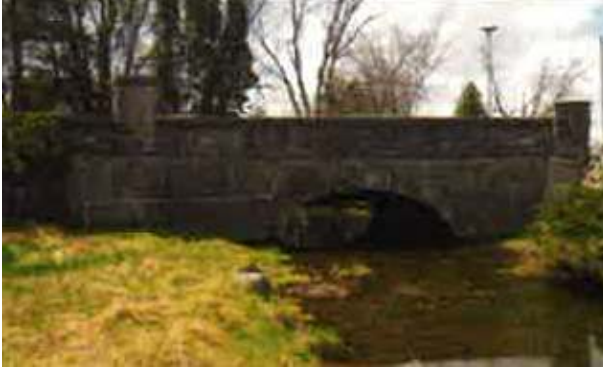
<p data-bbox="300 1249 673 1270">Stone and concrete road bridge.</p>	<p><b>No Impact:</b> Feature to remain in existing location.</p>	<p>May require repairs. This would be decided during the preparation of a Conservation Plan by a qualified heritage consultant.</p>
18

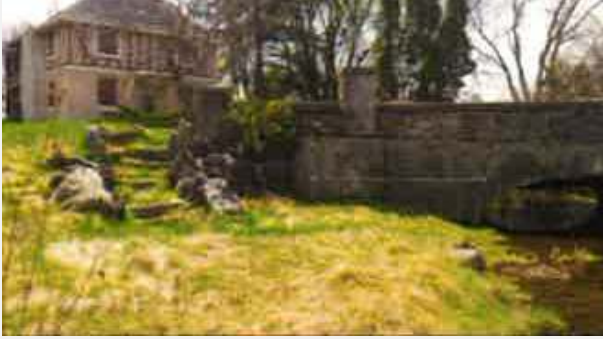
<p data-bbox="300 1619 820 1640">Fieldstone steps to the south of road bridge.</p>	<p><b>No Impact:</b> Feature to remain in existing location.</p>	<p>May require repairs. This would be decided during the preparation of a Conservation Plan by a qualified heritage consultant.</p>

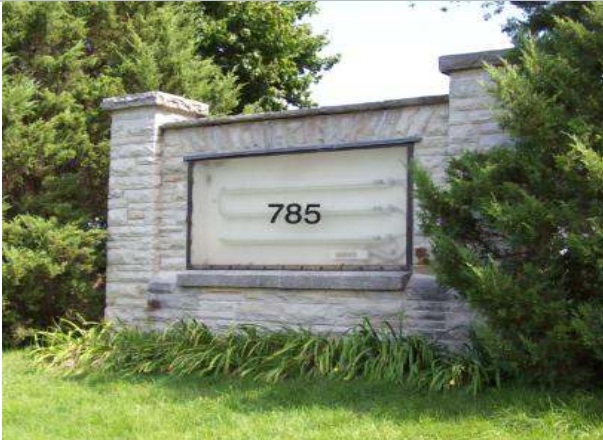
<p>Entrance sign, ashlar, rock-faced limestones with jack arch.</p>	<p><b>No Impact:</b> Feature to remain in existing location.</p>	<p>May require repairs. This would be decided during the preparation of a Conservation Plan by a qualified heritage consultant.</p>
20

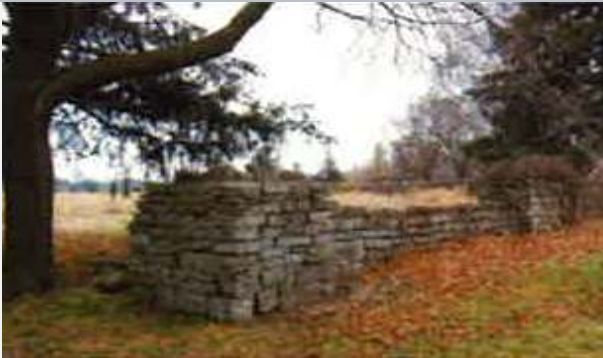
<p>Ashlar dry stone wall.</p>	<p><b>No Impact:</b> Feature is located within the floodplain and will not be impacted by proposed channel works. Feature is to remain in existing location.</p>	<p>May require repairs. This would be decided during the preparation of a Conservation Plan by a qualified heritage consultant.</p>
21

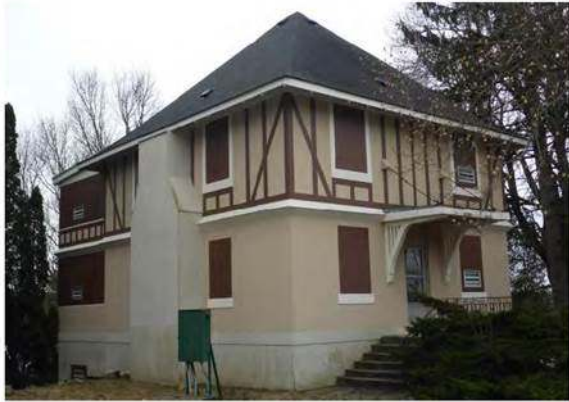
<p>Willowbank Hall (B13498) - North-East Elevation Willowbank Hall.</p>	<p><b>No Impact:</b> Feature to remain in existing location.</p>	<p>If it is to be part of the Conservation Plan, it may be rehabilitated. This would be decided during the preparation of a Conservation Plan by a qualified heritage consultant.</p>

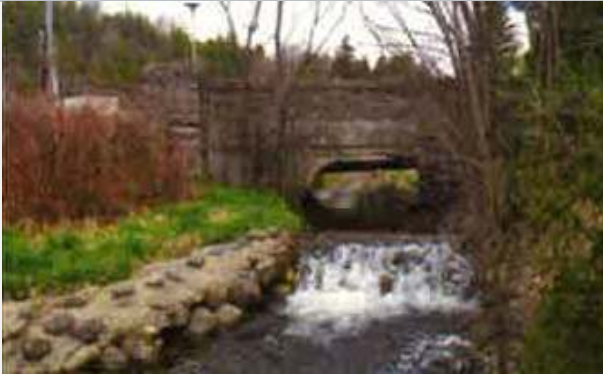
<p data-bbox="300 688 898 961">Fieldstone weir.</p>	<p data-bbox="914 317 1133 380"><b>Relocation or Removal:</b></p> <p data-bbox="914 380 1133 499">This feature would be removed as a result of channel work.</p>	<p data-bbox="1175 317 1411 926">If possible, relocation within the GCC or to other parts of Guelph in order to better accommodate conservation and adaptive reuse. The appropriate context of the resource must be considered in relocation. Partial salvage, documentation through measured drawings and high-resolution digital photographs, and/or historical plaquing.</p>
23

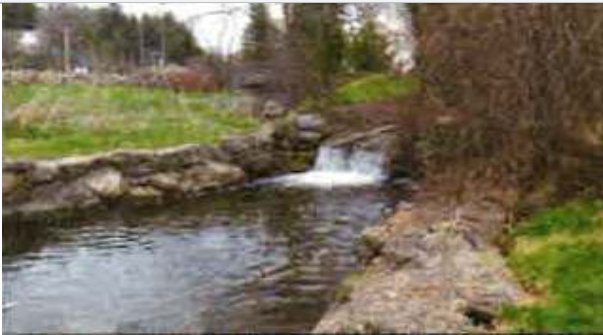
<p data-bbox="300 1293 898 1493">Fieldstone weir and culvert.</p>	<p data-bbox="914 961 1133 1024"><b>Maintained in situ:</b></p> <p data-bbox="914 1024 1133 1241">Feature would be maintained in landscape but would be impacted by loss of flow as a result of channel realignment.</p>	<p data-bbox="1175 961 1411 1486">May require repairs. This would be decided during the preparation of a Conservation Plan by a qualified heritage consultant. Where possible, creek realignment design should incorporate the 'high-flow' channel to convey higher flows over the weir structure.</p>

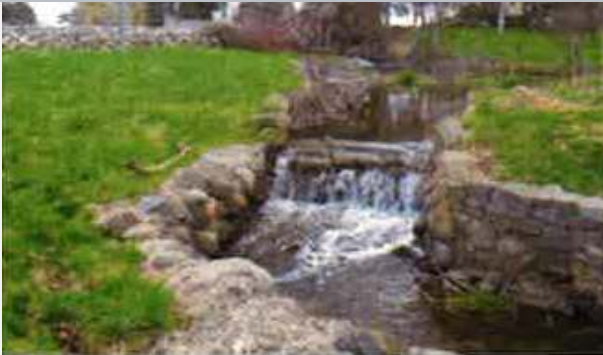
<p data-bbox="300 1845 898 1873">Fieldstone weir and culvert.</p>	<p data-bbox="914 1493 1133 1556"><b>Relocation or Removal:</b></p> <p data-bbox="914 1556 1133 1738">This feature would be removed as a result of channel work and grading for roadway and pathway.</p>	<p data-bbox="1175 1493 1411 1709">Partial salvage, documentation through measured drawings and high-resolution digital photographs, and/or historical plaquing.</p>

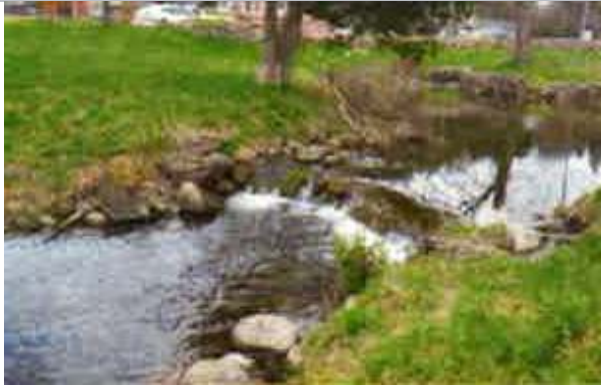
<p data-bbox="298 699 487 730">Fieldstone weir.</p>	<p data-bbox="911 317 1084 373"><b>Relocation or Removal:</b></p> <p data-bbox="911 380 1130 562">This feature would be removed as a result of channel work and grading for roadway and pathway.</p>	<p data-bbox="1170 338 1416 926">If possible, relocation within the GCC or to other parts of Guelph in order to better accommodate conservation and adaptive reuse. The appropriate context of the resource must be considered in relocation. Partial salvage, documentation through measured drawings and high-resolution digital photographs, and/or historical plaquing.</p>
26

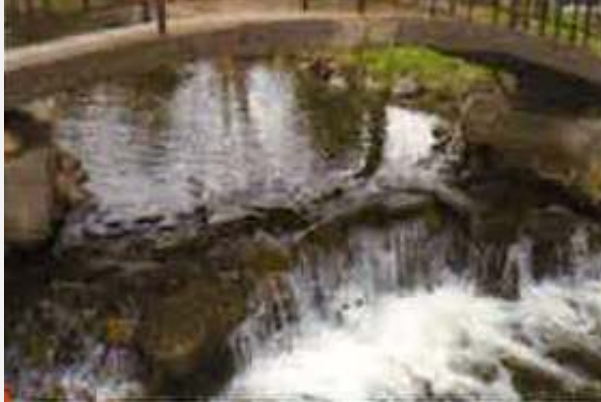
<p data-bbox="298 1367 487 1398">Fieldstone weir.</p>	<p data-bbox="911 968 1084 1024"><b>Relocation or Removal:</b></p> <p data-bbox="911 1031 1130 1146">This feature would be removed as a result of channel work.</p>	<p data-bbox="1170 968 1416 1577">If possible, relocation within the GCC or to other parts of Guelph in order to better accommodate conservation and adaptive reuse. The appropriate context of the resource must be considered in relocation. Partial salvage, documentation through measured drawings and high-resolution digital photographs, and/or historical plaquing.</p>

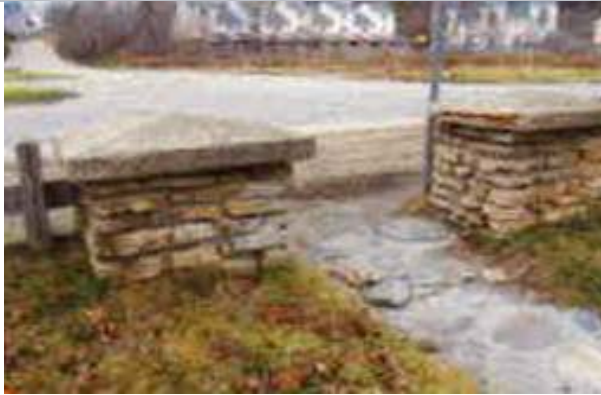
<p data-bbox="298 709 894 919">Limestone pillars with wood board fencing leading to main entrance.</p>	<p data-bbox="911 317 1148 533"><b>Relocation or Removal:</b> This feature would be removed due to grading needed for road widening and multi-use path.</p>	<p data-bbox="1170 317 1416 926">If possible, relocation within the GCC or to other parts of Guelph in order to better accommodate conservation and adaptive reuse. The appropriate context of the resource must be considered in relocation. Partial salvage, documentation through measured drawings and high-resolution digital photographs, and/or historical plaquing.</p>
28	  <p data-bbox="298 1398 894 1839">Metal and wood pedestrian bridge.</p>	<p data-bbox="911 932 1148 1234"><b>Potential Modification or Removal:</b> Potential for feature to be modified to accommodate pedestrian traffic or removed due to channel works.</p>	<p data-bbox="1170 932 1416 1818">The modifications to be developed during the preparation of a Conservation Plan by a qualified heritage consultant. If possible, relocation within the GCC or to other parts of Guelph in order to better accommodate conservation and adaptive reuse. The appropriate context of the resource must be considered in relocation. If removal is required, partial salvage, documentation through measured drawings and high-resolution digital photographs, and/or historical plaquing.</p>

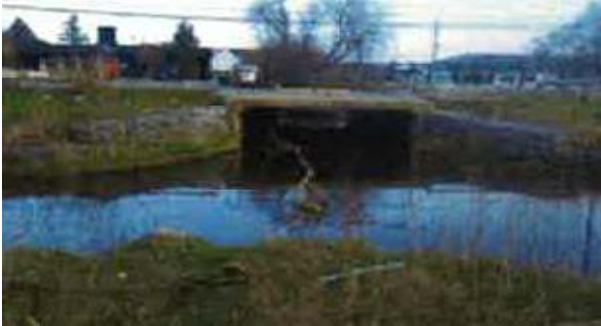
<p>Box culvert at confluence of Clythe Creek and Hadati Creek.</p>	<p><b>Potential Modification:</b> Culvert may be extended to accommodate roadway grading requirement and CSP replacement.</p>	<p>No Mitigation required.</p>
30	  <p>Concrete and stone weir.</p>	<p><b>Maintained in situ:</b> Feature would be maintained in landscape but would be impacted by loss of flow as a result of channel realignment.</p>	<p>May require repairs. This would be decided during the preparation of a Conservation Plan by a qualified heritage consultant. Were possible, creek realignment design should incorporate the 'high-flow' channel to convey higher flows over the weir structure.</p>
31	  <p>GJR railroad bridge.</p>	<p><b>No Impact:</b> Feature to remain in existing condition.</p>

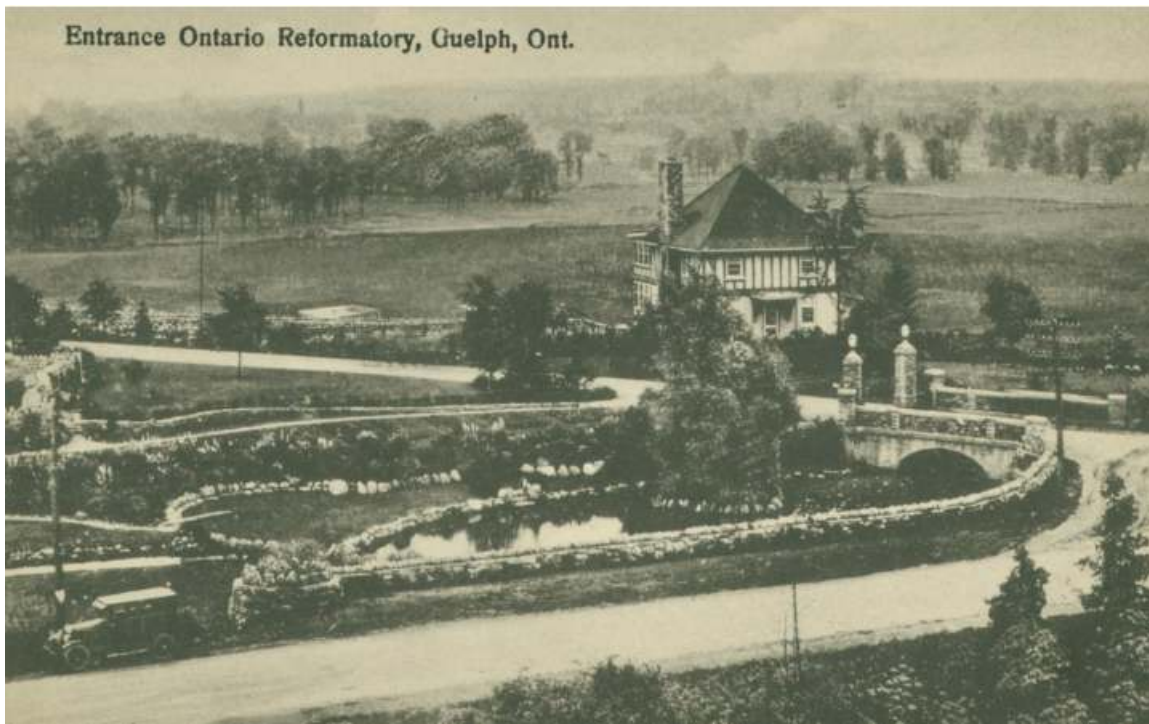
**Photograph 4: 1920's Picture of Dry Stone Wing Wall with Circular End Treatment. The height of the wall is noticeably taller. The existing wall has been partially buried due to road grading. Photo from the Guelph Civic Museum.**

interpretive signage, would improve the public's view and understanding of the history of the entranceway.

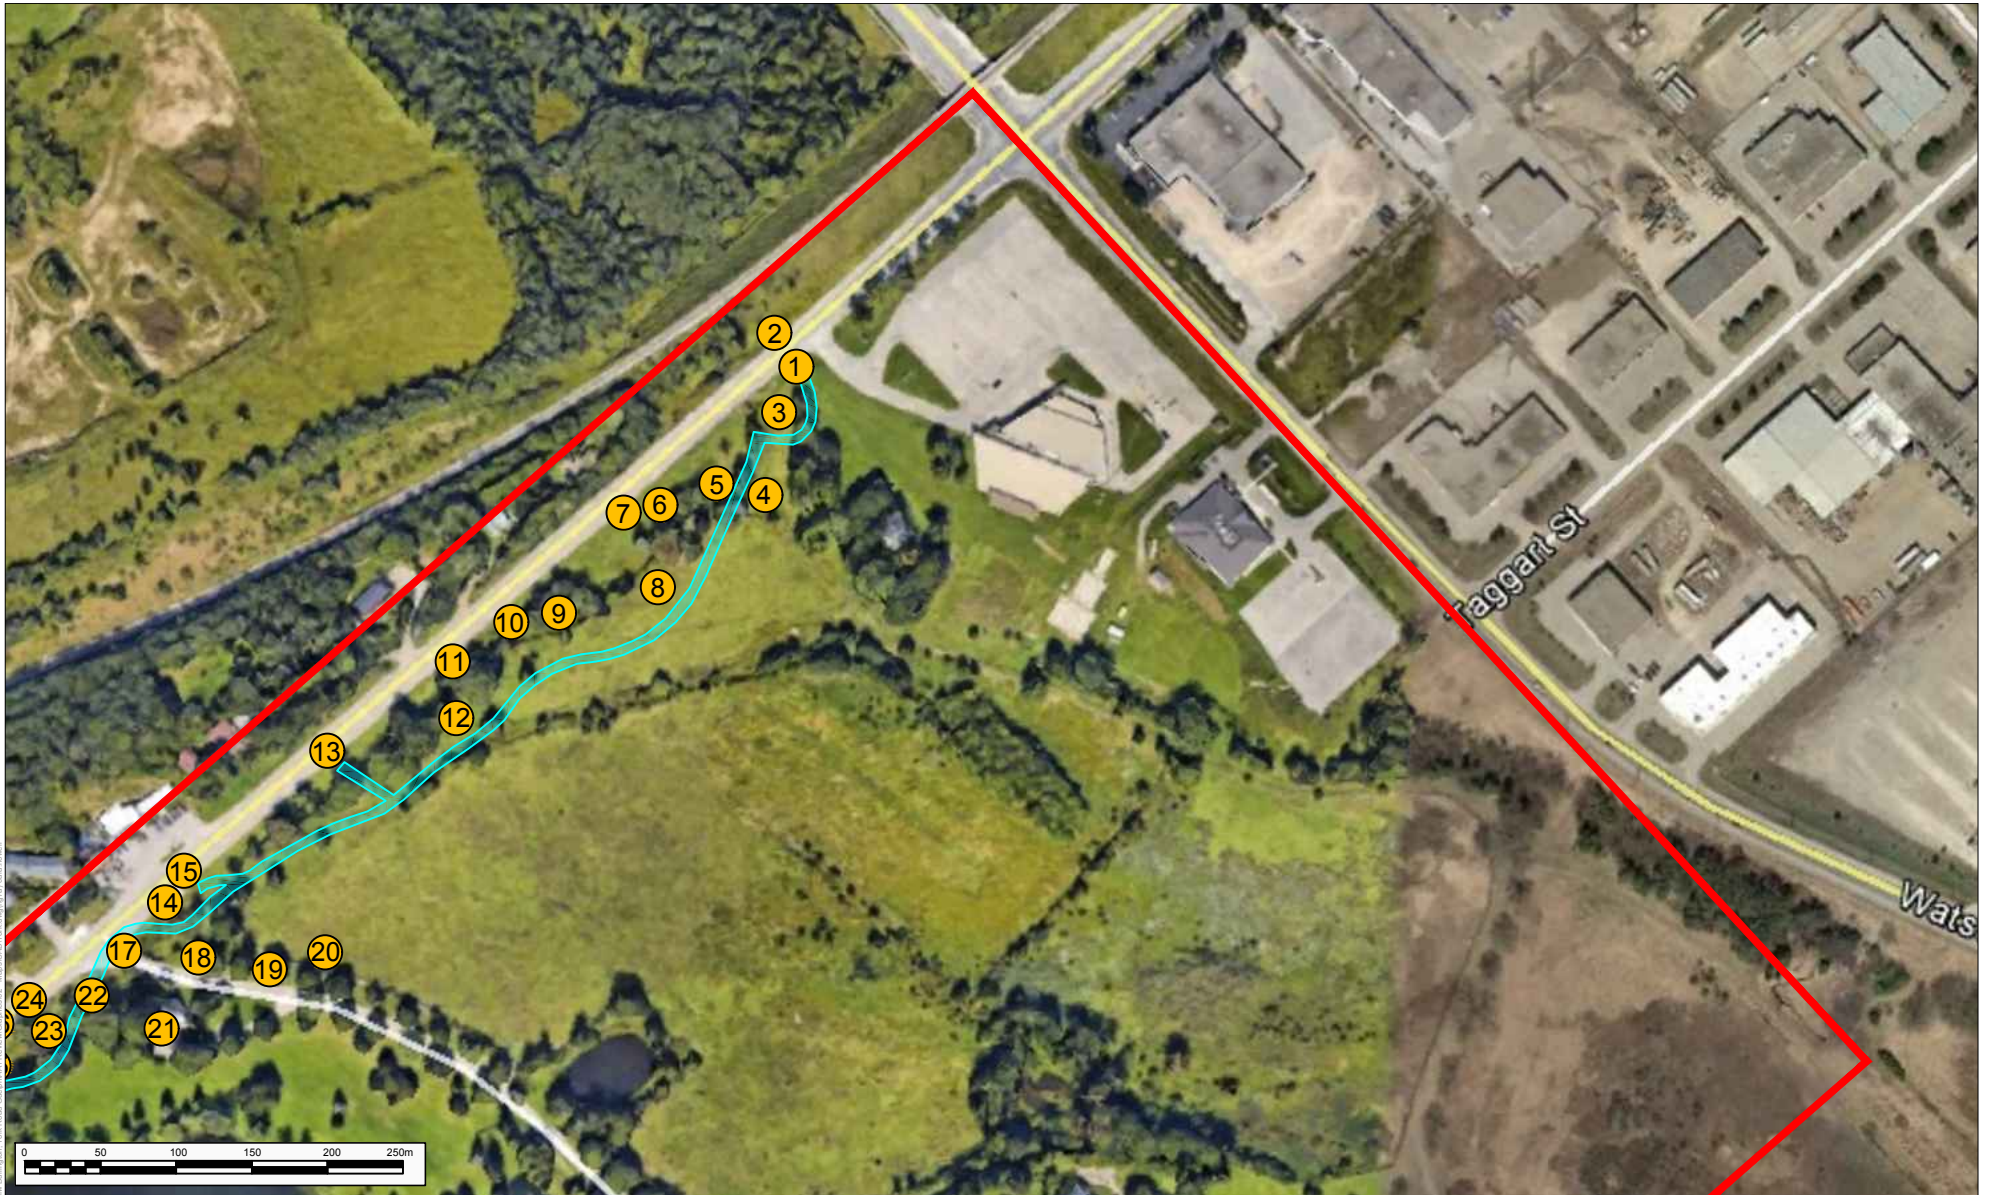
- Study area
- Proposed realignment Clythe Creek
- # Cultural heritage feature/structure

The potential re-alignment of Clythe Creek (Appendix A: Figure 7a, b and c), due to the potential widening of York Road and the natural heritage objective to create a cool/cold-water creek, would alter the overall look of the cultural heritage landscape in several ways. Furthermore, the widening of York Road could also potentially impact some of the heritage resources due to visibility, grading and road salt.

Appendix A: Figures 7a, b and c show the potential realignment of Clythe Creek (Option 4) and indicate numbers used in the Heritage Resources Table 3 below.
