Environmental Impact Study (EIS)

York Road Environmental Design Study
City of Guelph
Project # TP115100

Re: Final York Road Environmental Impact Study

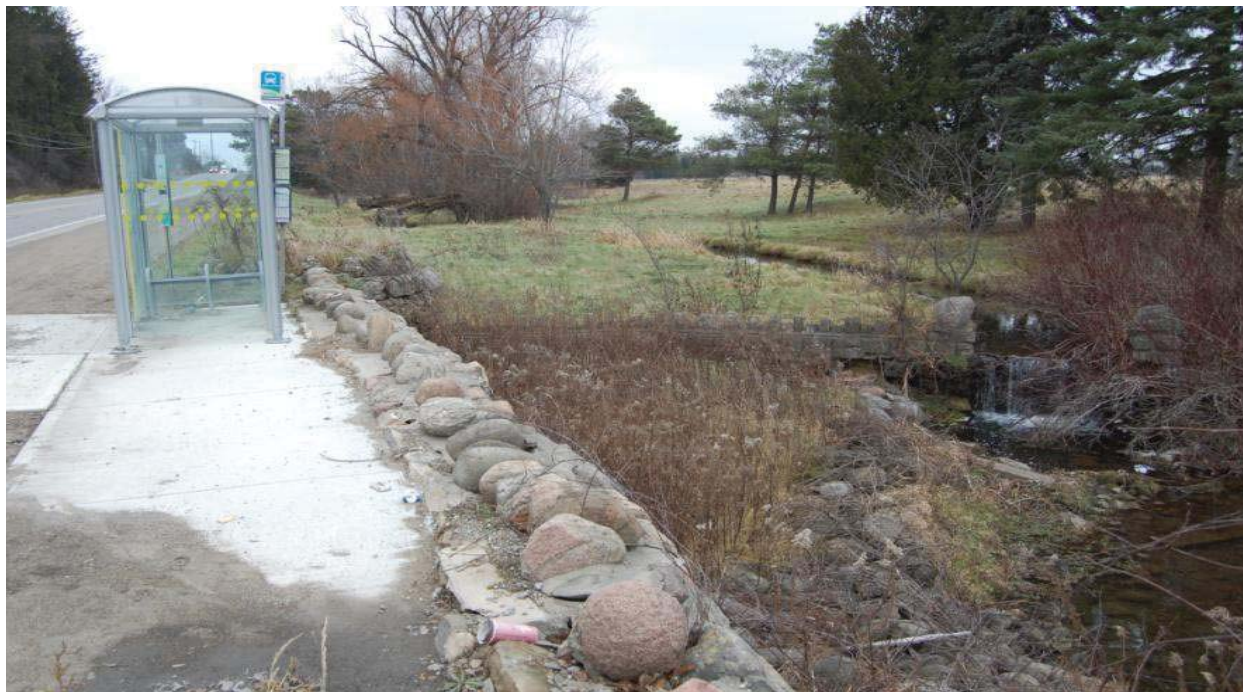
Photograph 1A: East side of entrance bridge. Only top of wall is visible

These quotes are based on phone conversations, emails, photographs (ref. Photographs 1A-5A) and plan drawings (ref. Sub- Appendix E, Appendix K2), and are considered to be preliminary cost estimates only. None of the stone masons visited the site for additional understanding of the wall reconstruction scope. Due to the limited nature of the information available, the preliminary cost estimates are considered to be lower than the anticipated construction costs. Detailed cost estimates from stone masons during the detailed design stage (when more information could be made available), and tender stage (requiring a mandatory site visit), would be expected to be significantly higher than the estimates received, based on the three (3) heritage masons not being able to assess the walls in detail through a site visit, and determine more accurately the potential scope for relocation of the walls.

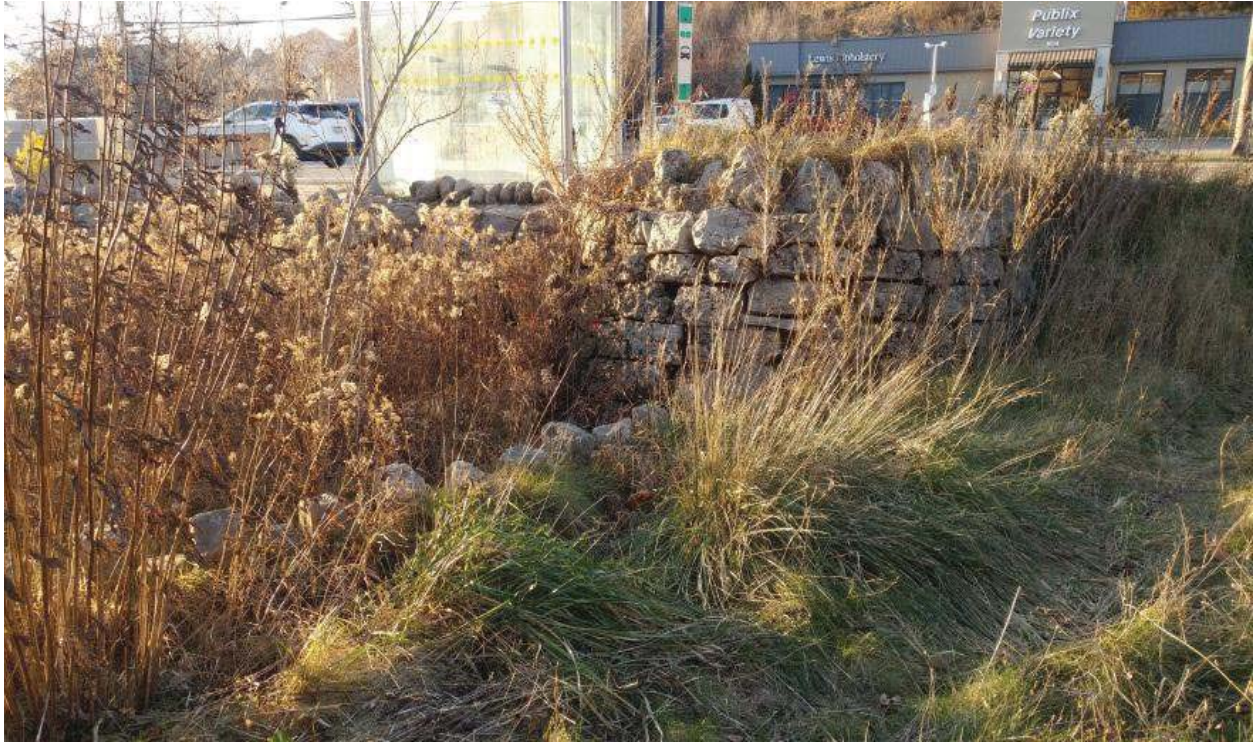
Photograph 2A: Taken from inside the property with wall more visible

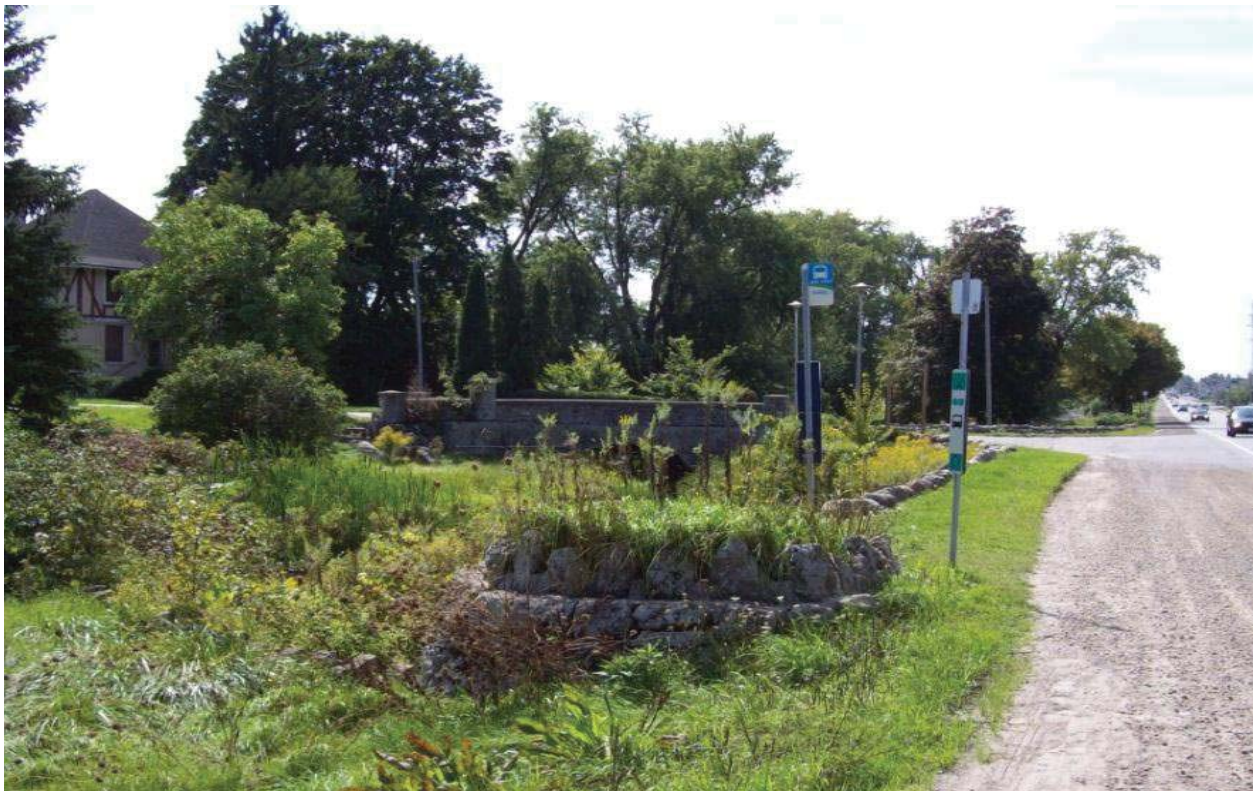
Photograph 3A: The circular end treatment east of the entrance bridge.

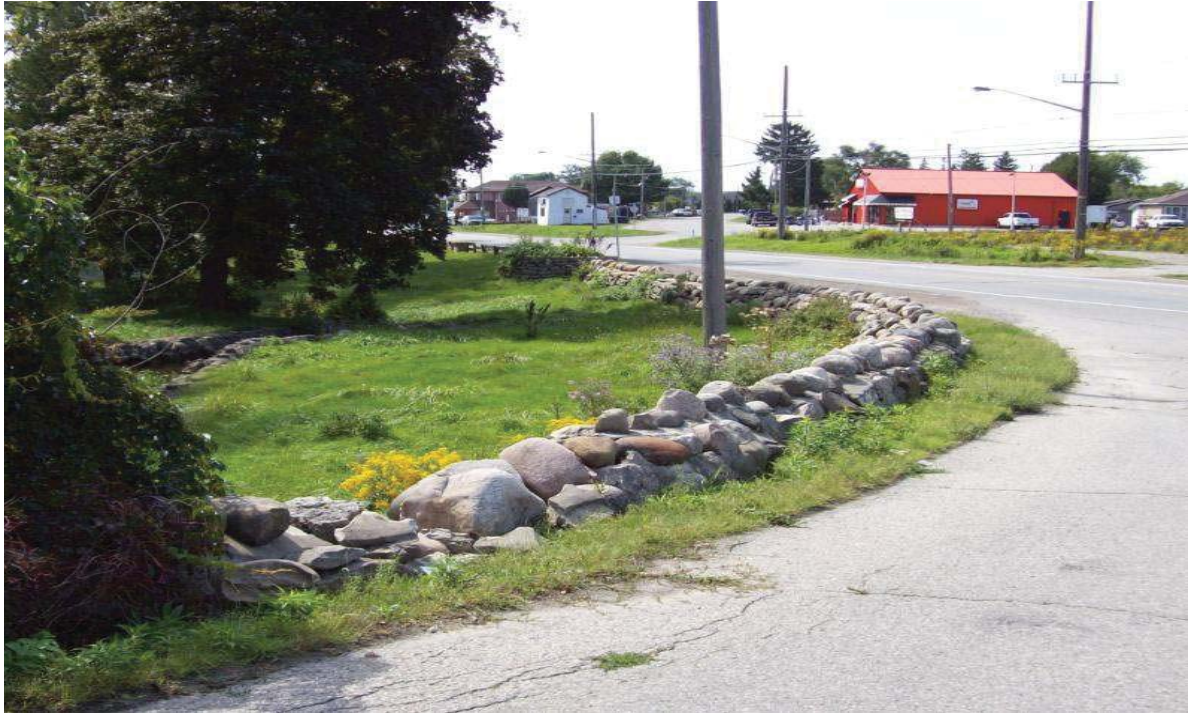
Photograph 4A: West of the entrance. Only the top of the wall is visible.

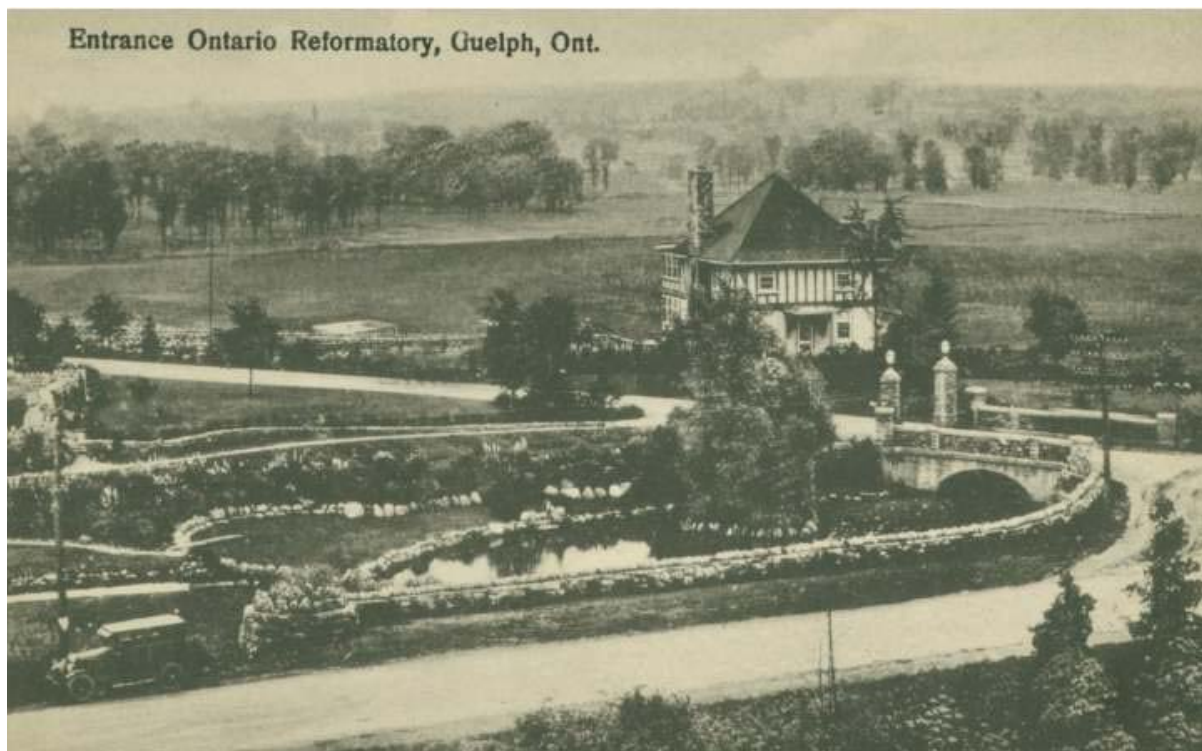
Photograph 5A: 1920 picture of dry stone wing wall with circular end treatment. The height of the wall is noticeably taller. The existing wall has been partially buried due to road grading.

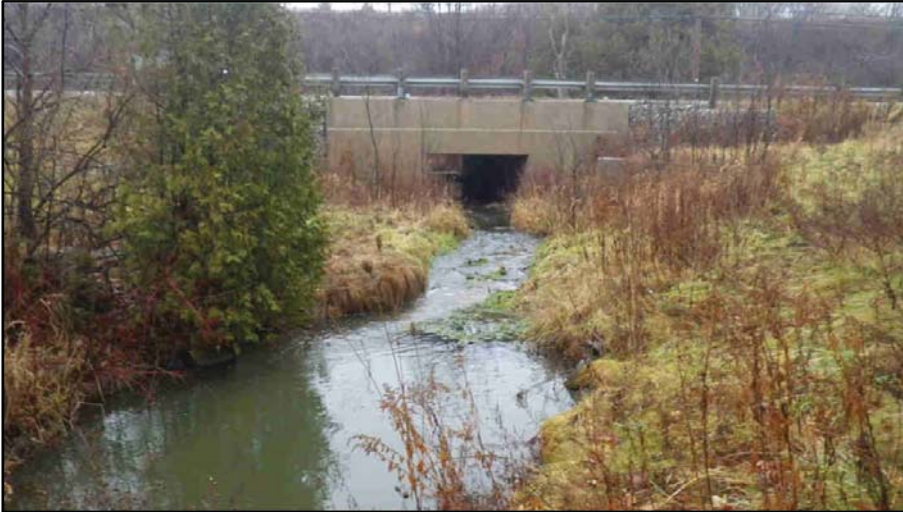
1. York Road crossing of Clythe Creek. Structure is a concrete box culvert , a pool has formed downstream from a transition riffle .

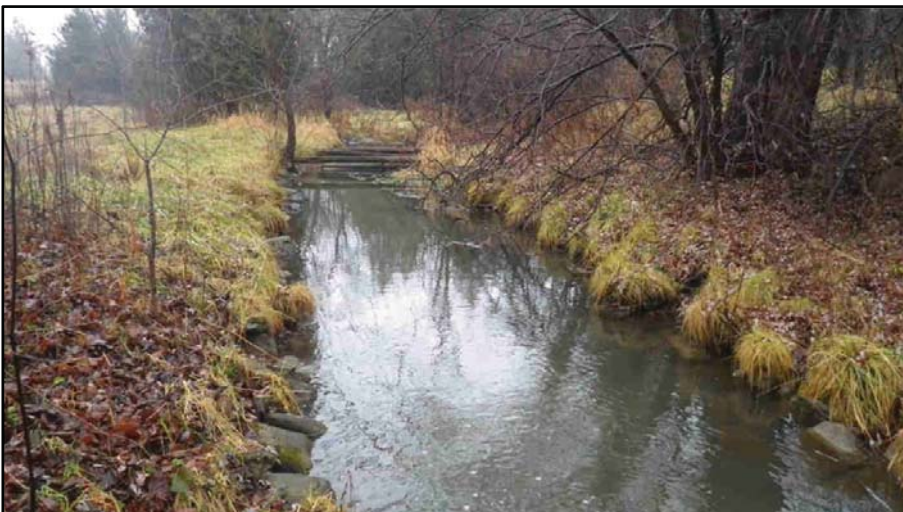
2. Looking downstream along Clythe Creek; channel is straight with rock protection located along banks.

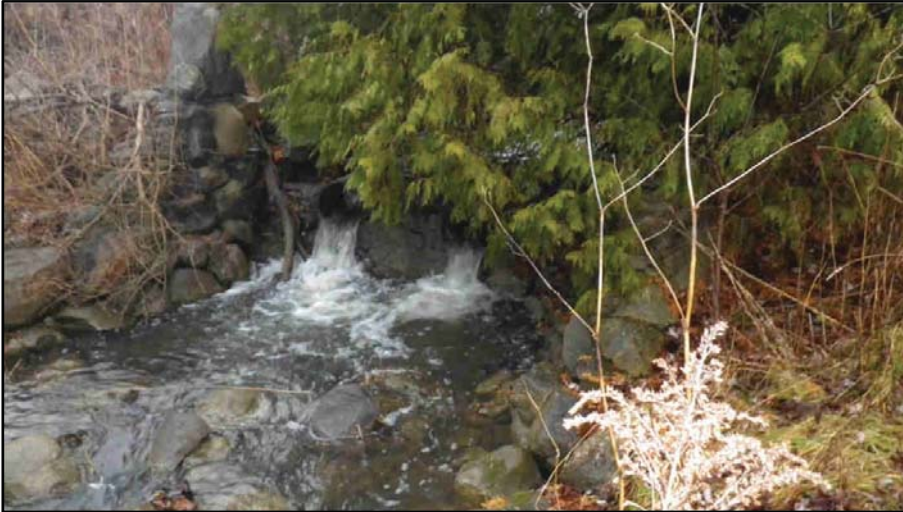
3. Two clay pipes convey flow downstream from a grade control weir. Channel banks are protected by stone.

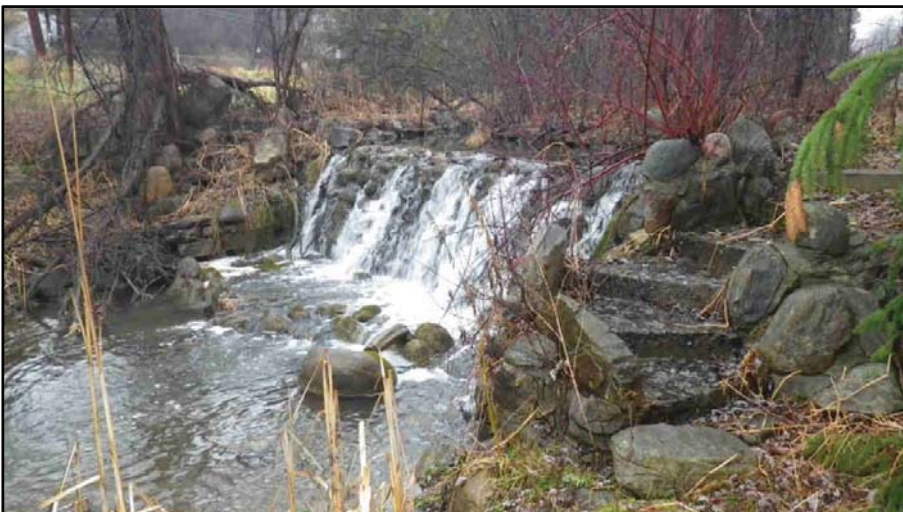
4. Approximately 250m downstream from York Road, an approximate 1.2m stone weir grade control structure is present.

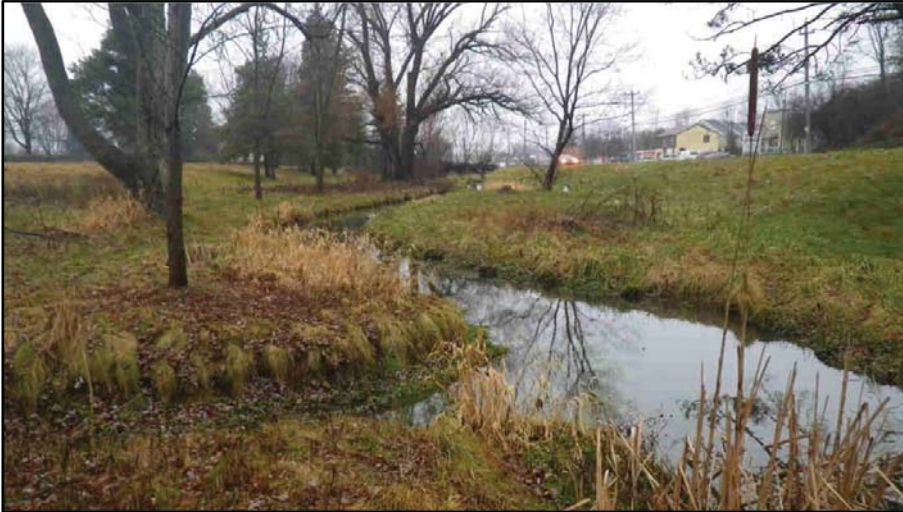
5. Looking downstream along Clythe Creek channel; minor tributary enters the creek in the foreground.

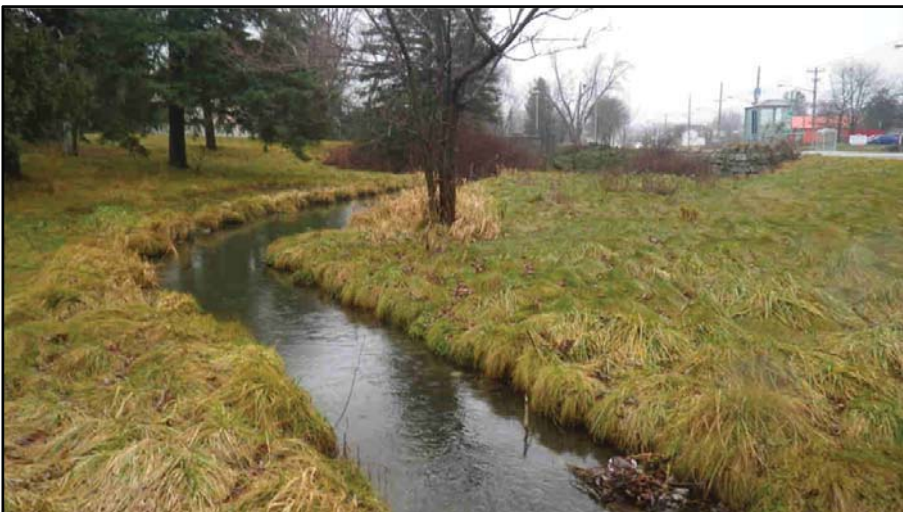
6. Looking downstream along Clythe Creek. Slow moving water appears to be just below bankfull height.

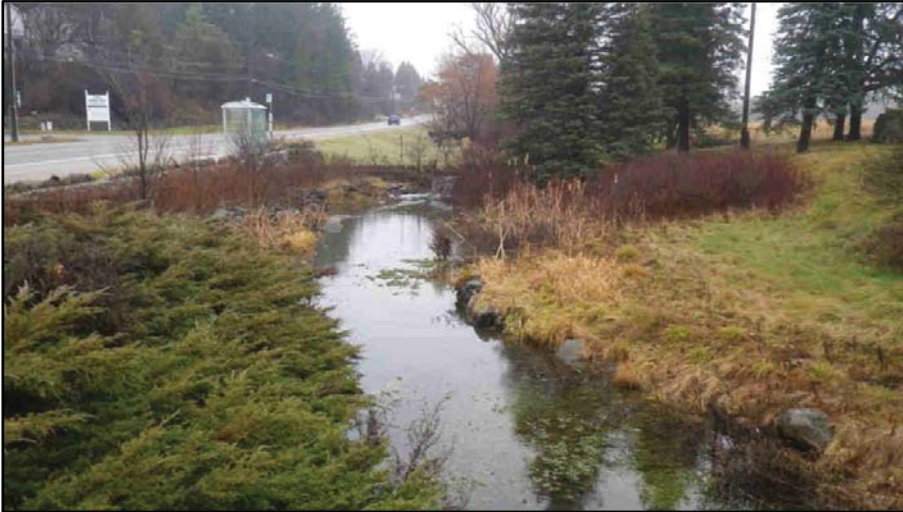
7. Looking upstream along Clythe Creek from the historic stone bridge (access to institution lands); a grade control weir is present in the background.

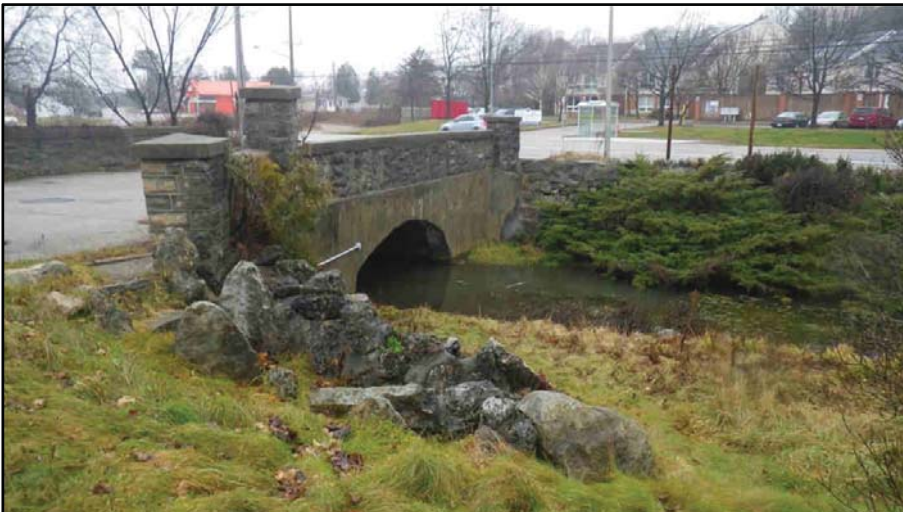
8. Historic stone bridge is main access to institution lands.

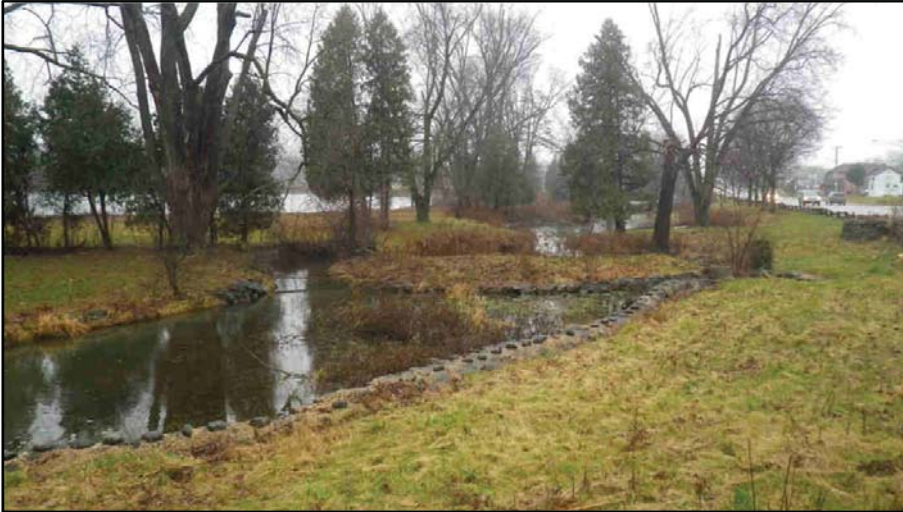
9. Looking downstream along Clythe Creek from the historic stone bridge; aesthetic islands present in the background.

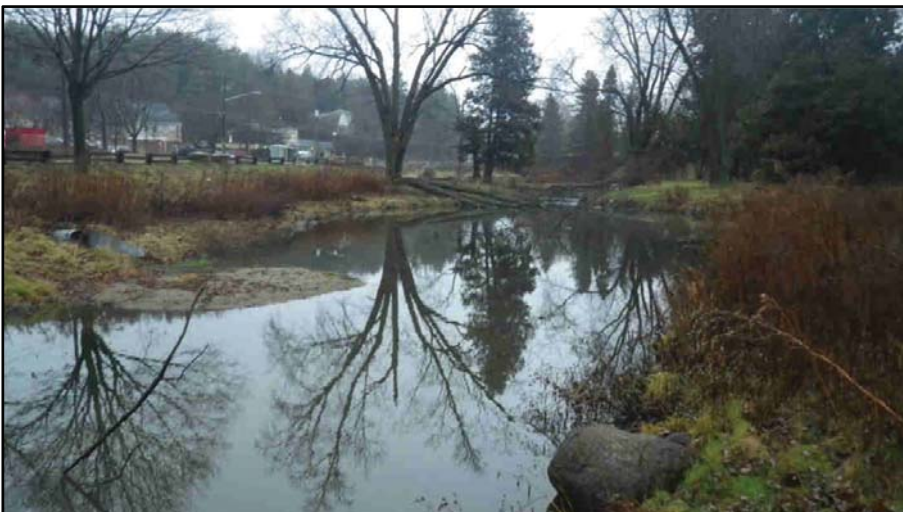
10. Looking upstream along Clythe Creek; channel is over widened and stagnant, a CSP culvert contributes surface discharge from the north side of York Road, a sediment bar has formed downstream from the CSP.

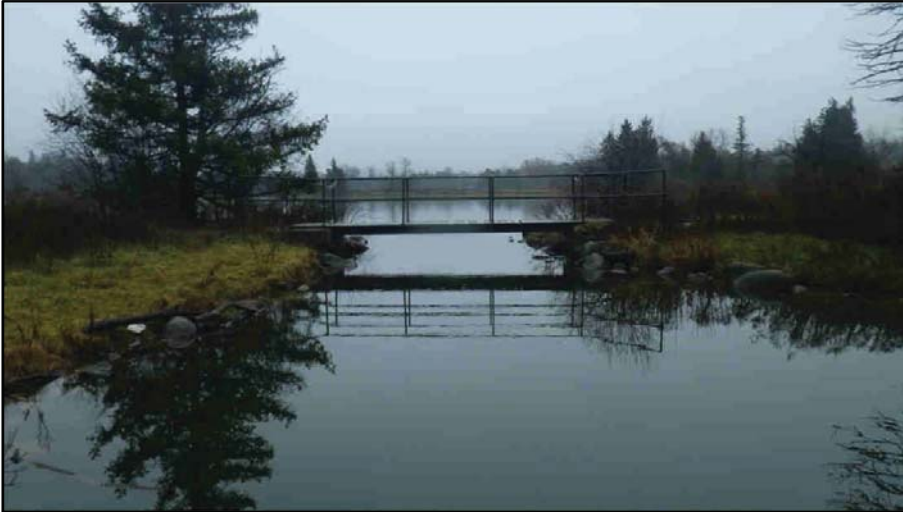
11. Looking upstream along the North Pond connection channel and pedestrian bridge.

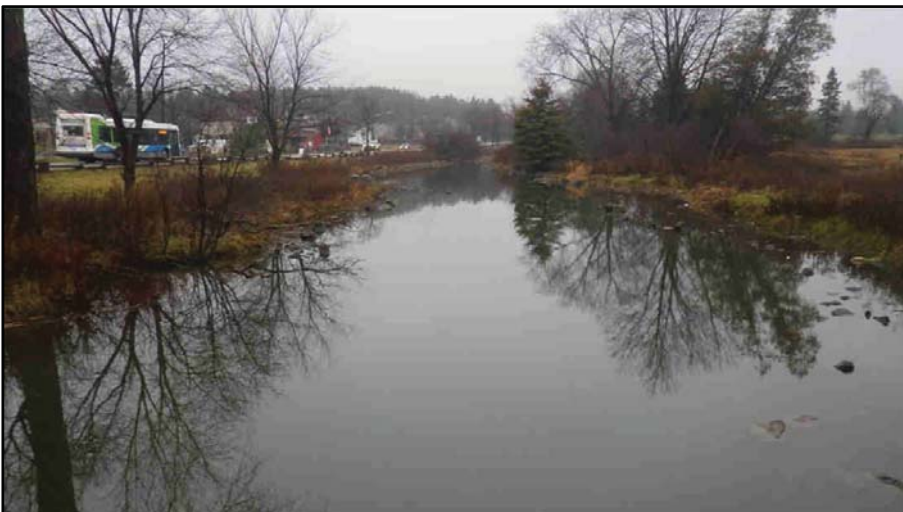
12. Looking upstream along Clythe Creek; channel is over widened and slow moving.

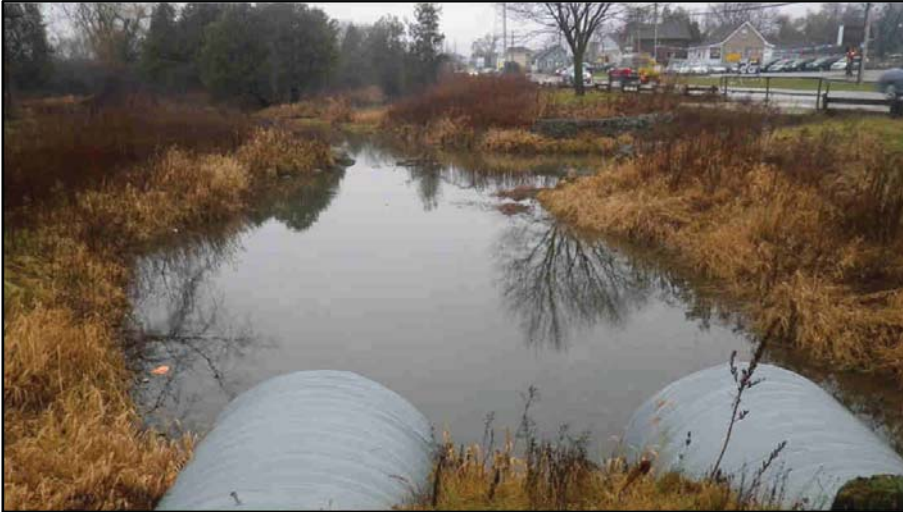
13. Two CSP culverts convey flows downstream from a parklands access road; channel immediately regains width downstream before Hadati Creek Confluence (background, right bank).

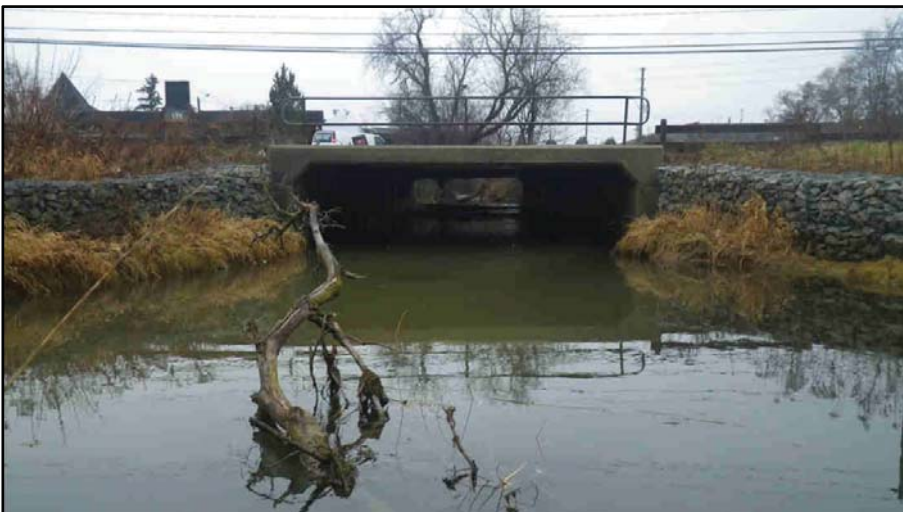
14. York Road crossing of Hadati Creek; structure is a concrete box culvert , gabion wing-walls protect the banks.

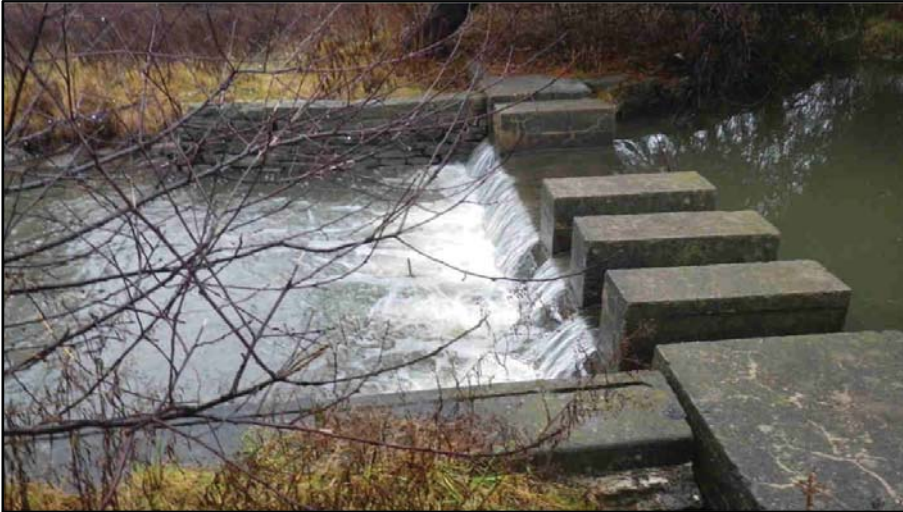
15. Flow control structure downstream from Hadati Creek confluence.

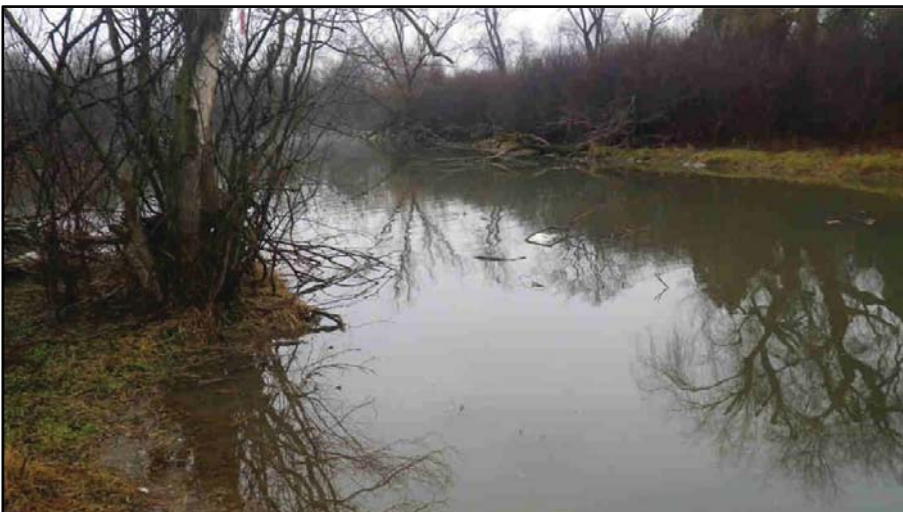
16. Channel remains wide and stagnant downstream from Hadati Creek. Water is turbid and woody debris is frequent.

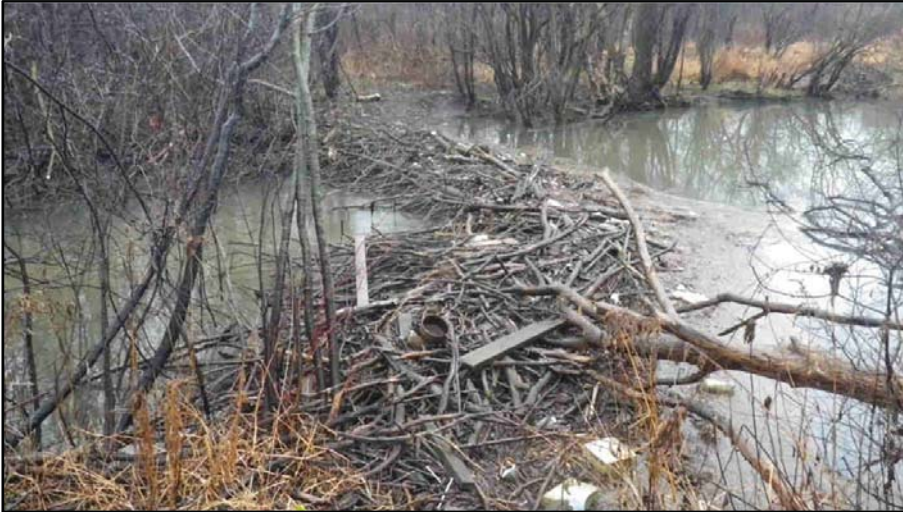
17. Beaver dam located approximately 250m upstream from the Eramosa River confluence.

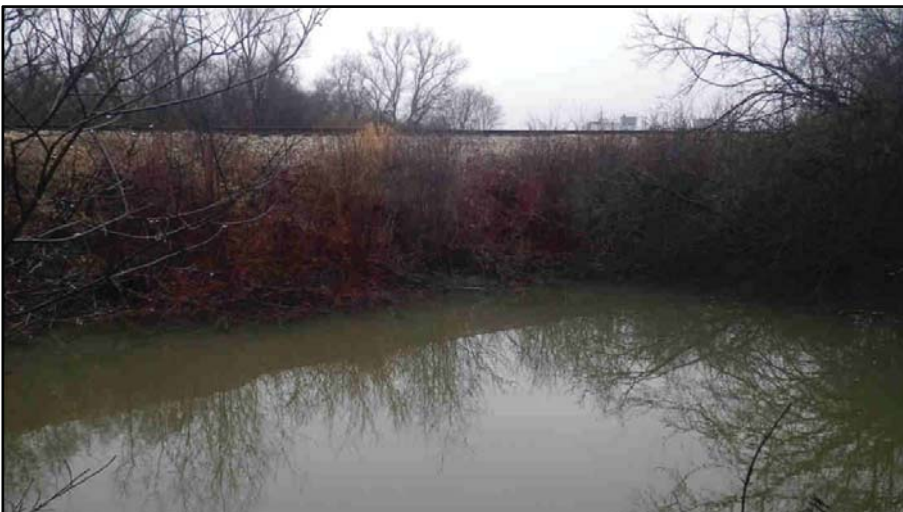
18. Clythe Creek flows immediately adjacent to railway embankment; embankment protection appears to be limited to vegetation. Water turbidity changes colour to appear more beige.

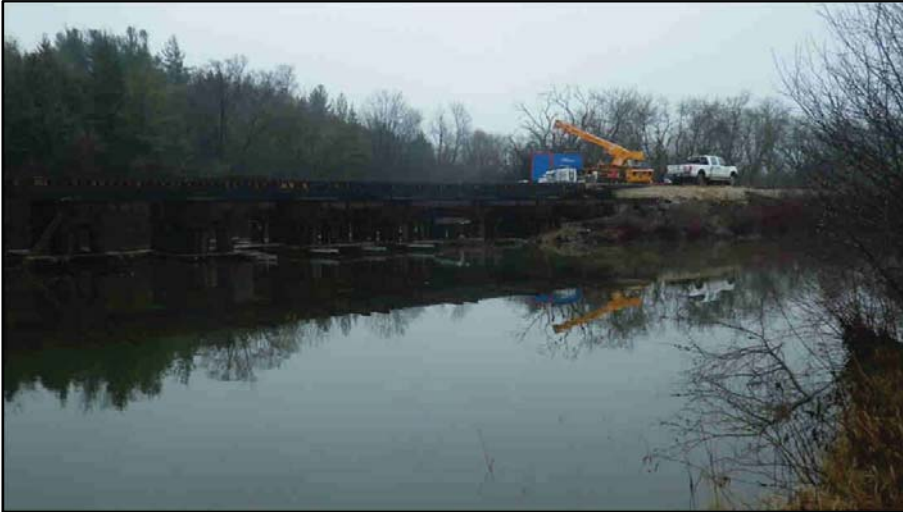
19. Looking downstream along the Eramosa River towards the Clythe Creek confluence located to the right. Railway embankment and bridge structure crossing the Eramosa River also present in background.

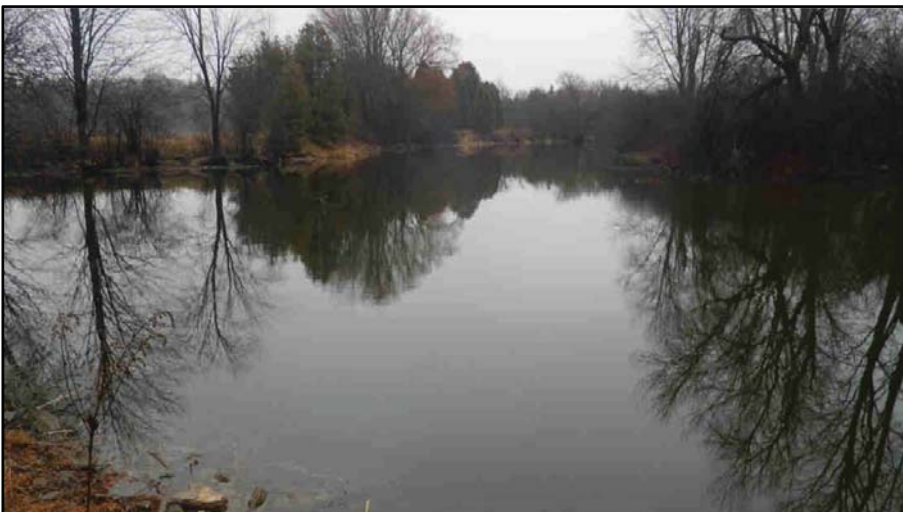
20. Looking upstream along the Eramosa River; embankment separating the South Pond and Eramosa visible in the background left.

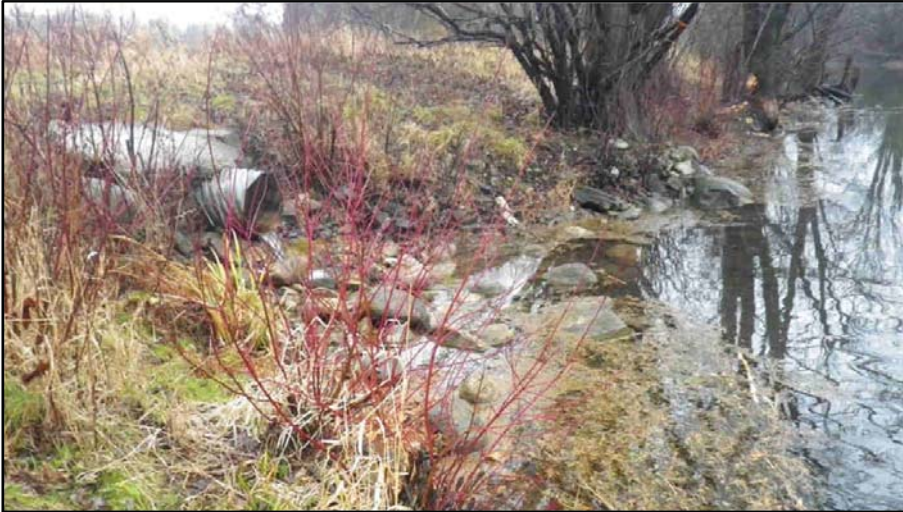
21. South Pond connection to the Eramosa River through an CSP pipe elevated approximately 30cm; the pipe appears to be blocked and discharge is minimal.

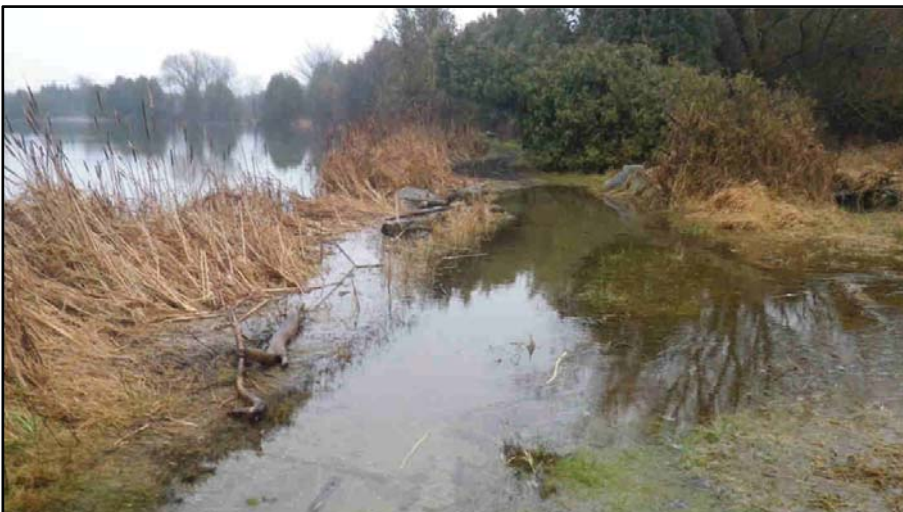
22. South pond breaches its banks at the ponds north-east corner; flow is contributed to a surface drainage tributary that flows adjacent to the pond and into the Eramosa River.

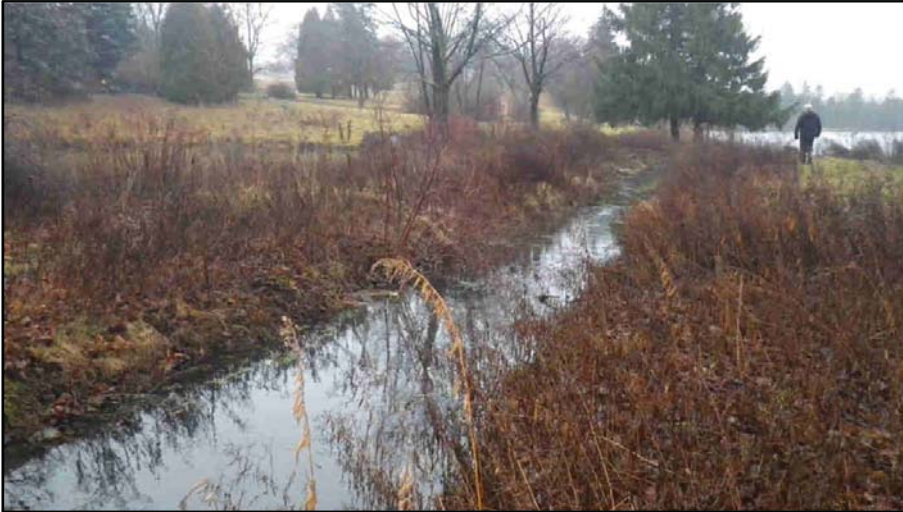
23. Drainage channel from decorative ponds discharges into the South Pond.

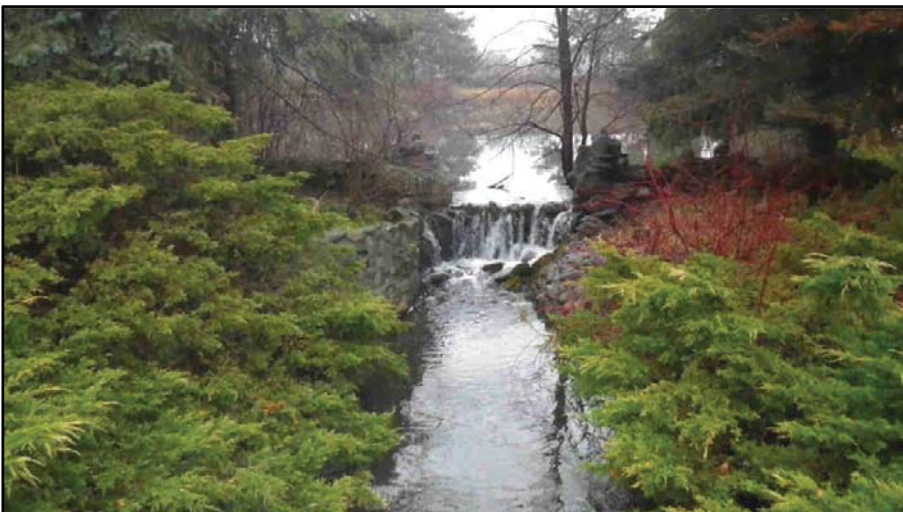
24. Decorative pond, grade control feature.

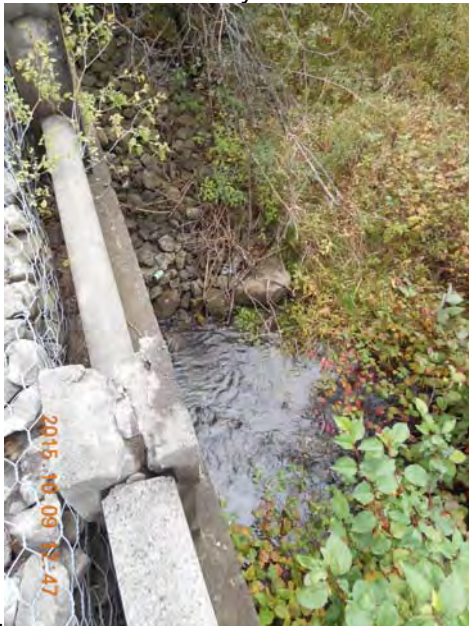
Upstream face of Clythe Creek crossing

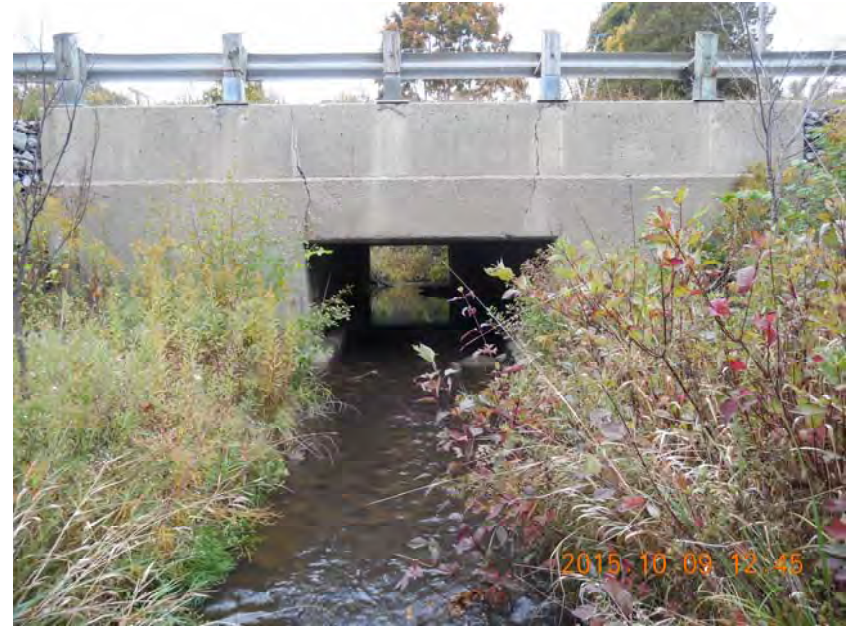
Downstream face of Clythe Creek

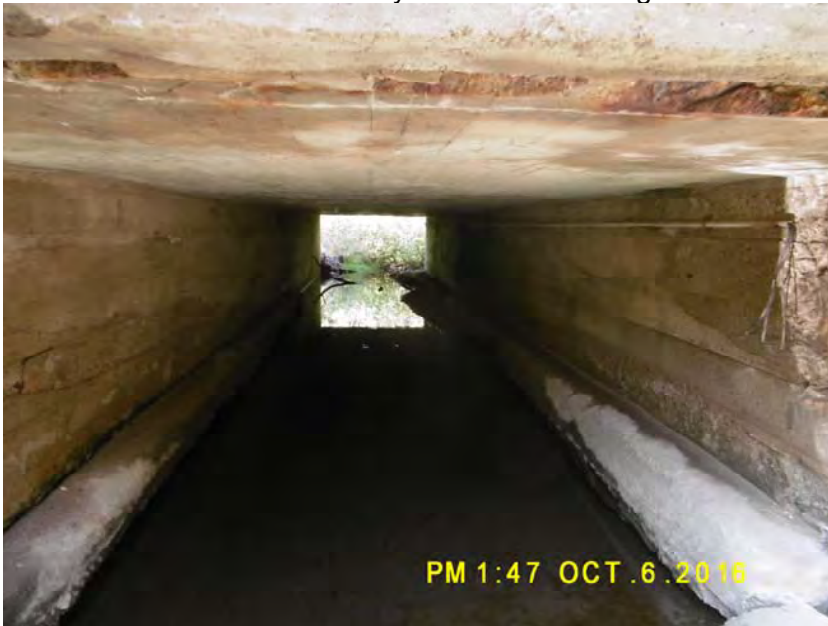
Clythe Creek culvert

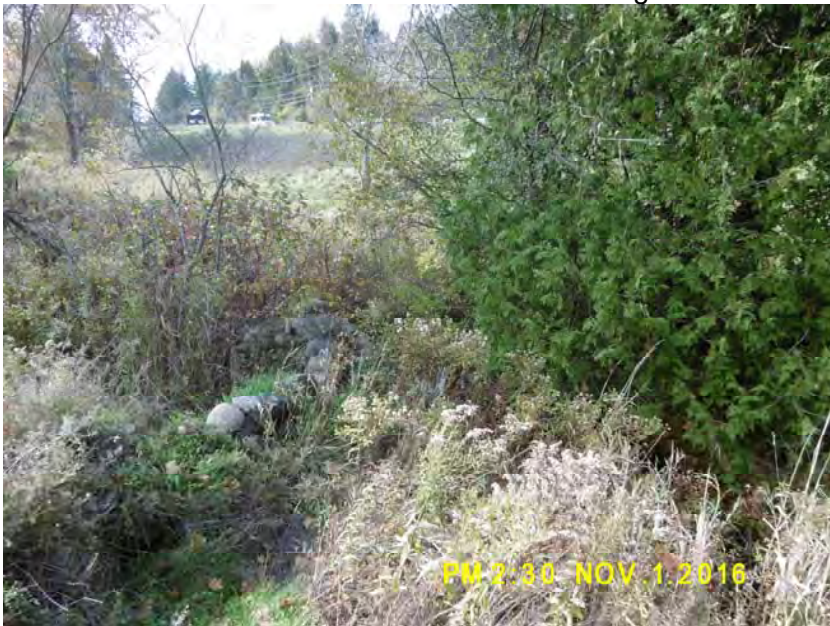
Cultural heritage wall close to York Road culvert

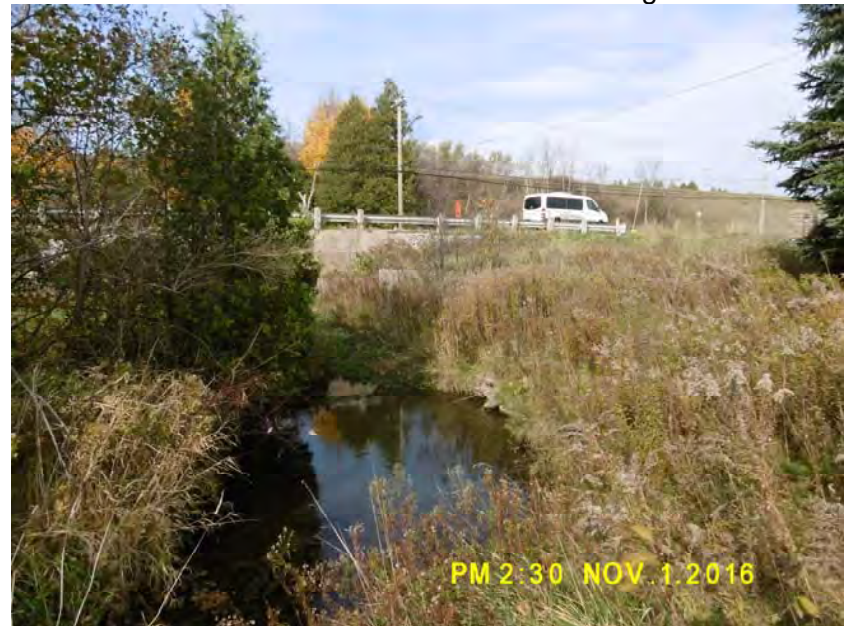
Pool feature immediately downstream of culvert

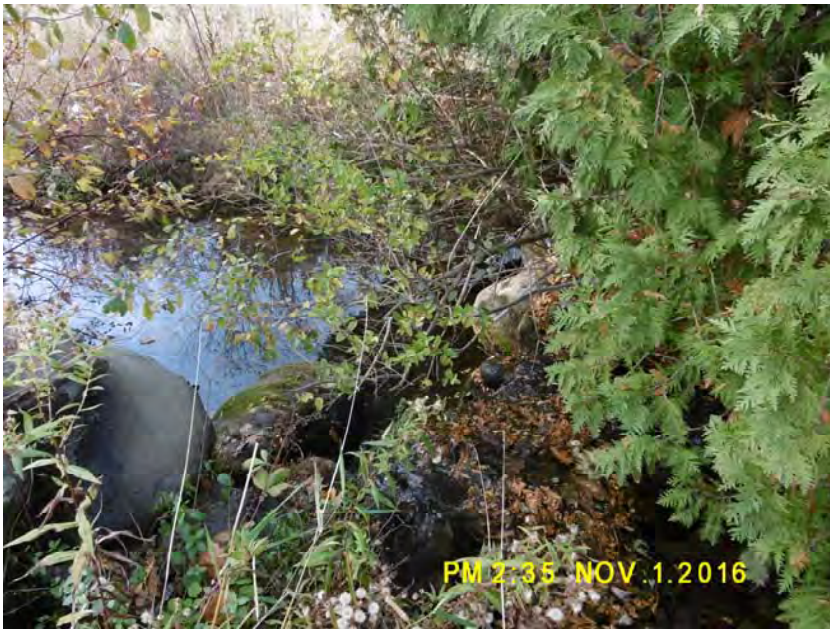
Cultural heritage weir structure

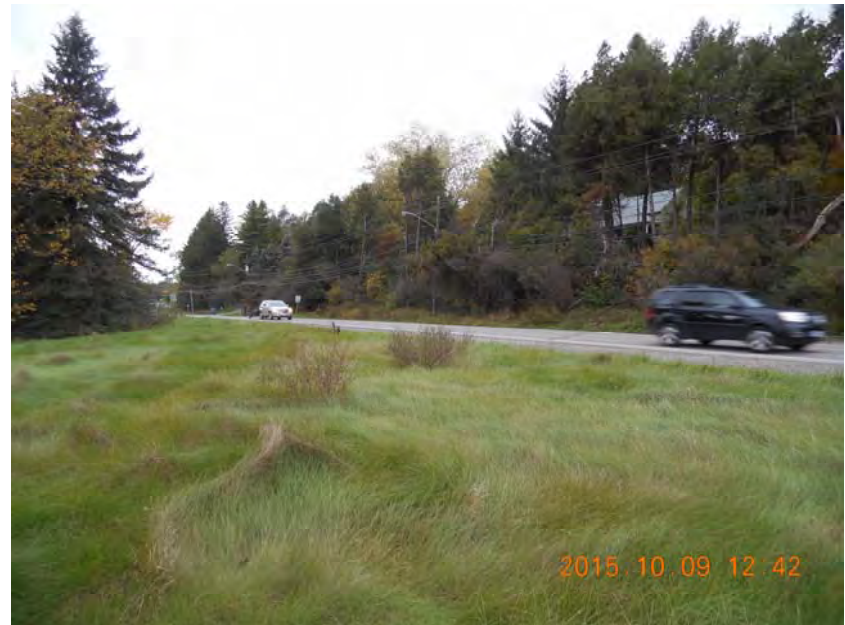
Steep grading along north side of road

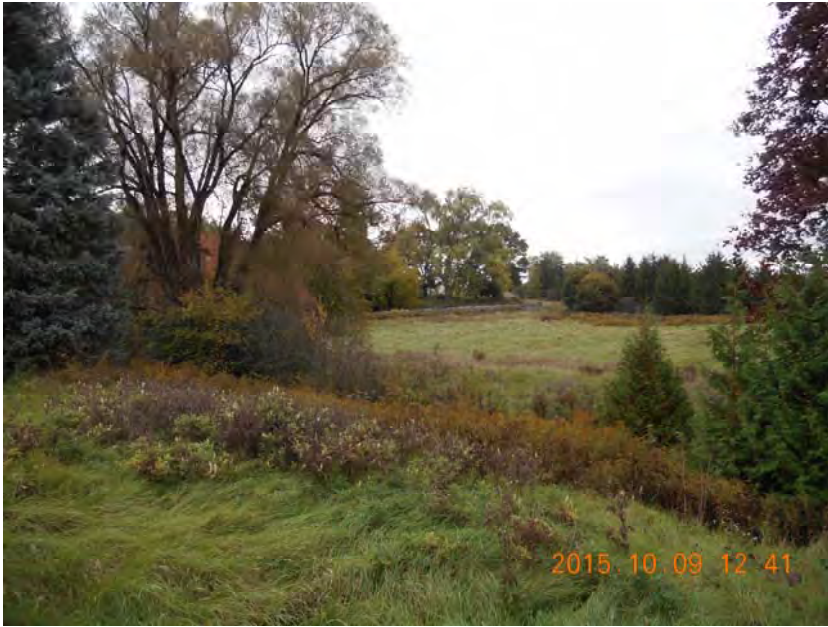
Cultural heritage wall south of creek

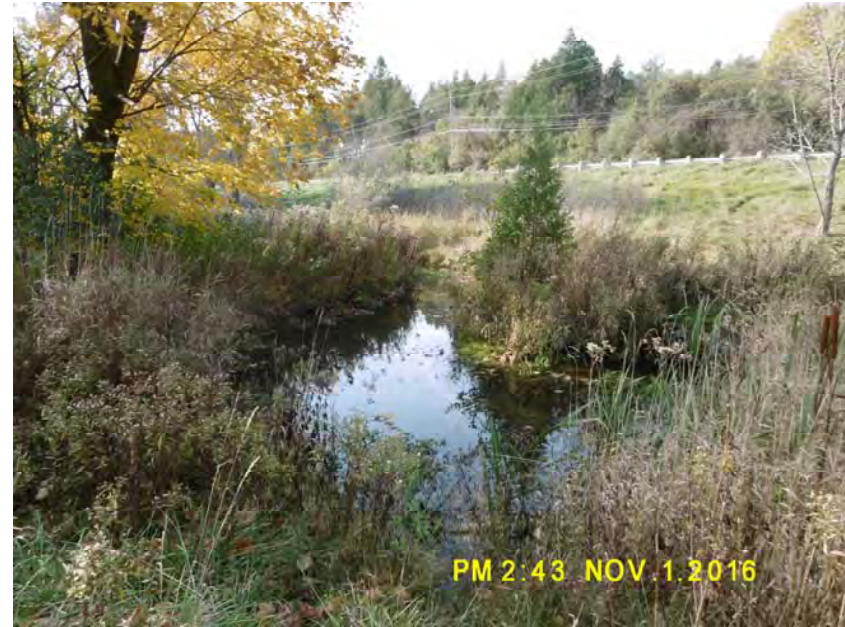
Pool downstream of culvert

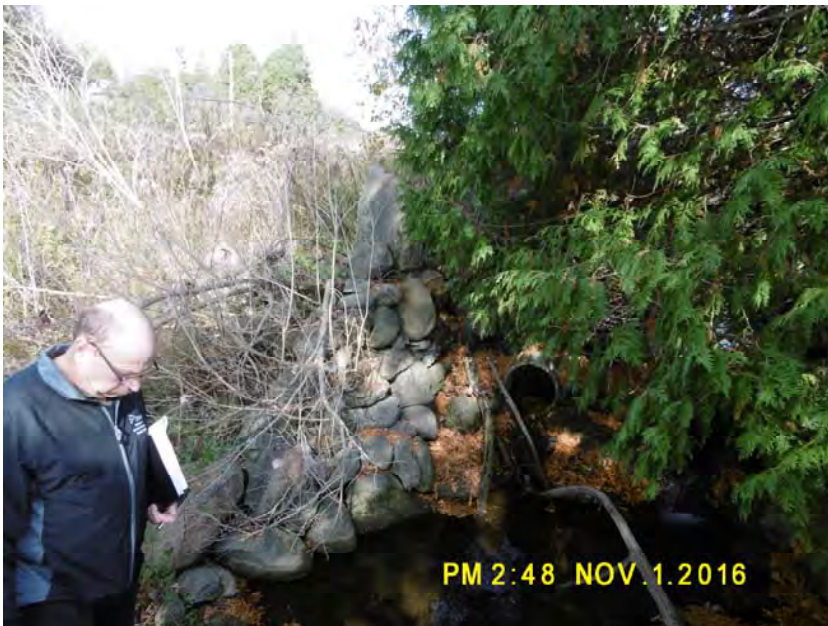
Cultural heritage drop structure with side walls and pipes

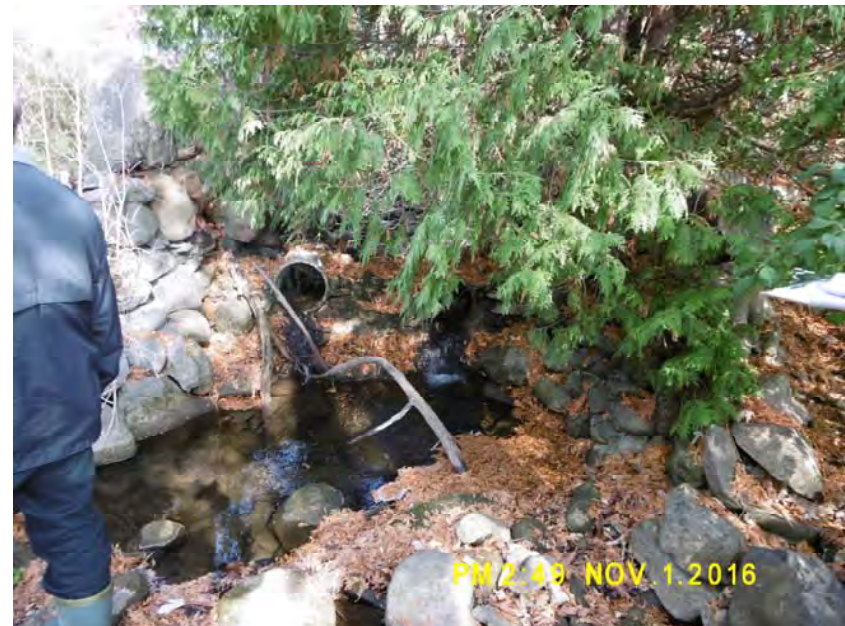
Cultural heritage drop structure with side walls and pipes

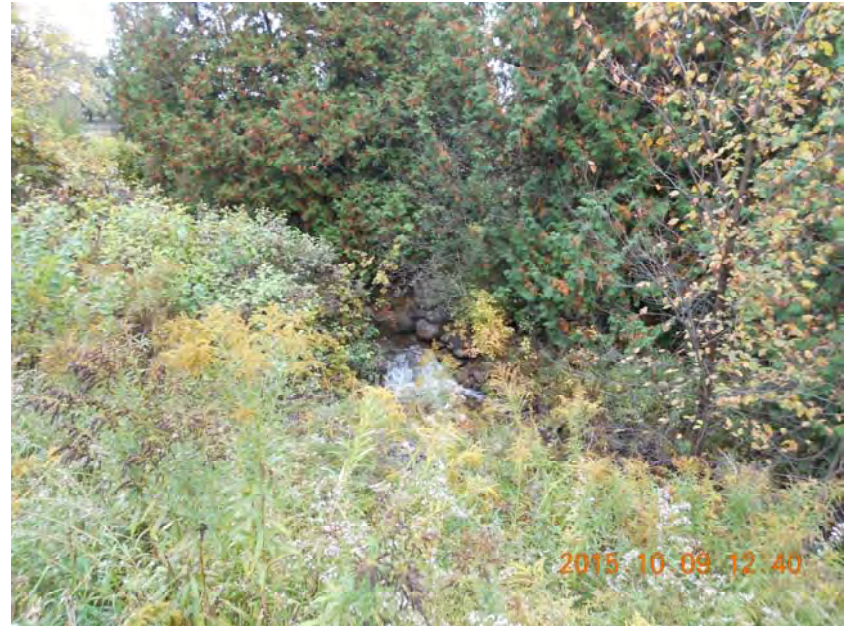
Cultural heritage drop structure
