Environmental Impact Study (EIS)

York Road Environmental Design Study
City of Guelph
Project # TP115100

Re: Final York Road Environmental Impact Study

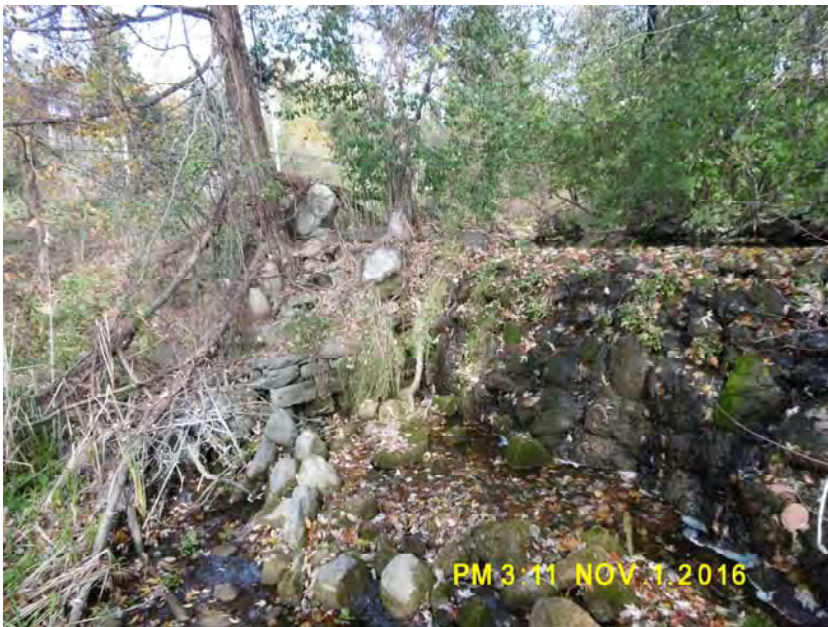
Cultural heritage drop structure

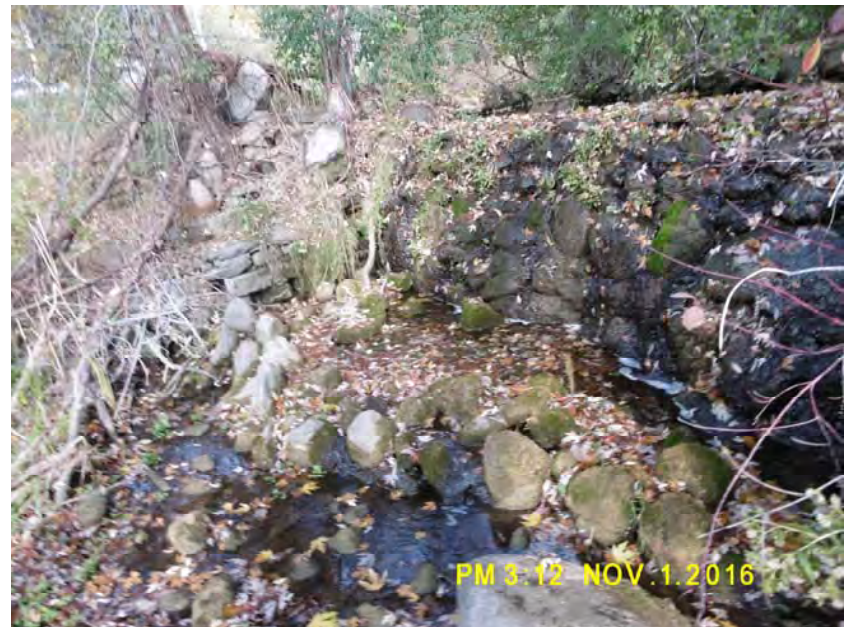
Cultural heritage drop structure

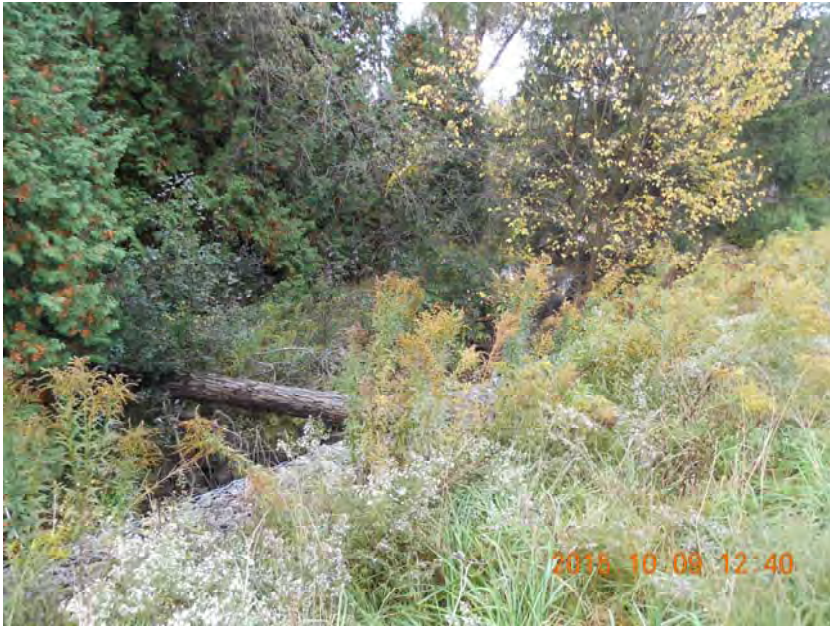
Gabion baskets next to roadway

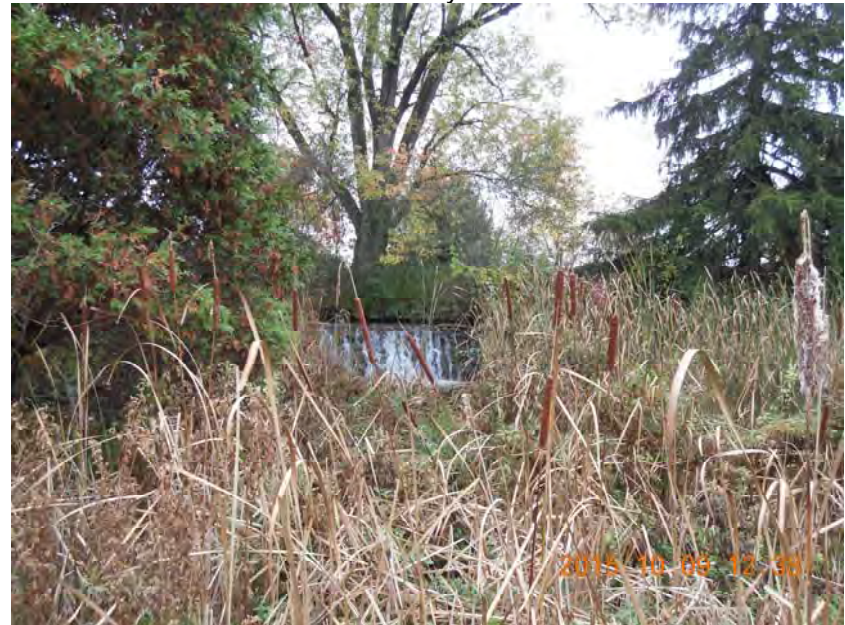
Cultural heritage drop structure

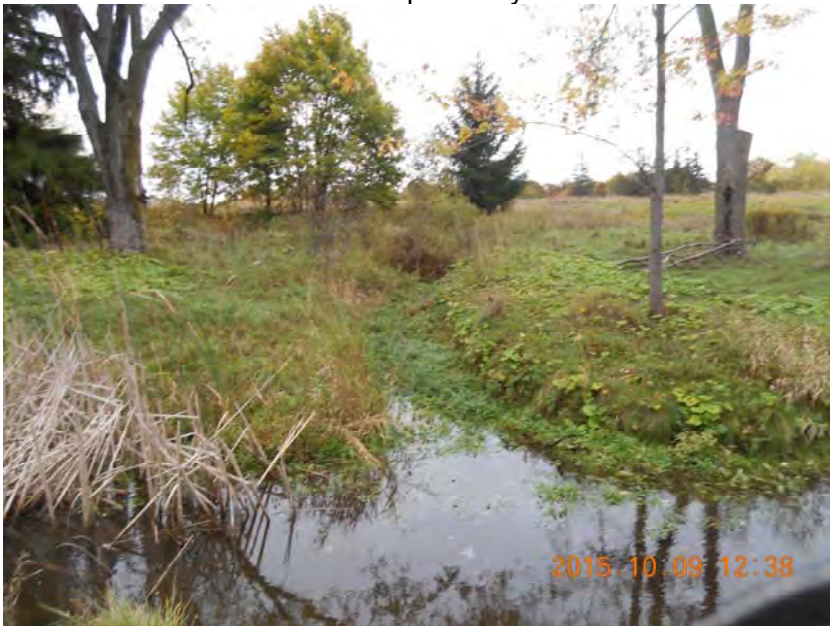
Drainage feature confluence with the creek

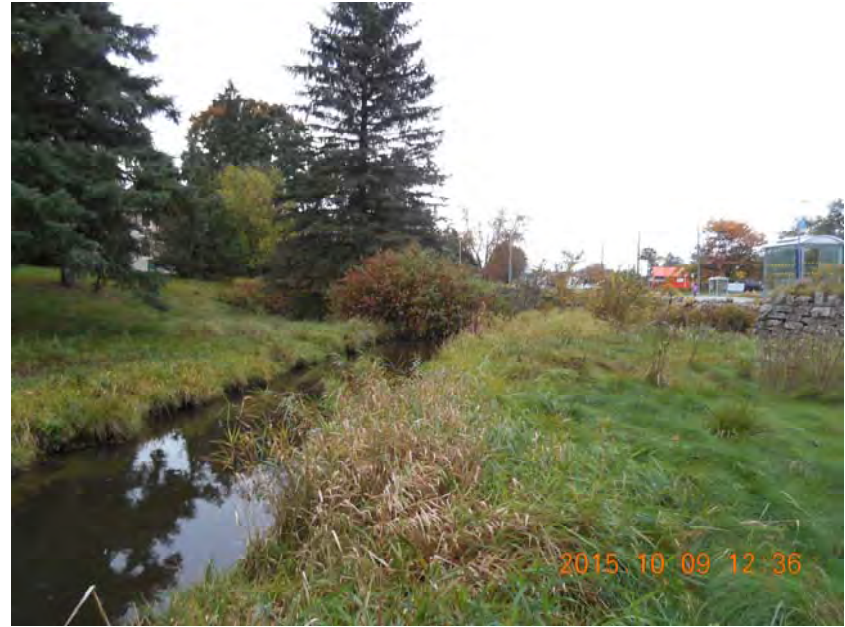
Cultural heritage wall feature

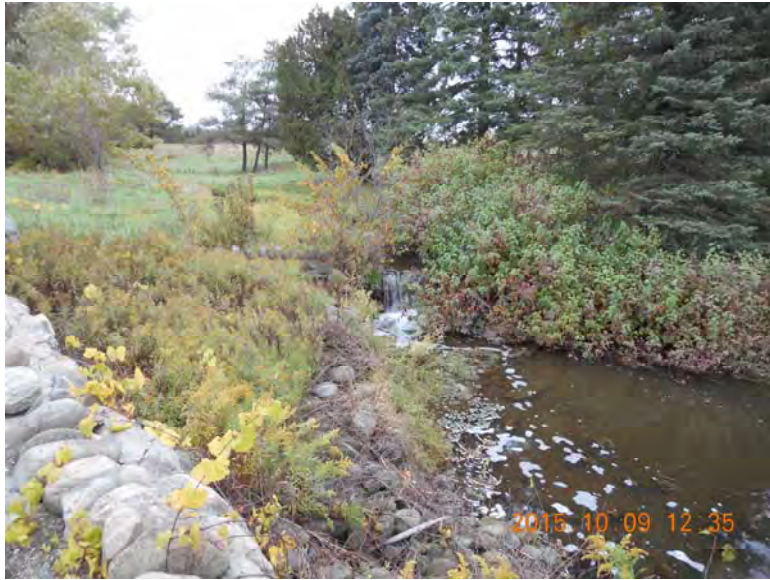
Cultural heritage wall and drop structure just west of former Reformatory driveway

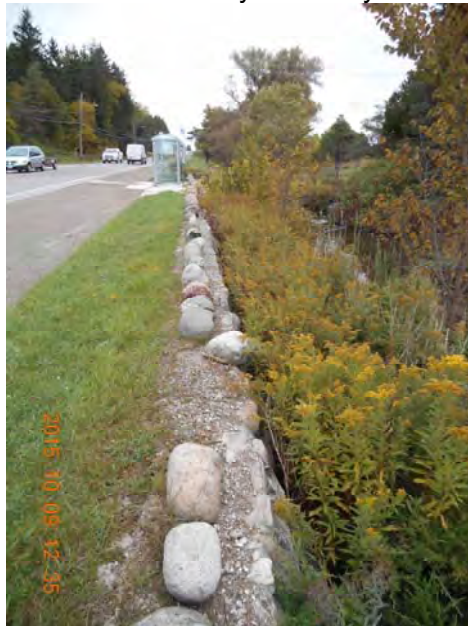
Cultural heritage wall along York Road

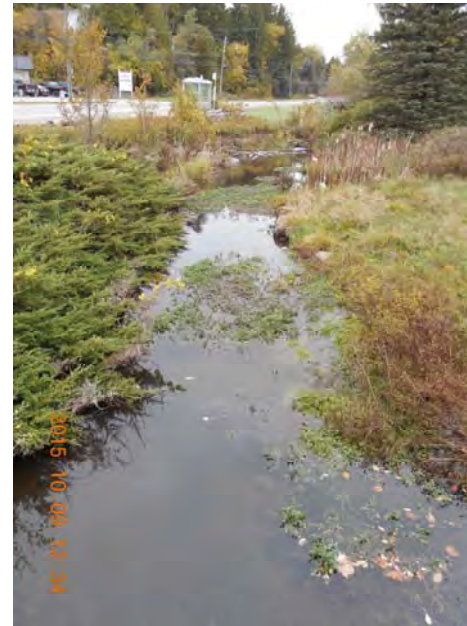
Creek immediately upstream of former Reformatory driveway
Note creek is in a backwater condition

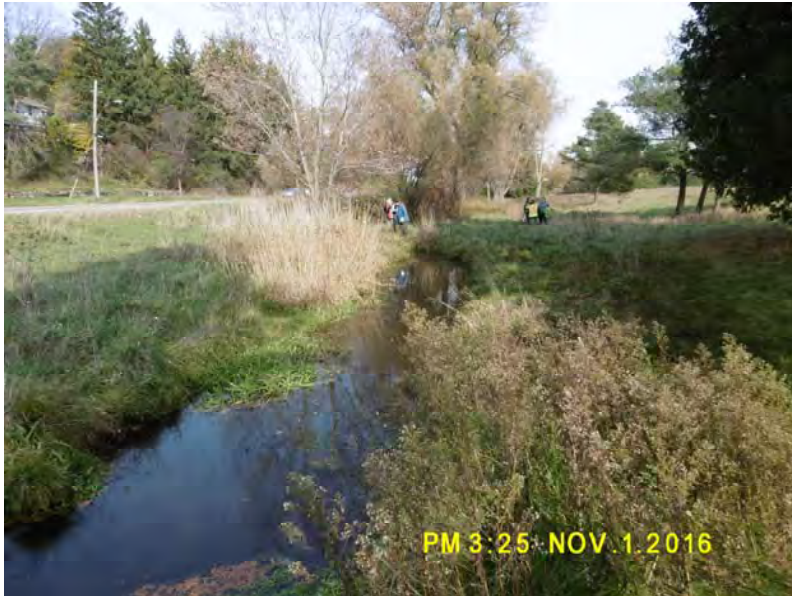
Creek immediately upstream of former Reformatory driveway
Note creek is in a backwater condition

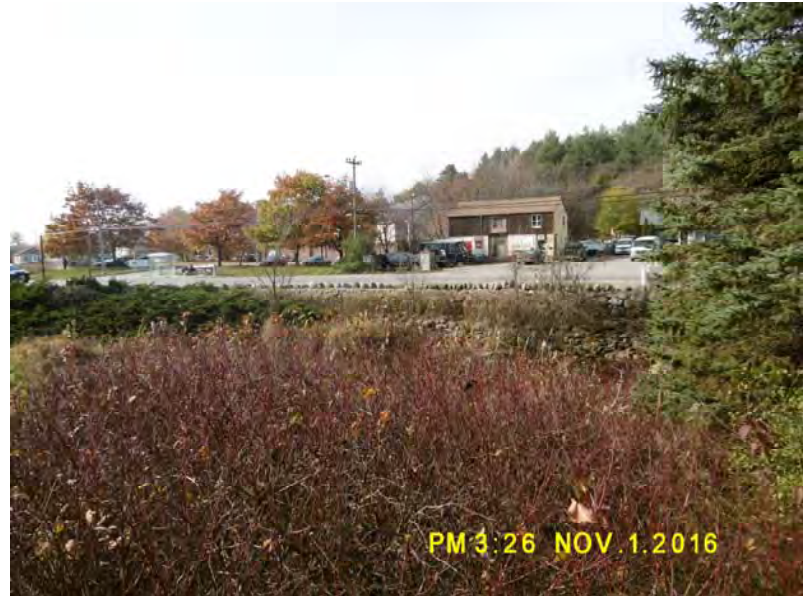
Looking at Cultural Heritage wall upstream of former Reformatory driveway

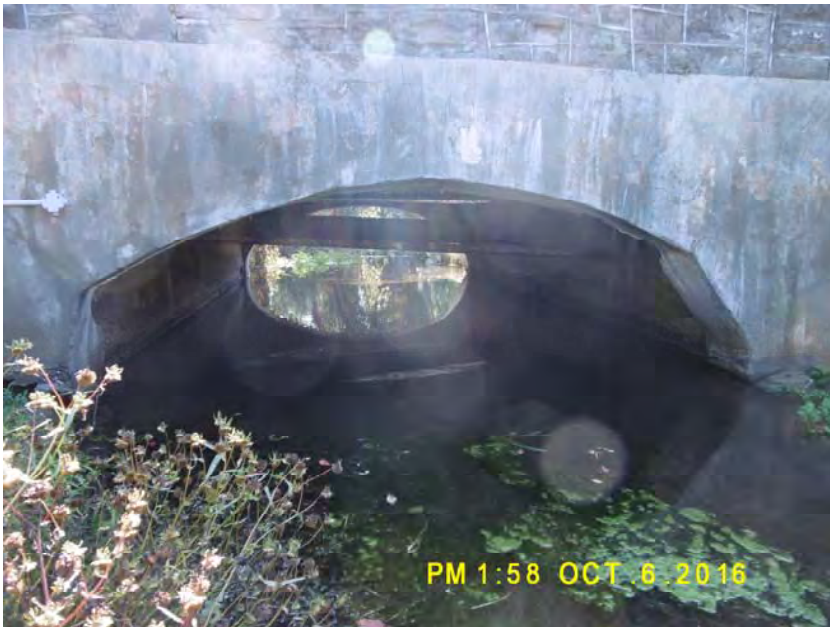
Former Reformatory driveway crossing

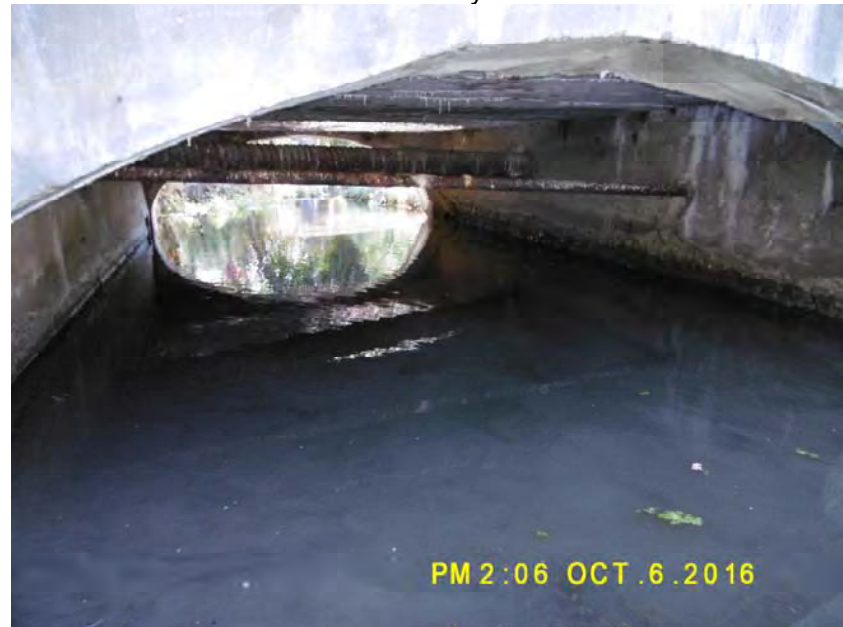
Former Reformatory driveway crossing

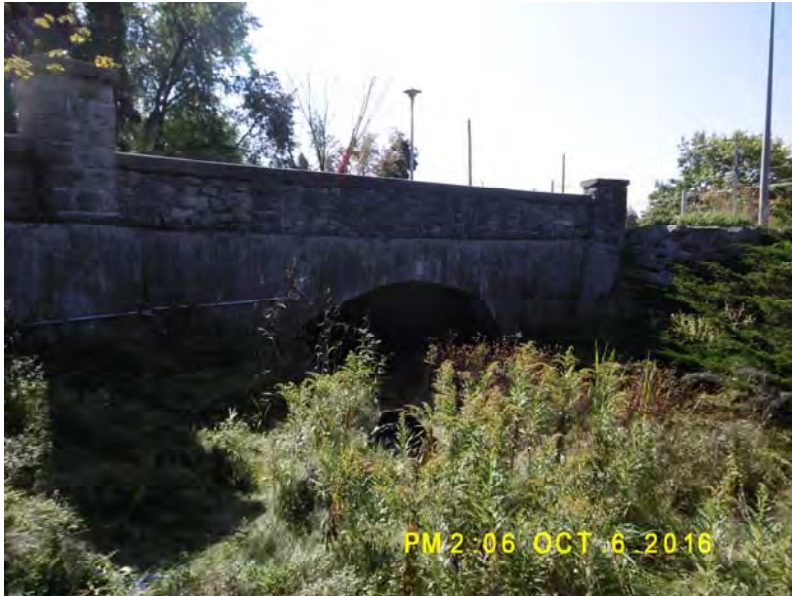
Former Reformatory driveway crossing

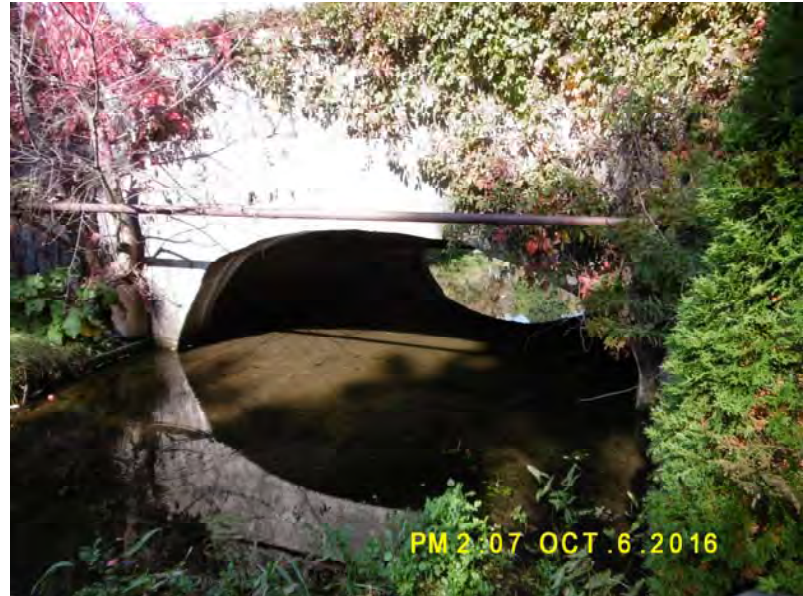
Former Reformatory driveway crossing

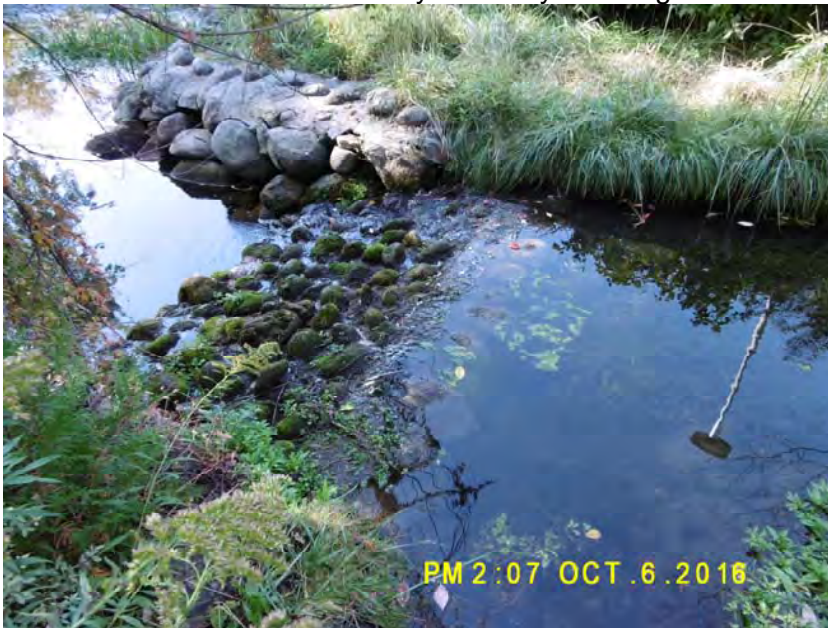
Downstream of former Reformatory driveway crossing
Note drop structure

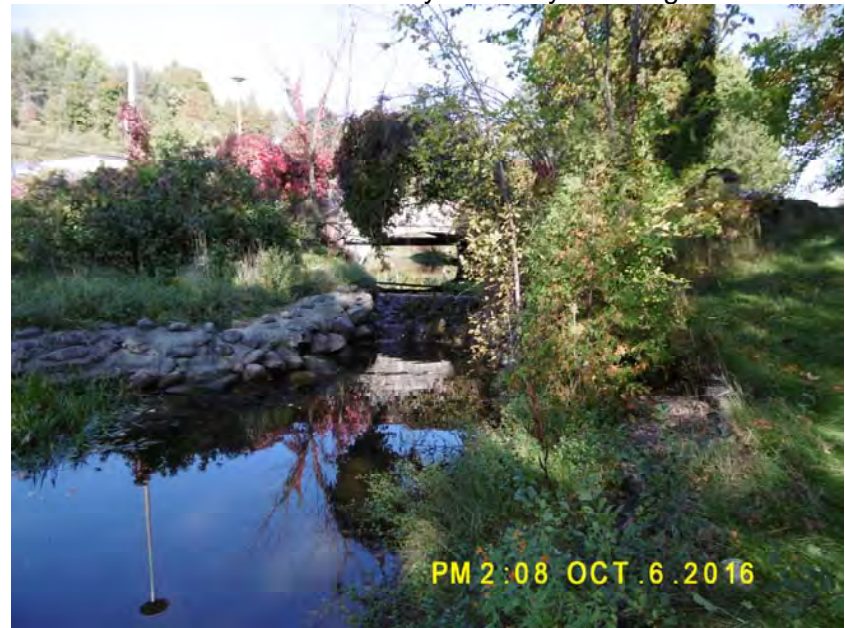
Lined channel downstream of former Reformatory driveway

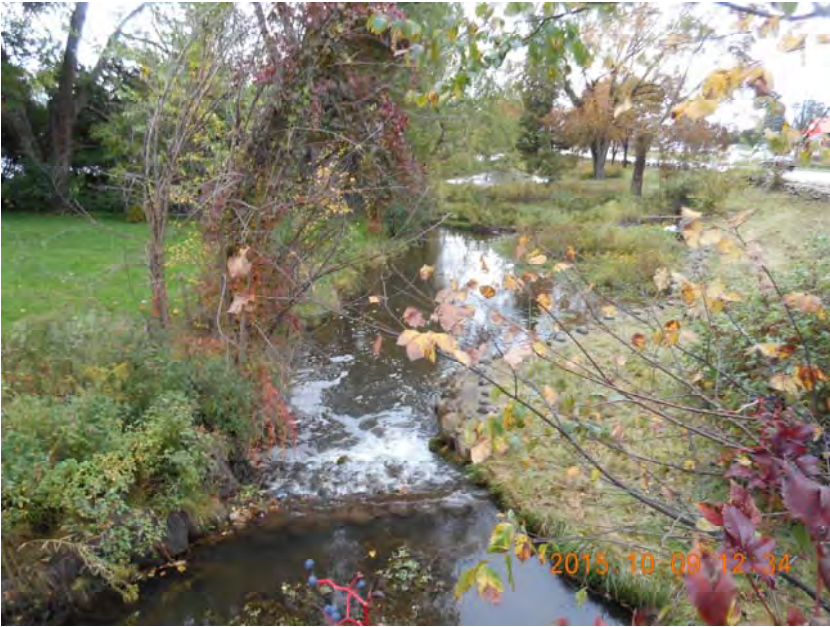
Drop structure downstream of former Reformatory driveway crossing

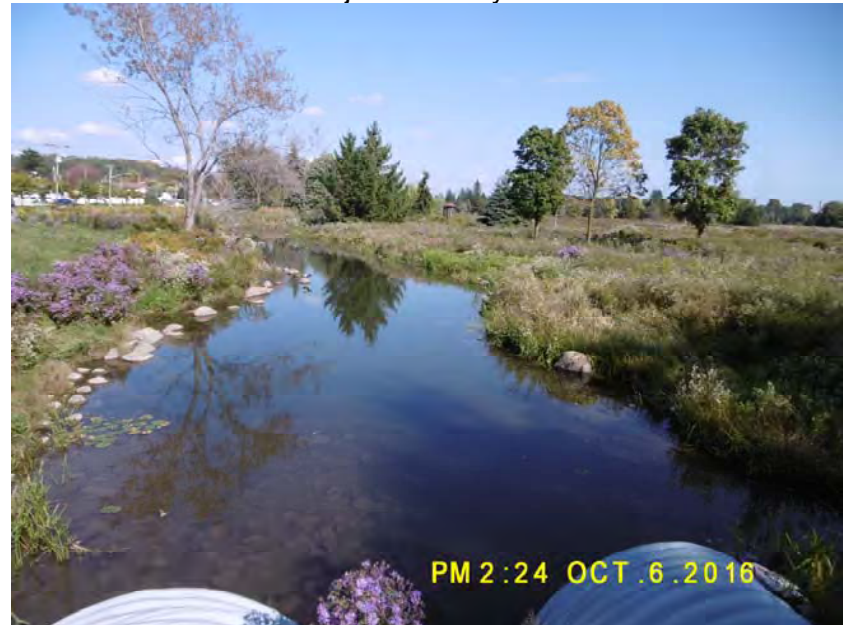
Upstream of twin CSP crossing into park parking lot

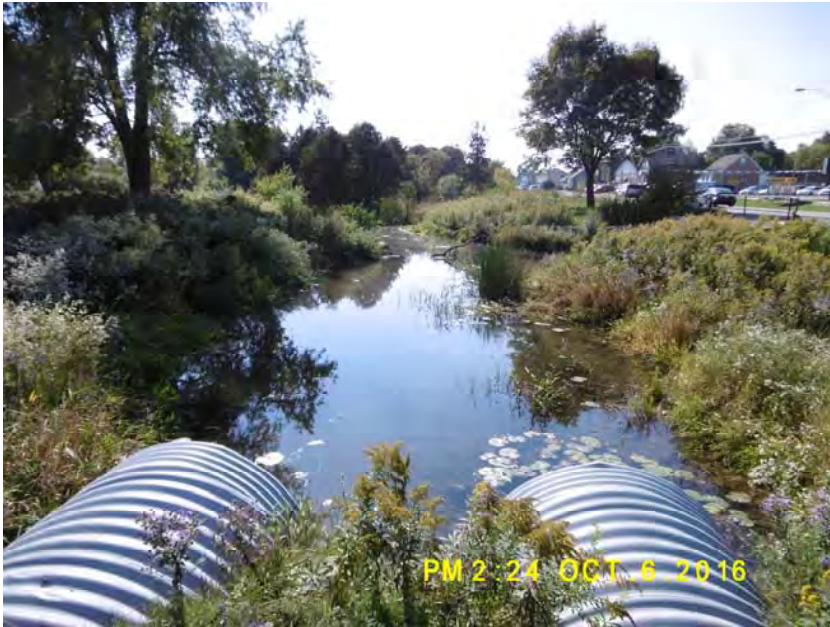
Downstream of twin CSP culverts

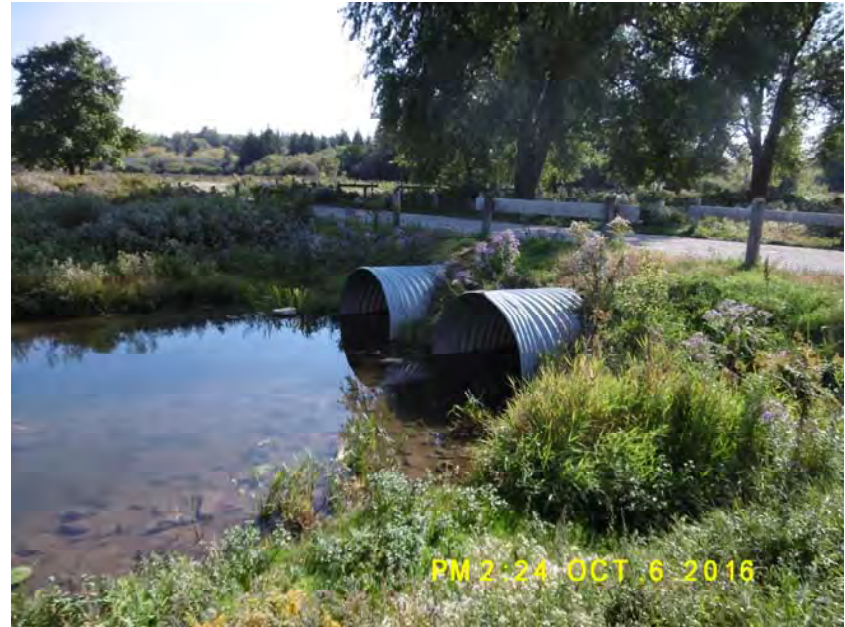
Driveway into park

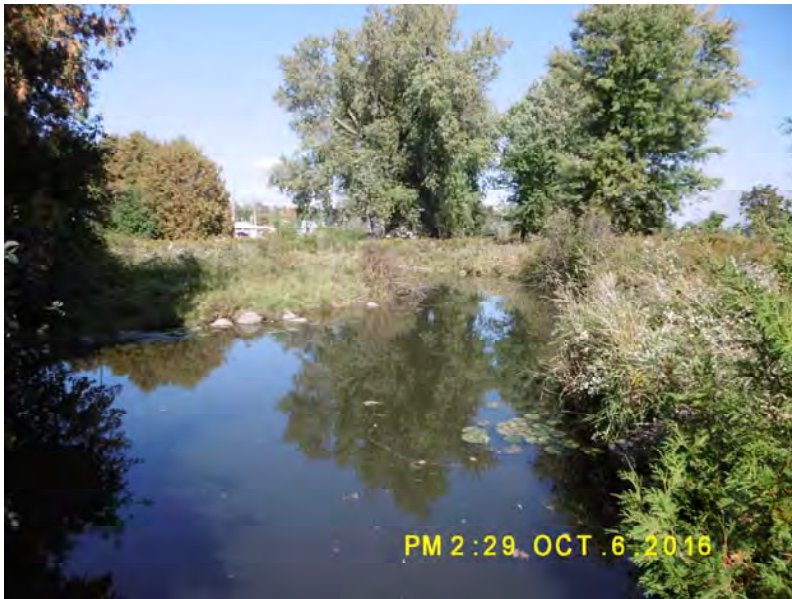
Clythe Creek at meander downstream of park driveway

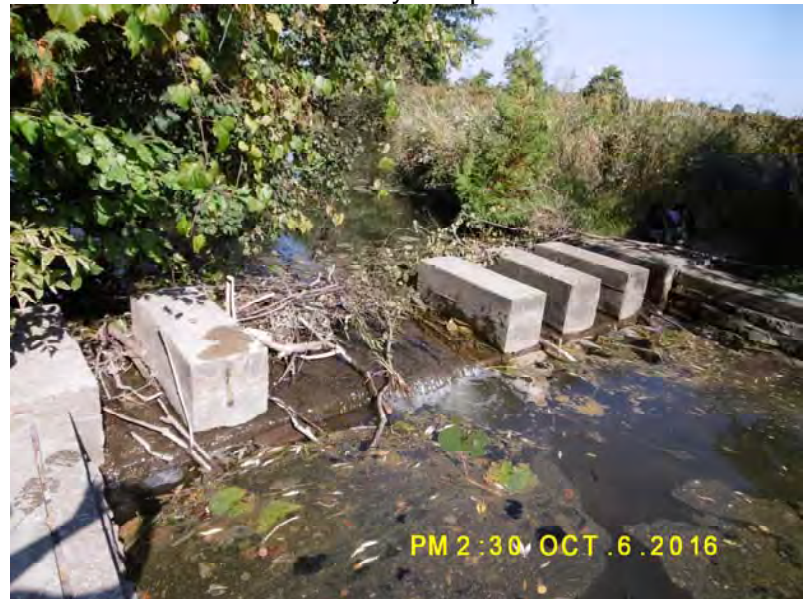
Damaged energy dissipation structure upstream of confluence with the Eramosa River

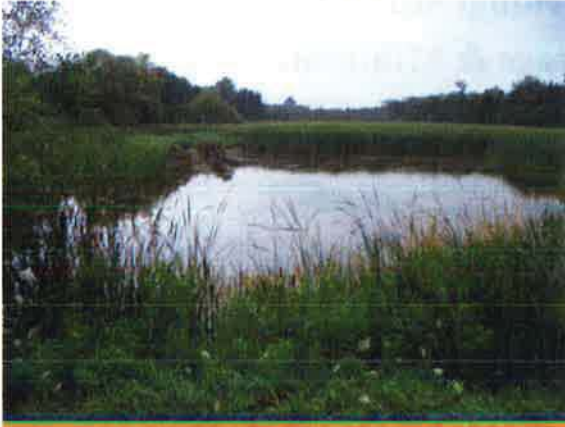
Photo 1: Large online pond created by a weir at Jones Baseline. The pond is located downstream of Site 1 and immediately upstream of Site 2. The pond is likely the primary cause of the observed increase in water temperature.

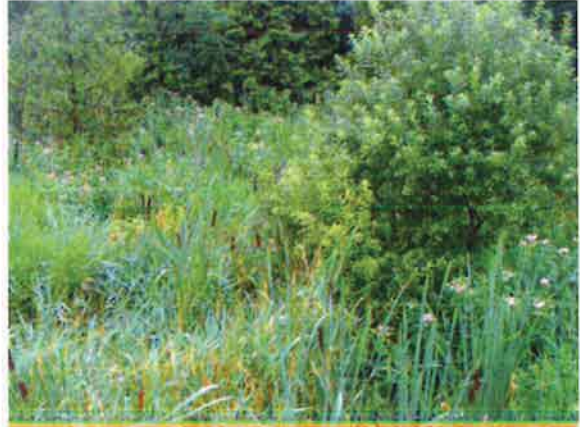
Photo 2: Dense vegetation downstream of Jones Baseline (Site 2) presents a challenge to exploring the Creek. A pump used for taking water for the irrigation of a garden was observed in the Creek just downstream of Site 2.

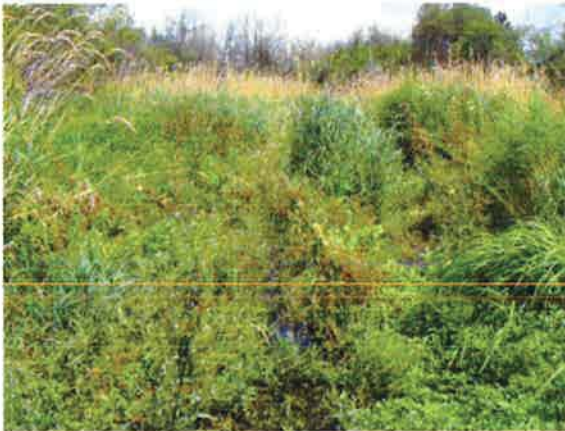
Photo 3: Dense riparian vegetation typical of the Creek between Highway 7 (Site 3) and Watson Road North (Site 4). Groundwater seeps were observed in this section of Creek and watercress was observed in the channel.

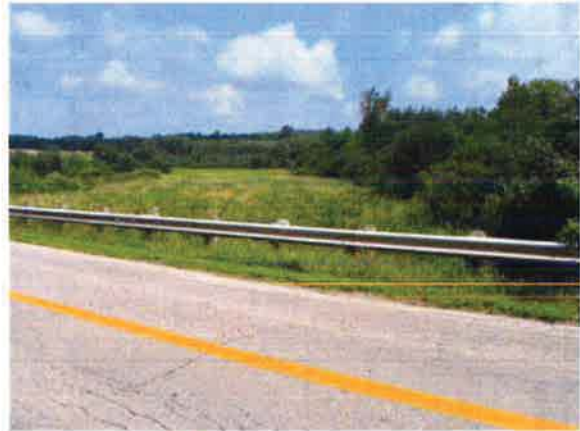
Photo 4: The Creek meanders through a wetland immediately upstream of Watson Road North (Site 4). Hills to the north of the Creek have been cleared for development (construction in progress) and storm water ponds have been constructed.

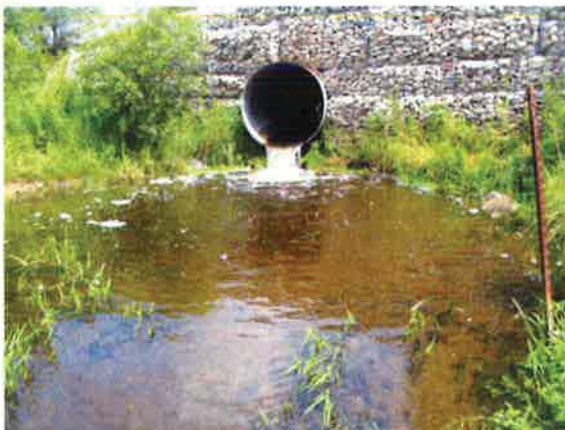
Photo 5: Perched culvert at Watson Road North (Site 4) presents a significant barrier to fish migration. Large schools of minnows (and minnow traps) can usually be observed in the pool below the culvert.

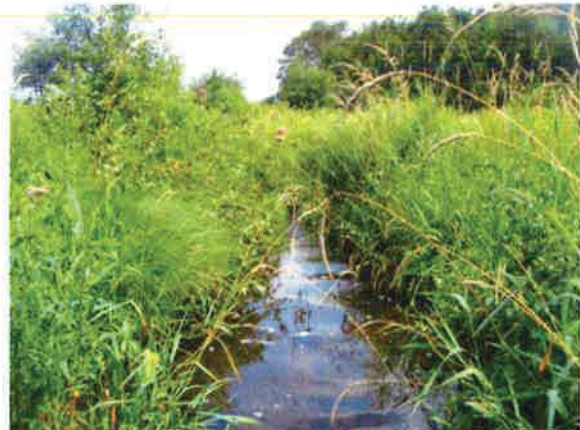
Photo 6: Sections of the Creek between Watson Road North (Site 4) and Watson Parkway (Site 5) have been channelized; however, the Creek is relatively narrow with areas of gravel streambeds and some riparian cedar trees.

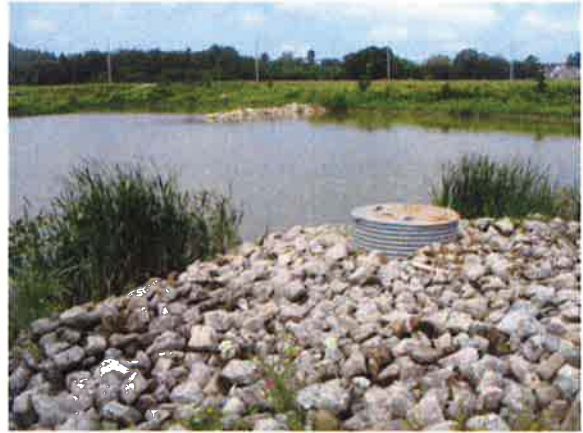
Photo 8: Storm water management pond collects runoff from the developing portion of the watershed near Starwood Drive and Grange Road. The pond discharges to the Creek just upstream of Watson Parkway (Site 5).

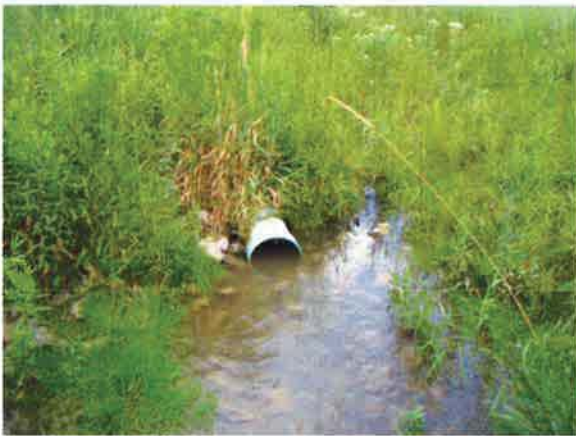
Photo 9: Discharge from the storm water pond was consistently turbid throughout the summer. Water quality in Clyde Creek was noticeably impacted and sedimentation of the Creek channel downstream of the pond outlet was observed.

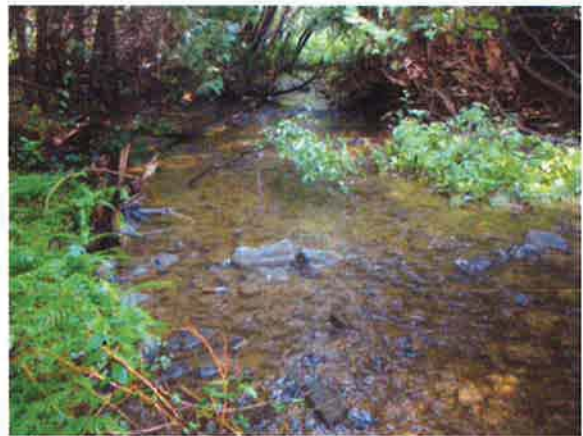
Photo 10: The Creek flows through a small patch of dense cedar forest between Watson Parkway (Site 5) and Highway 7 (Site 6). Numerous groundwater seeps can be found in this area. Sedimentation of the Creek channel is evident.

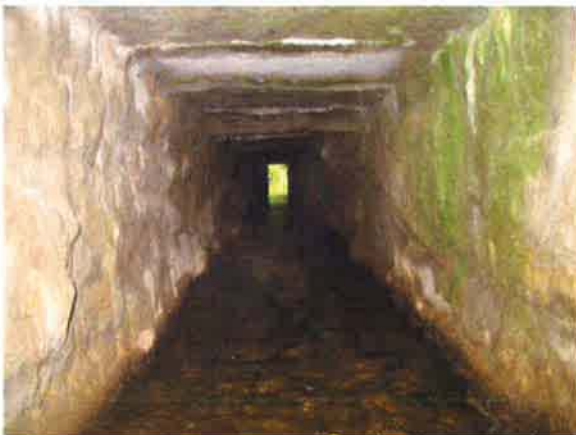
Photo 11: A long, dual-channelled, concrete culvert diverts the Creek from the north to the south side of the railway line.

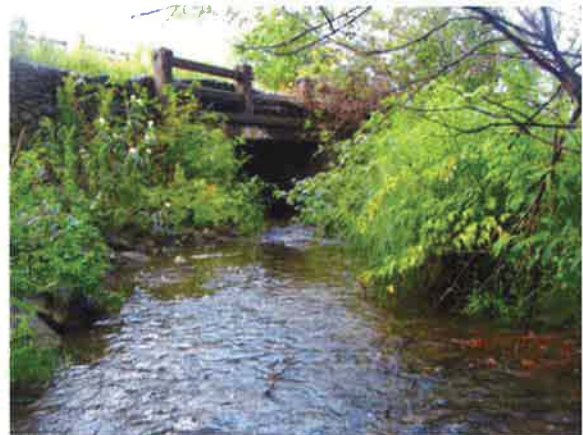
Photo 12: The Creek passes under Highway 7 (Site 6) and flows along the north side of the highway toward its confluence with the Eramosa River. This section of the Creek is highly altered with numerous dams, weirs and ponds.

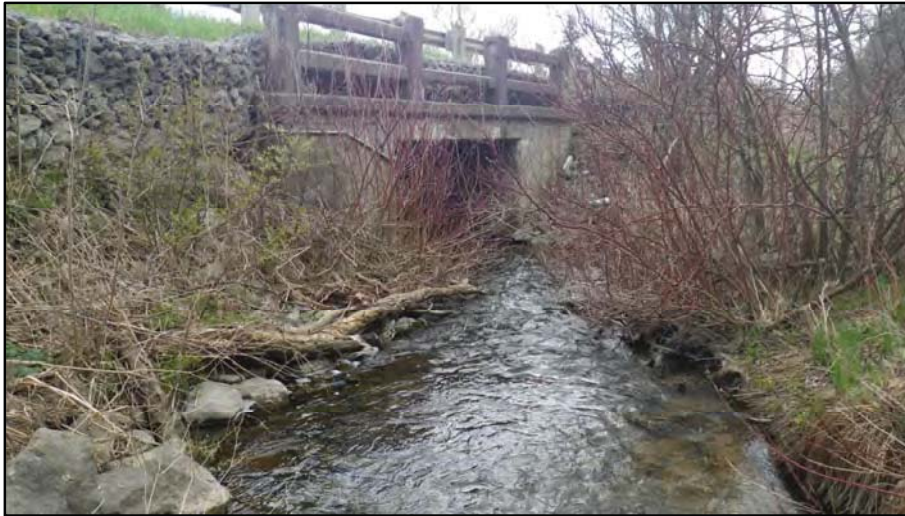
1. Reach C-9A: Clythe Creek culvert inlet at York Road. Gabion protection along road embankment and rip rap placement along the channel banks. Channel approaches culvert at a 45 degree angle; rip rap protection limits bank scour at inlet.

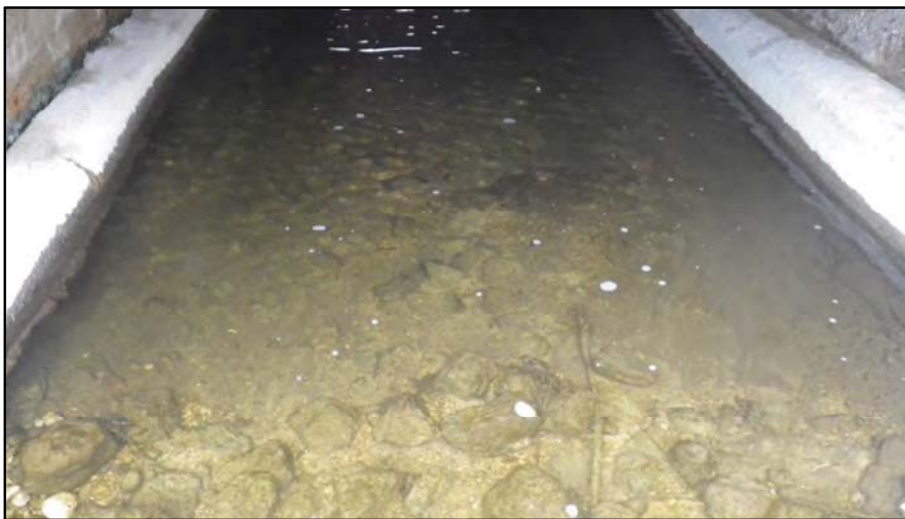
2. Reach C-9A: Substrate inside York Road culvert. Wetted channel width occupies the entire culvert width.

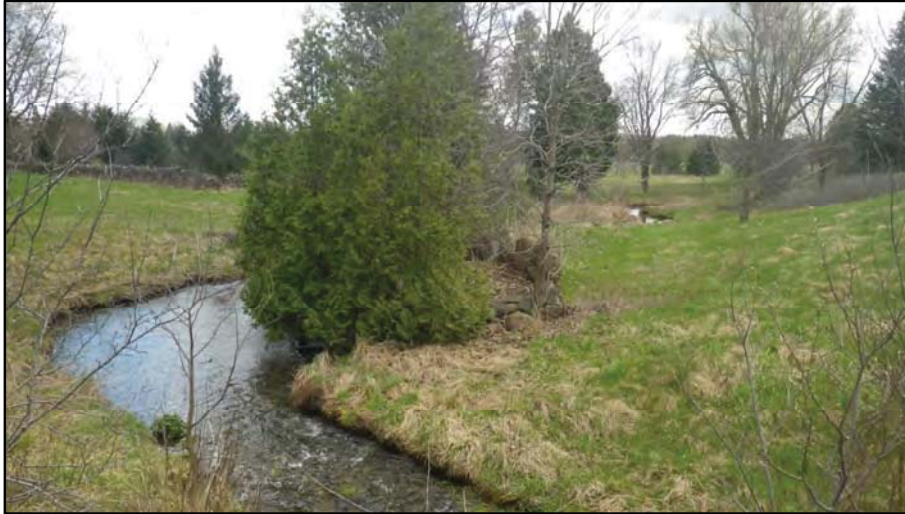
3. Reach C-9A: Looking downstream from York Road culvert outlet.

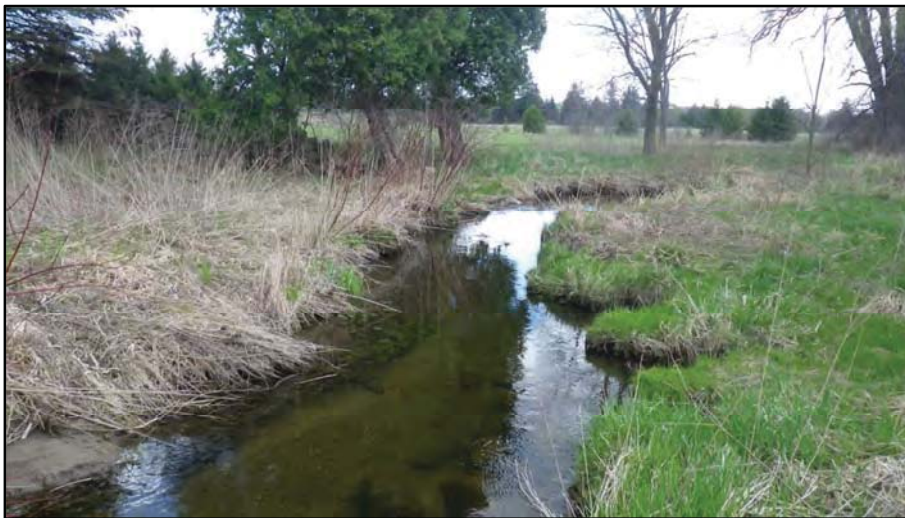
4. Reach C-9A: Typical cross section within the reach. Water level site near bankfull, banks are oversaturated and slumping causing hummocky terrain.

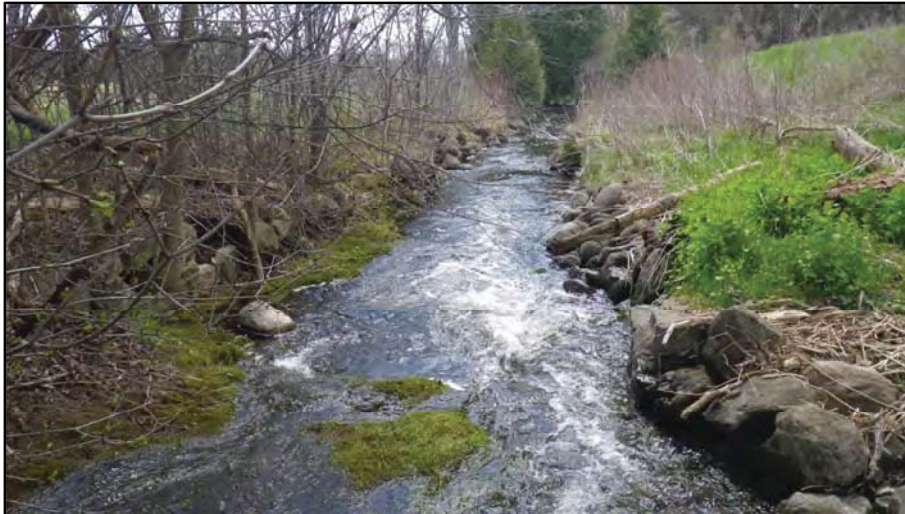
5. Reach C-9A: Banks are typically lined with small boulders.

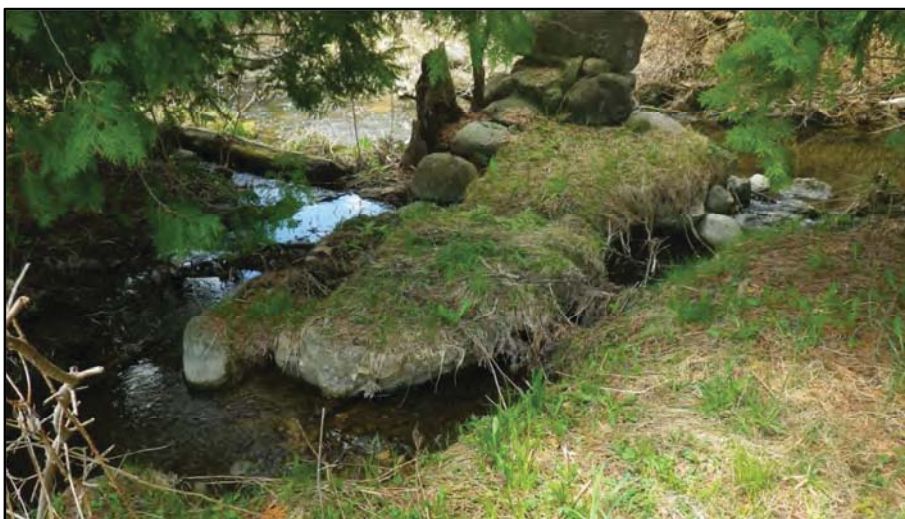
6. Reach C-9A: Channel outflanks in-stream weir structure.

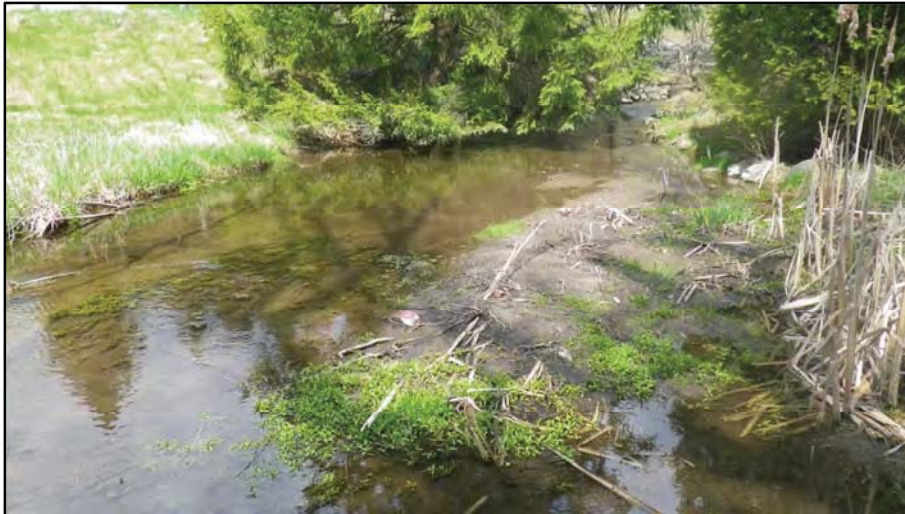
7. Reach C-9A: Section of over widened channel upstream from weir where water is ponded. Sediment deposition occurs and cat tail growth observed.

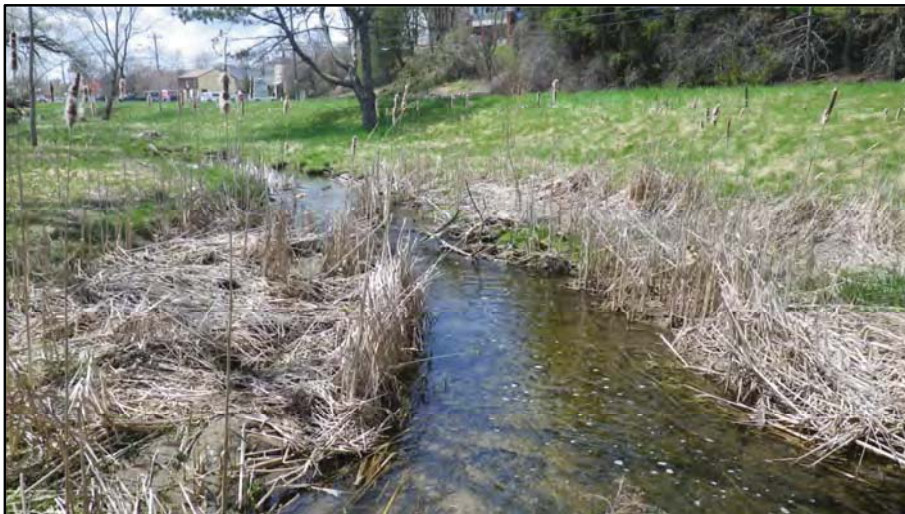
8. Reach C-9A: Channel is locally widened downstream from weir structure that spans approximately 2x bankfull width. Deposition and infill occurs to compensate.

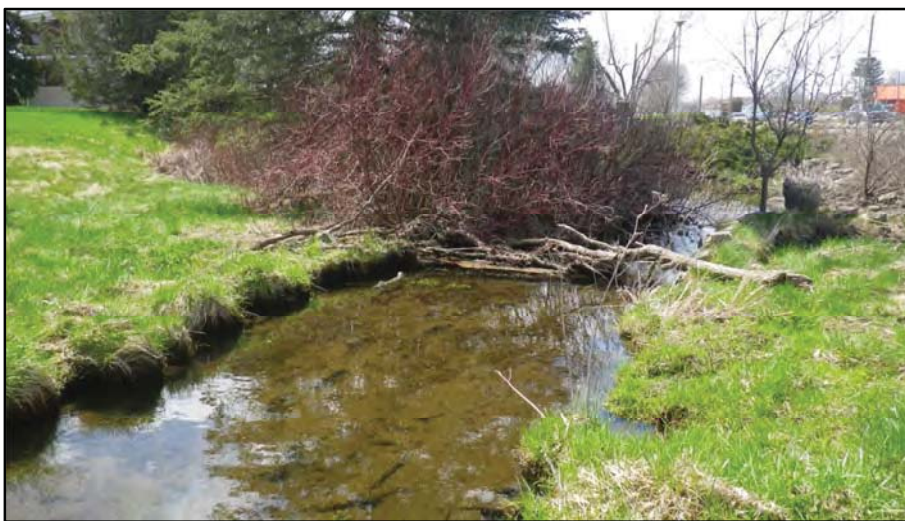
9. Reach C-9A: Tributary channel through ornamental grounds that confluences' with Clythe Creek.

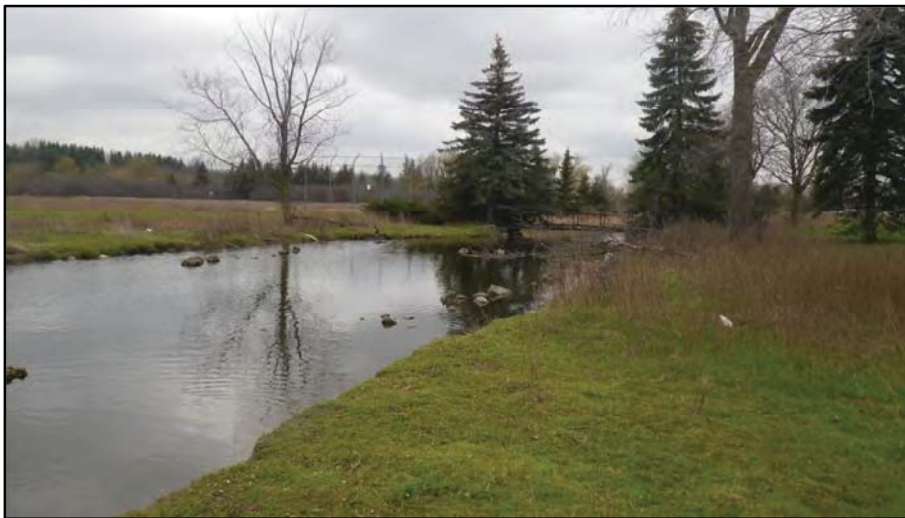
13. Reach C-9B: Looking upstream along Clythe Creek adjacent to Jaycee Park.

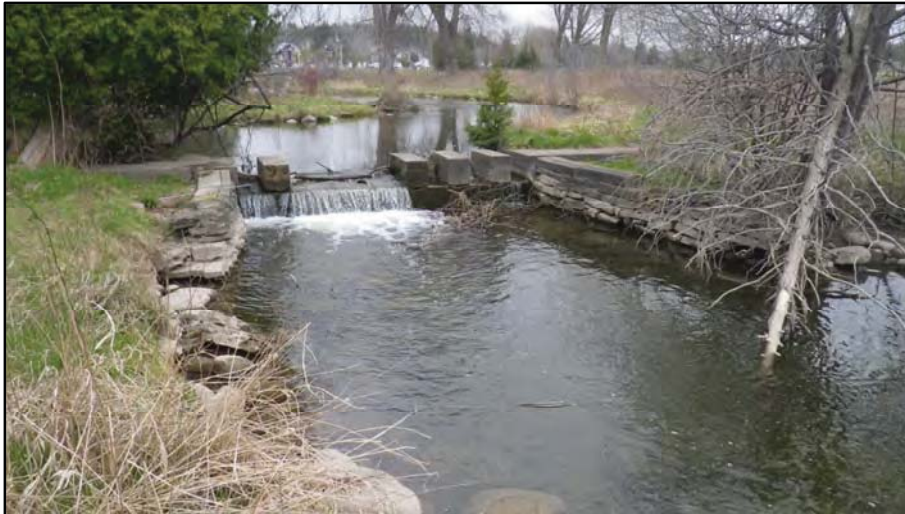
16. Reach C-10: Clythe Creek downstream from Hadati Creek confluence; flow is ponded upstream from flow splitter.

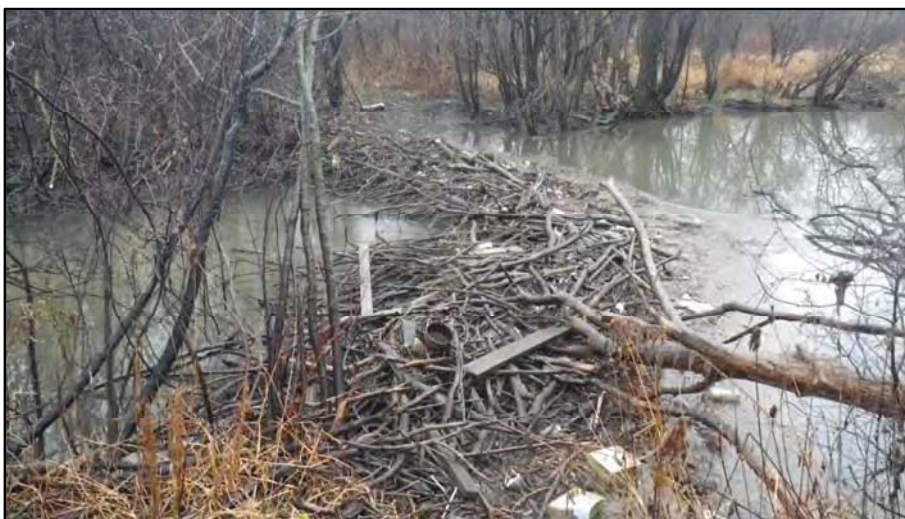
17. Reach C-10: Flow splitter structure installed along Clythe Creek.

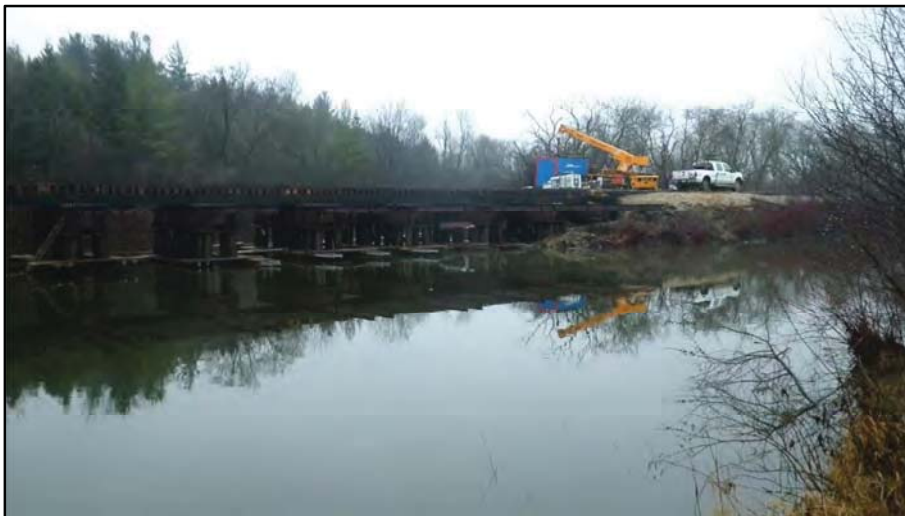
19. Reach C-10: Channel flows adjacent to CNRL embankment at the Eramosa River confluence.

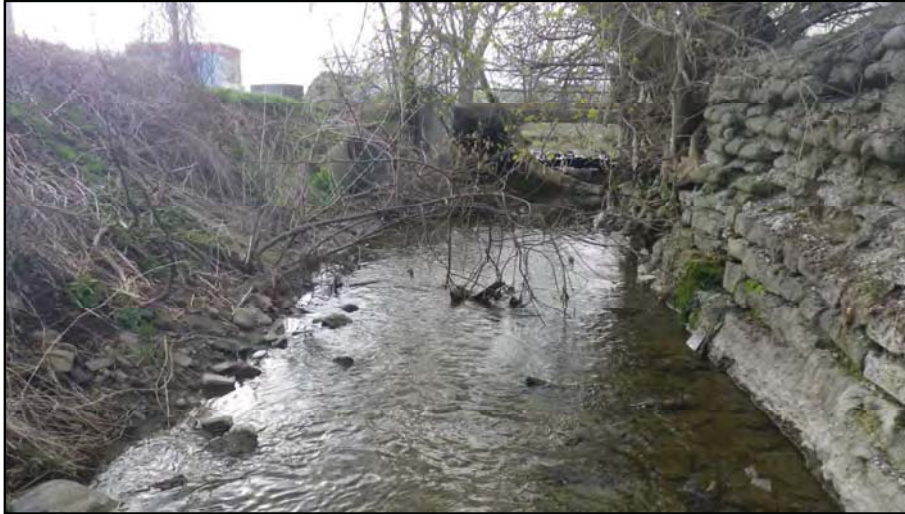
20. Reach C-10: Confluence with the Eramosa.

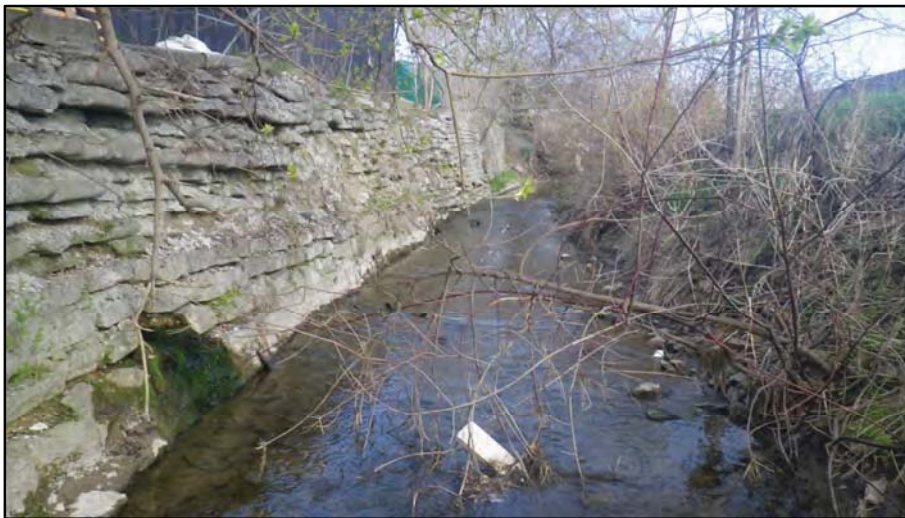
21. Reach HC-1: Looking downstream towards York Road culvert crossing.

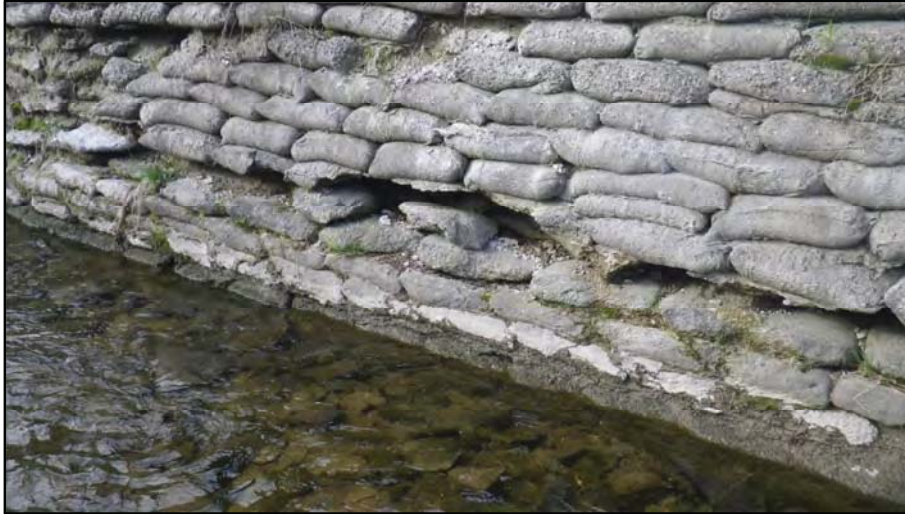
22. Reach HC-1: Looking upstream along Hadati Creek.
