Environmental Impact Study (EIS)

York Road Environmental Design Study
City of Guelph
Project # TP115100

Re: Final York Road Environmental Impact Study

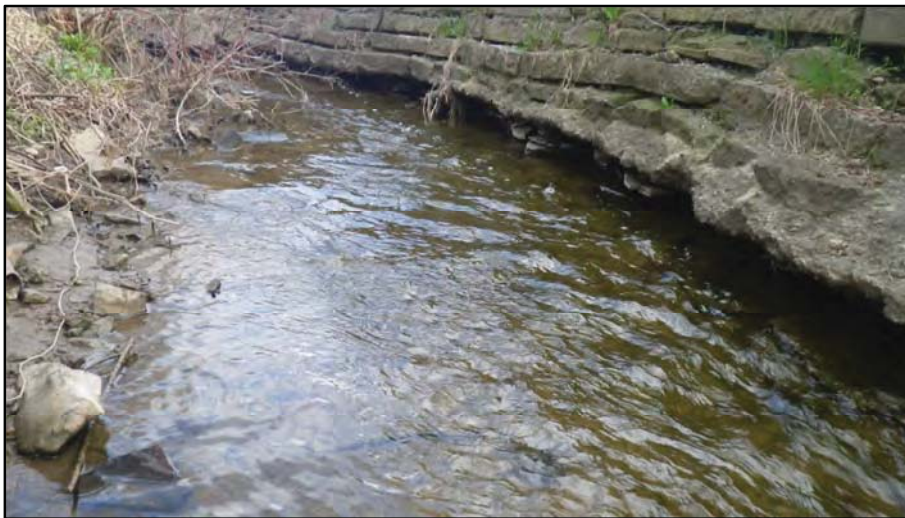
23. Reach HC-1: Concrete cushion bank protection installed along the west bank is failing.

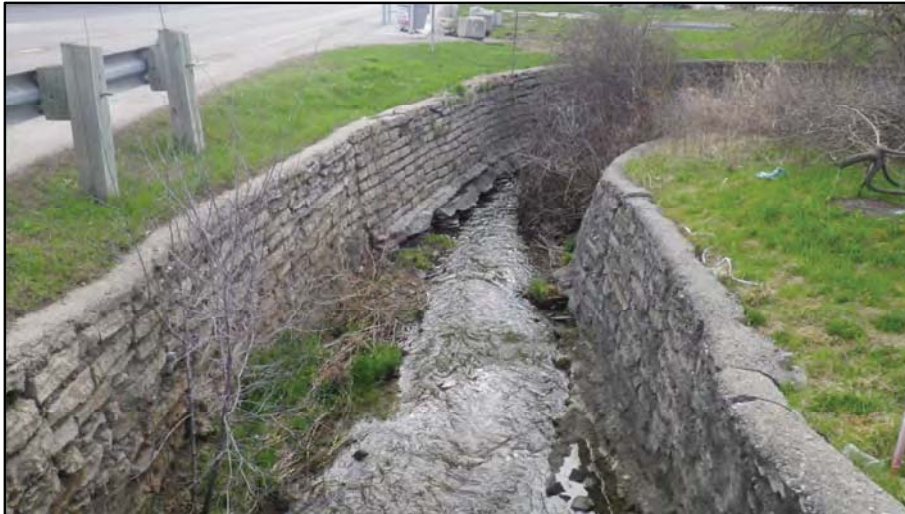
24. Reach HC-1: Concrete block wall at channel bend is undermined.

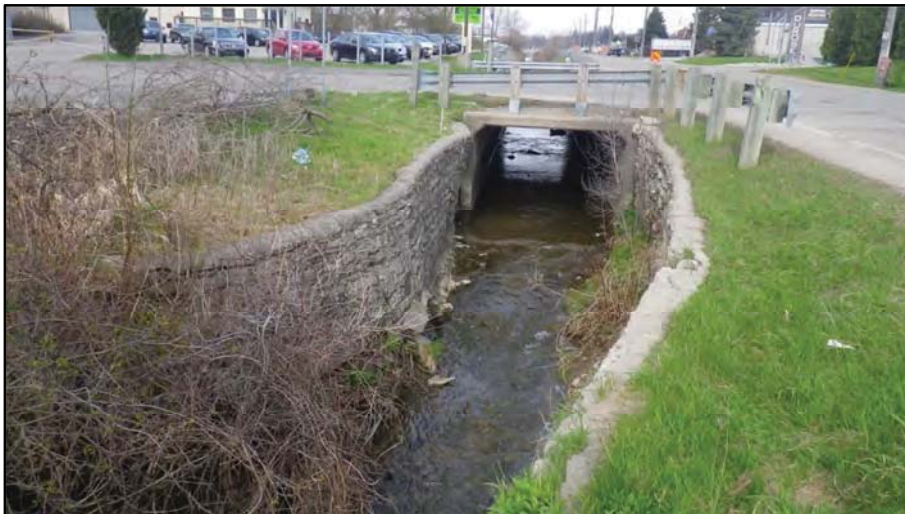
25. Reach HC-1: Channel immediately downstream from Beaumont Cres. Both banks are lined with concrete and shale bricks. Bank protection is undermined along meander bend.

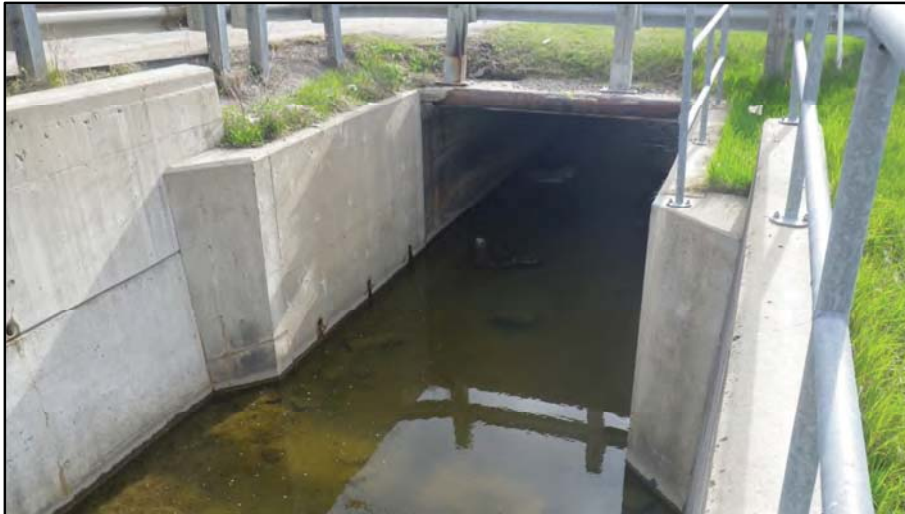
26. Reach HC-1: Looking upstream towards Beaumont Cres culvert crossing.

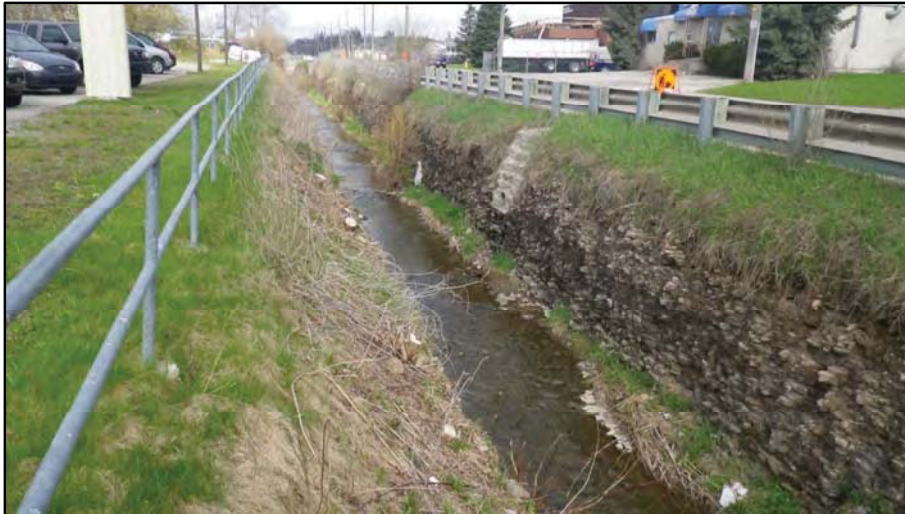
28. Reach HC-1: Looking upstream from Beaumont Cres crossing. Channel is lined with concrete for approximately 18 m.

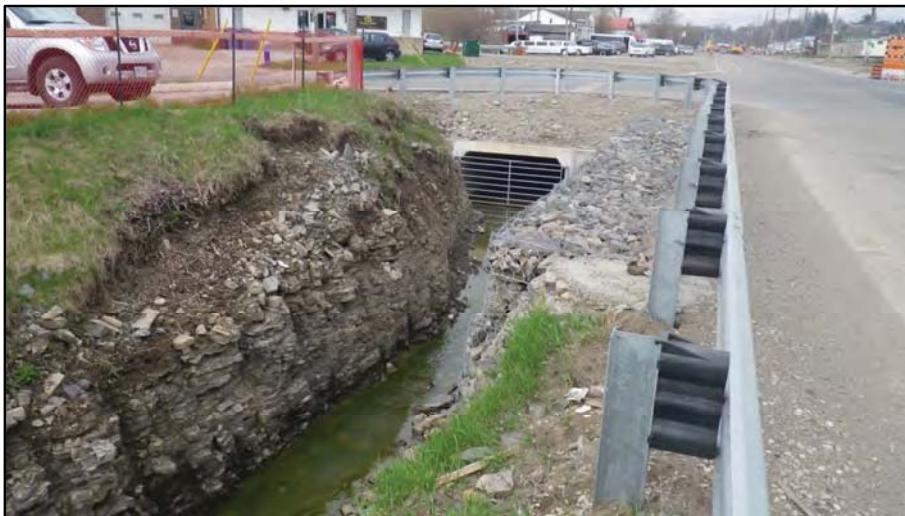
29. Reach HC-1: Channel occupies roadside ditch and has been historically altered.

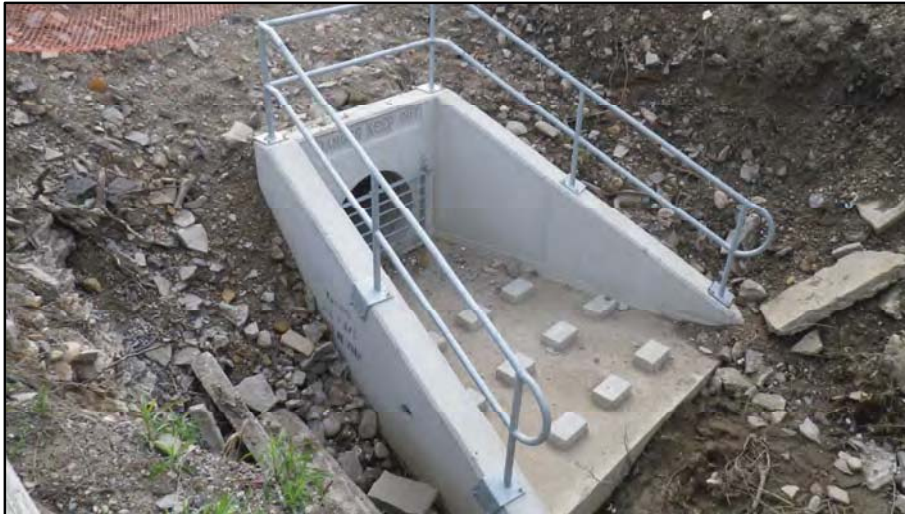
30. Reach HC-1: Culvert crossing at Industrial Ave. Channel has been buried for approximately 60 m upstream from Industrial Ave.

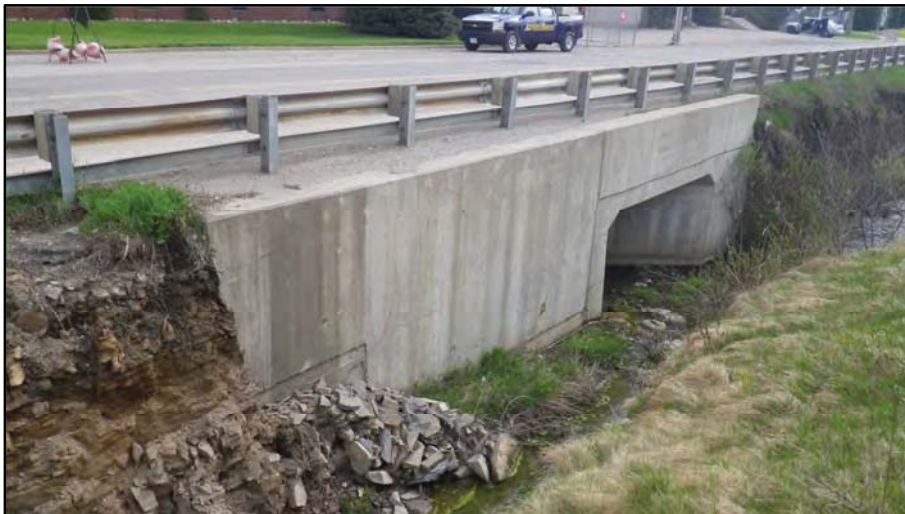
31. Reach HC-1: Inlet 60 m upstream from Industrial Ave. Channel was dry at the time of field inspection.

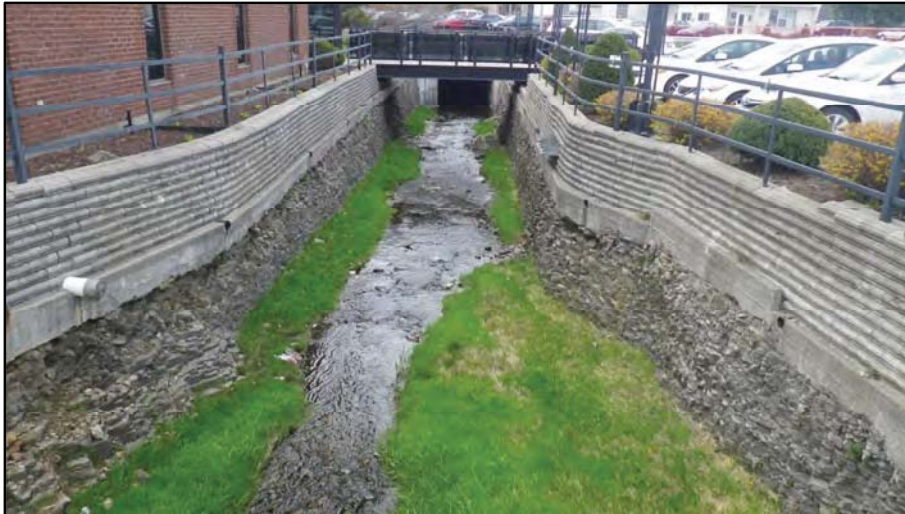
32. Reach HC-1: Elizabeth Street culvert crossing

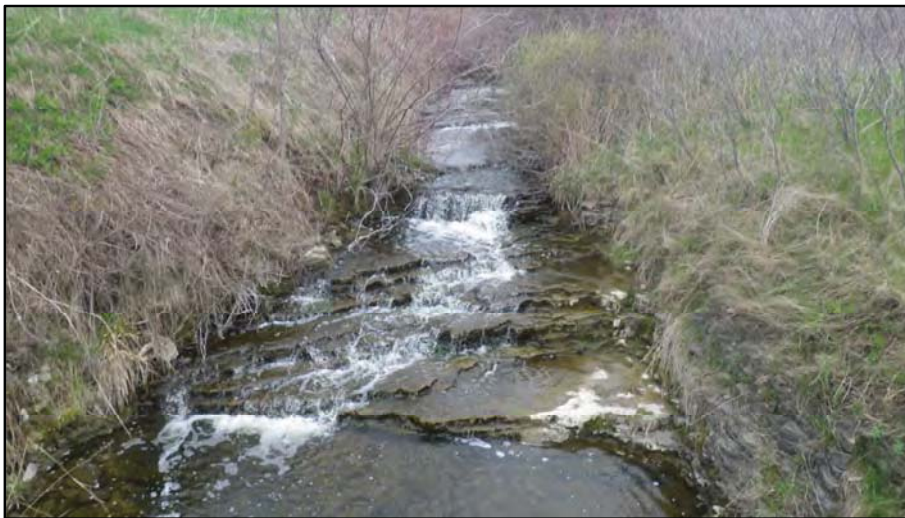
33. Reach HC-1: Upstream from Elizabeth Street the channel is confined through private property.

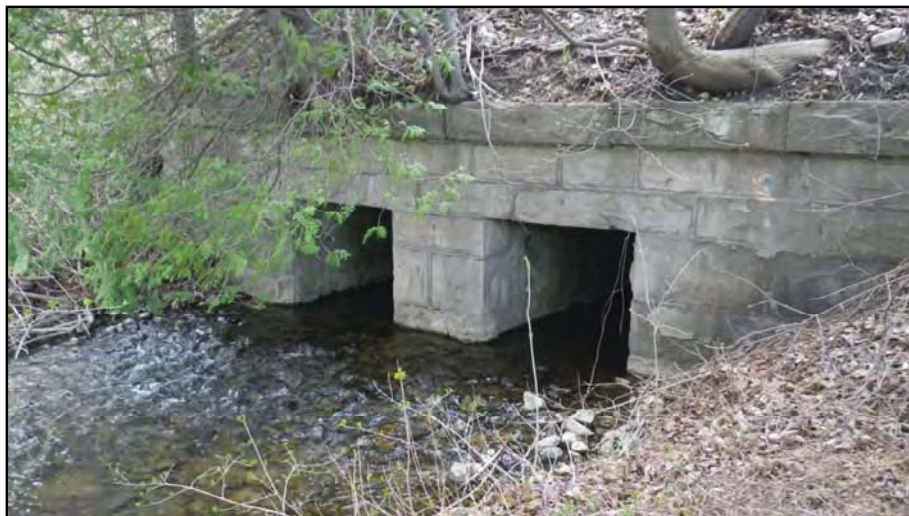
1. Feature #1: Ashlar stone culvert (potential significance) north of York Road. Culvert is 25 m upstream from York Road and conveys Clythe Creek flow underneath the CNR line. The double box culvert has approximate dimensions of 1.2 m wide by 1.4 m high. Substrate is present along the bed of the culvert however, natural light does not penetrate and the upstream inlet is not visible.

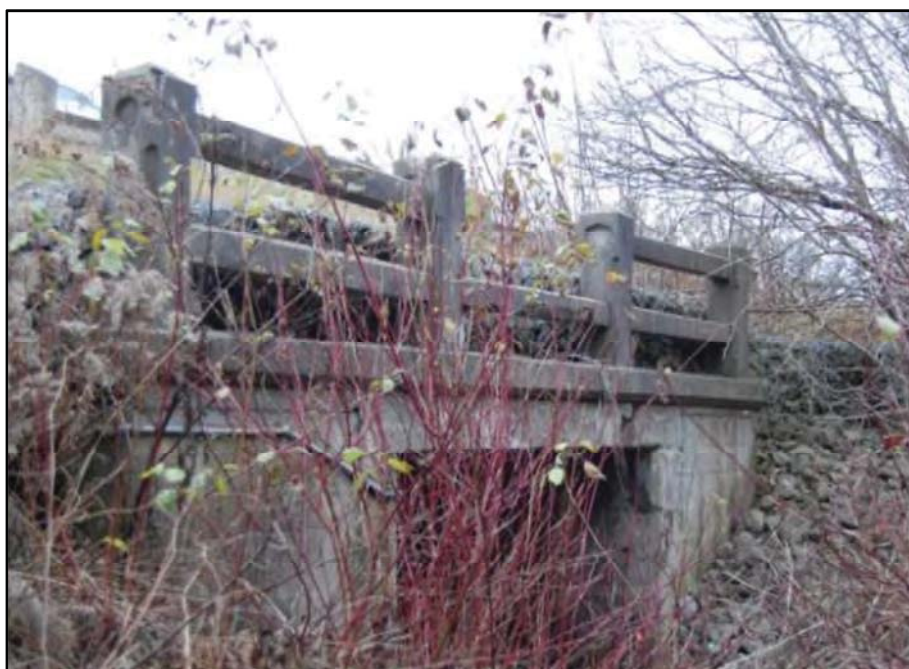
2. Feature #2: Reinforced concrete road bridge railing (potential significance) north of York Road. Railing has been reinforced with gabion and rip-rap.

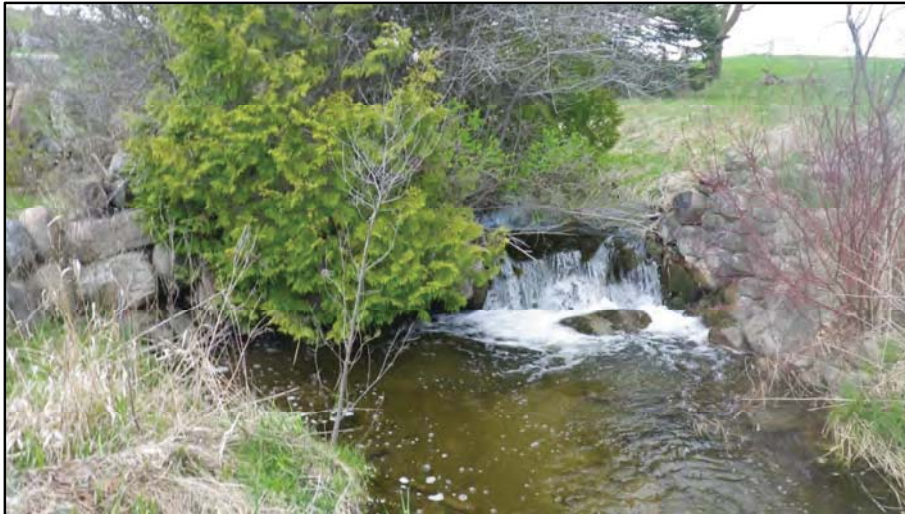
3. Feature #3: Fieldstone weir with steps and sentinel stones (listed, non-designated significant feature). Structure height is 0.5 m above water level with an additional 0.45 m scour pool (total height above bed 0.95 m). At the time of survey, flow depth over the structure was 0.08 m and 1.6 m wide. Backwatering upstream from the structure had a depth of 0.45 m. Channel has scoured out downstream from the weir, over-widening the channel to 4m

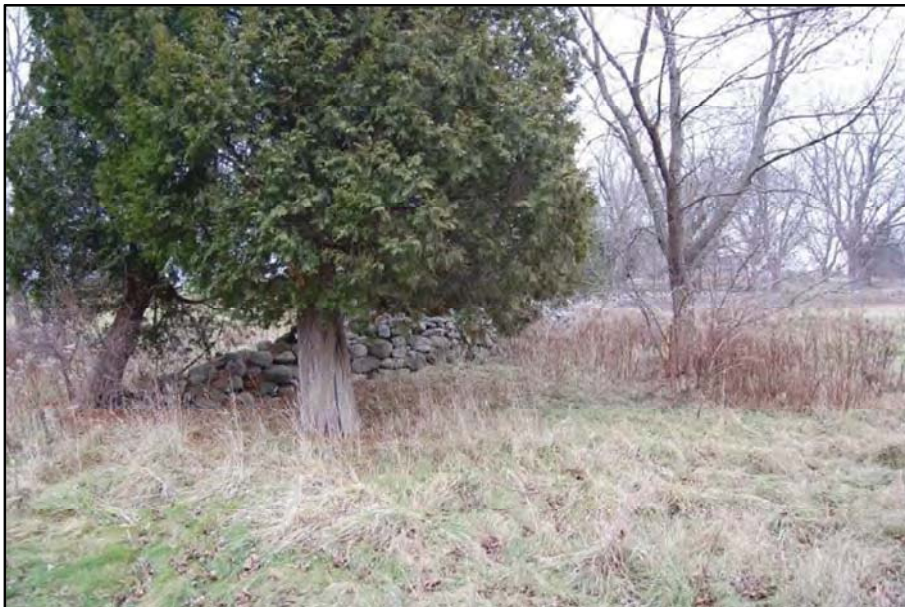
4. Feature #4: Fieldstone garden wall with sentinels (listed, non-designated significant feature). Feature extends for 110 m south-east across the floodplain.

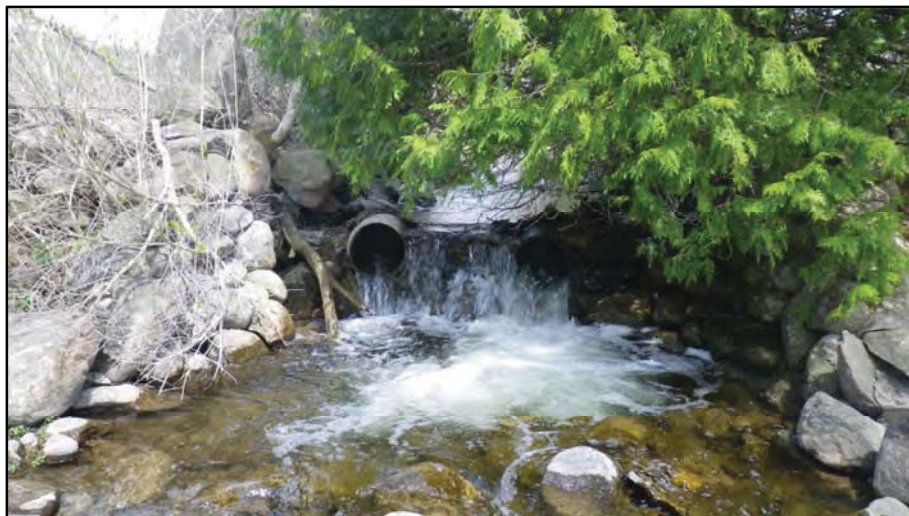
5. Feature #5: Fieldstone weir with clay pipes (listed, non-designated significant feature). Two clay pipes are imbedded into concrete and fieldstone weir structure. The feature is 2m wide and has a total height of 1.1 m; 0.5 m above existing water level plus 0.6 m scour depth. Feature imposes a significant barrier to downstream flow movement and has trapped woody debris at its crest.

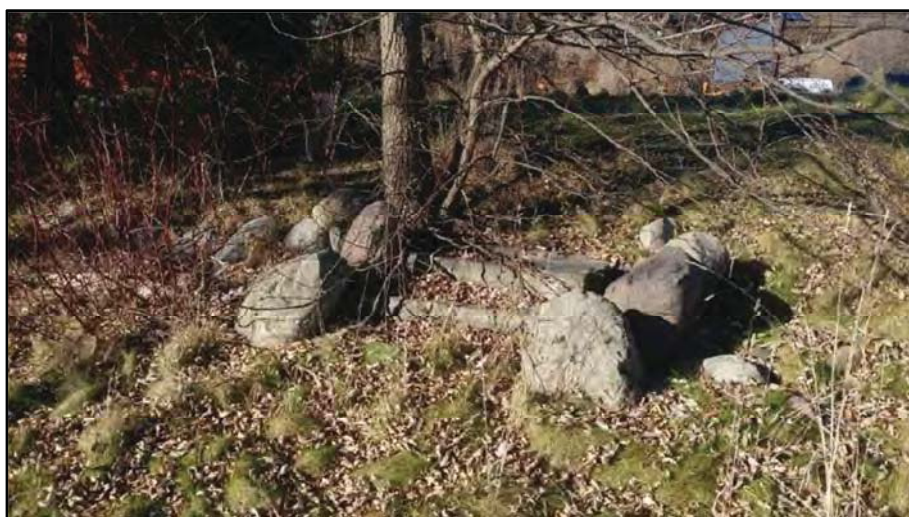
6. Feature #6: Fieldstone steps (listed, non-designated significant feature). Feature is located on the floodplain north of Clythe Creek and south of York Road.

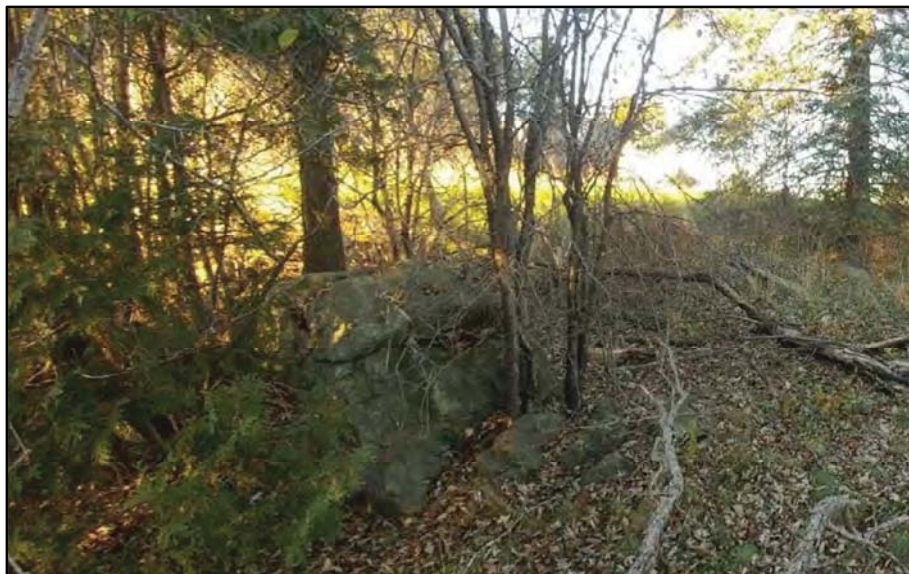
7. Feature #7: Large boulder or bedrock outcrop (potential significance). Feature is located on the floodplain north of Clythe Creek and south of York Road.

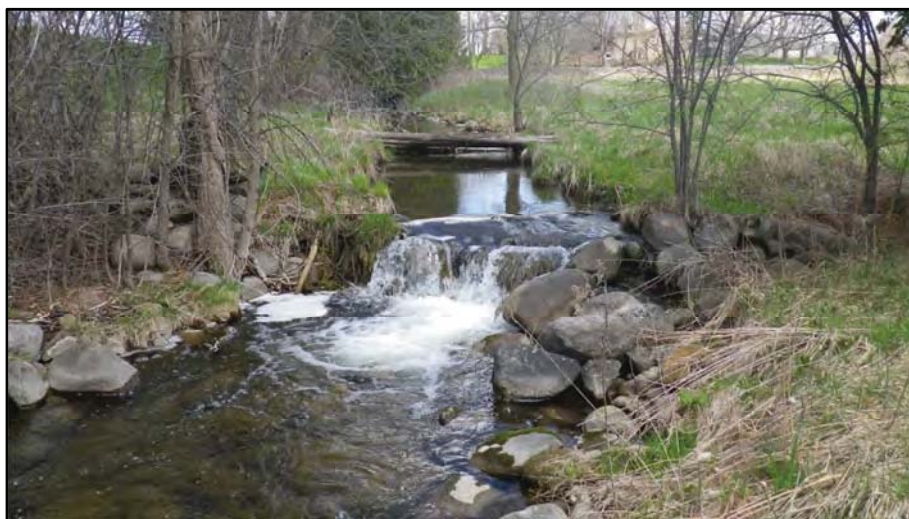
8. Feature #8: Fieldstone weir (listed, non-designated significant feature). This feature is made from fieldstone and concrete with decorated stones placed along the banks. The feature is 1m high; 0.55 m above existing water level plus 0.45 m scour pool. The upstream pool created by backwater is 0.4 m deep with a flow depth of 0.04 m over the crest of the feature. Width of the feature is 2m conforming to the bankfull channel.

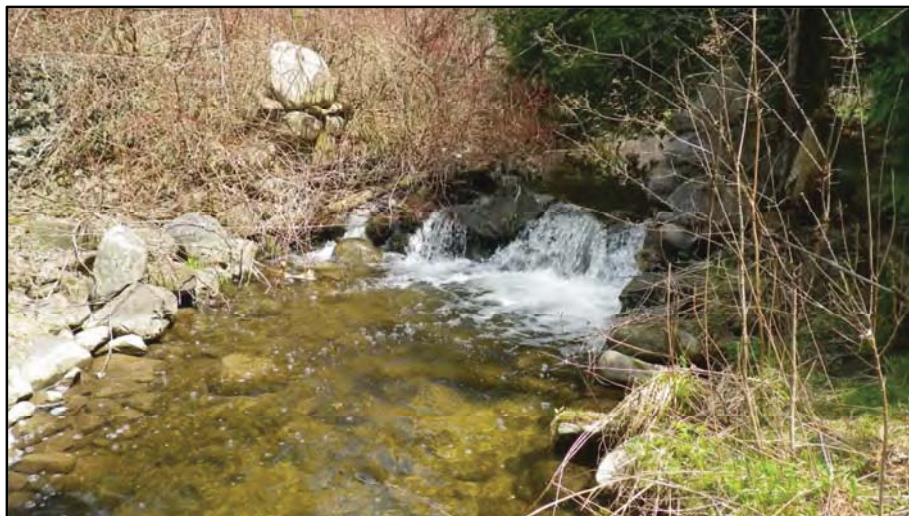
9. Feature #9: Fieldstone weir (listed, non-designated significant feature). This feature is located within a group of cedar trees and the feature and been outflanked to the south. Channel banks are lined with decorative stone and gabion baskets are in place along the road embankment to the north. The feature is 0.9 m high with a downstream scour pool

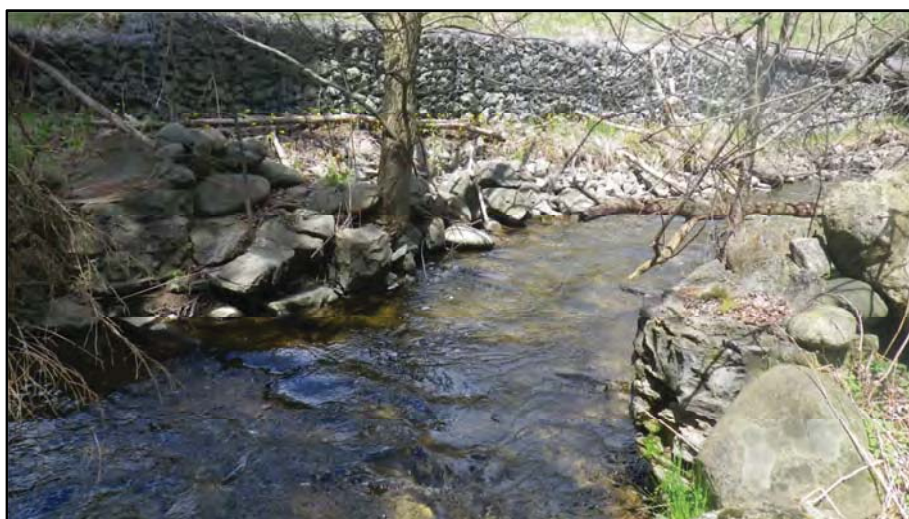
10. Feature #10: Fieldstone weir (listed, non-designated significant feature). No in-stream structure is visible, however banks are lined with decorative stone. Bankfull width is 2m and wetted depth is 0.15 m.

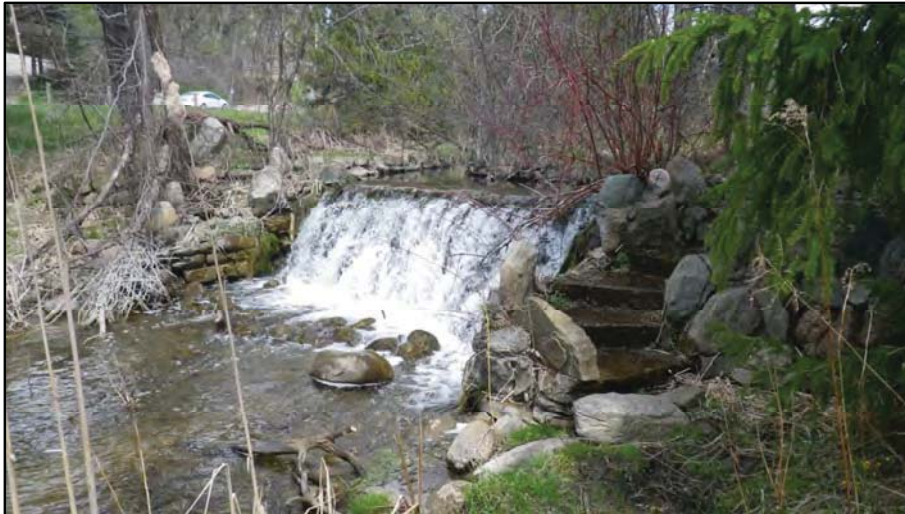
11. Feature #11: Fieldstone weir with steps and ashlar stone terrace wall (listed, non-designated significant feature). This feature is 4m wide and 1.4 m high from the channel bed to crest. Stone placement along the channel bed downstream from the feature limits scour. Decorative stone placement line the banks of the channel.

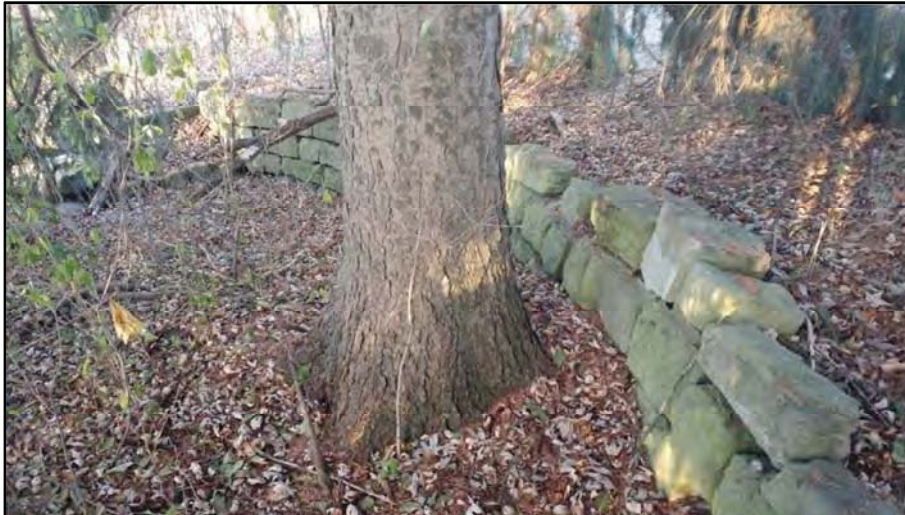
12. Feature #12: Ashlar limestone wall (listed, non-designated significant feature). The feature is approximately 10m in length and extends south across the floodplain adjacent to Feature #11.

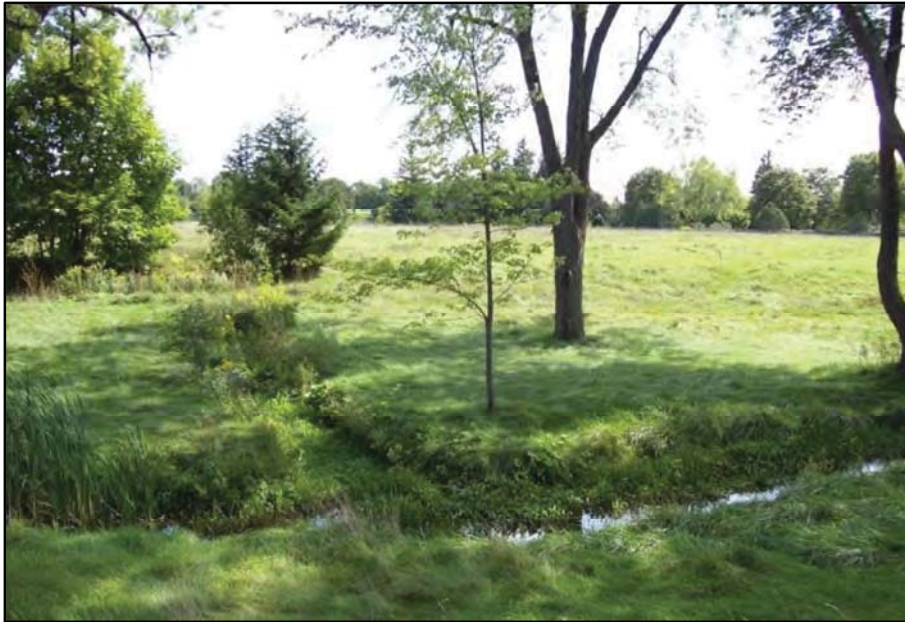
13. Feature #13: Confluence of Clythe Creek and intermittent stream (potential significance). The intermittent stream flows through the southern floodplain and typically conveys groundwater flows. There is a small CSP culvert crossing immediately upstream from the confluence that allows for pedestrian crossing.

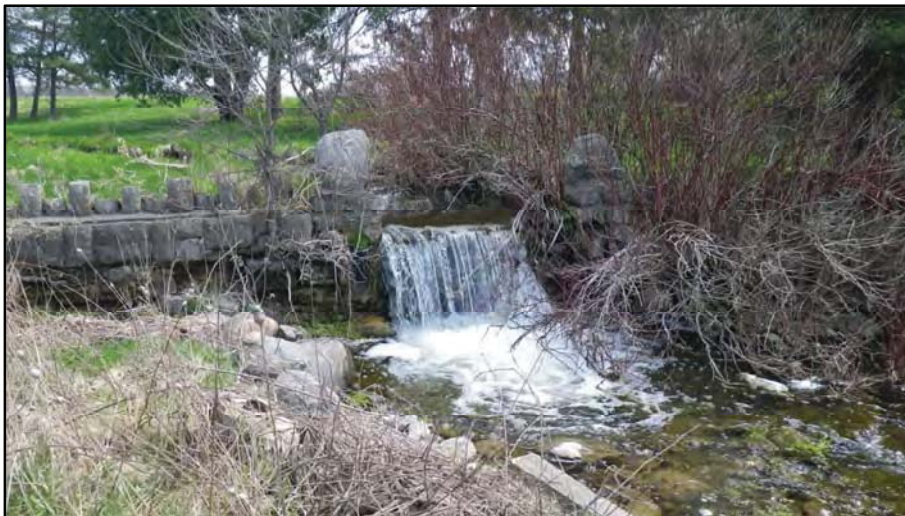
14. Feature #14: Fieldstone weir with cut stone terrace wall (listed, non-designated significant feature). The crest of this feature is 1.5 m wide between the two main sentinel stones and is 1.45 m high from the base of the downstream scour pool. The backwater pool upstream from the feature is 0.55 m deep. Noticeable sedimentation is occurring behind the structure, with unconsolidated material measuring 10-15 cm.

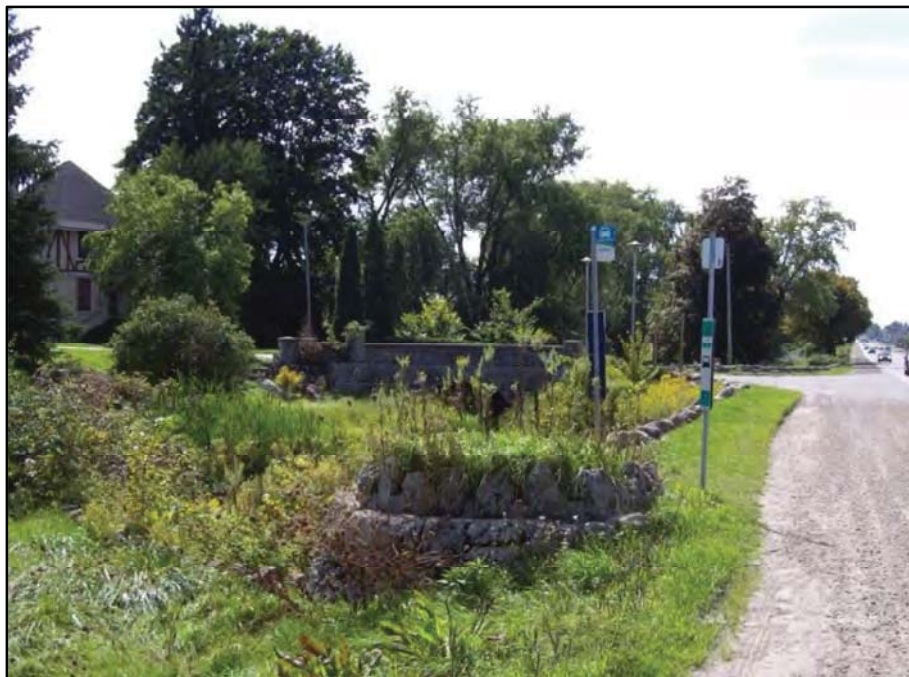
15. Feature #15: Fieldstone east entrance wall with sentinel stones (listed, non-designated significant feature). This feature is located to the north of the channel adjacent to York Road. The feature is 42 m long.

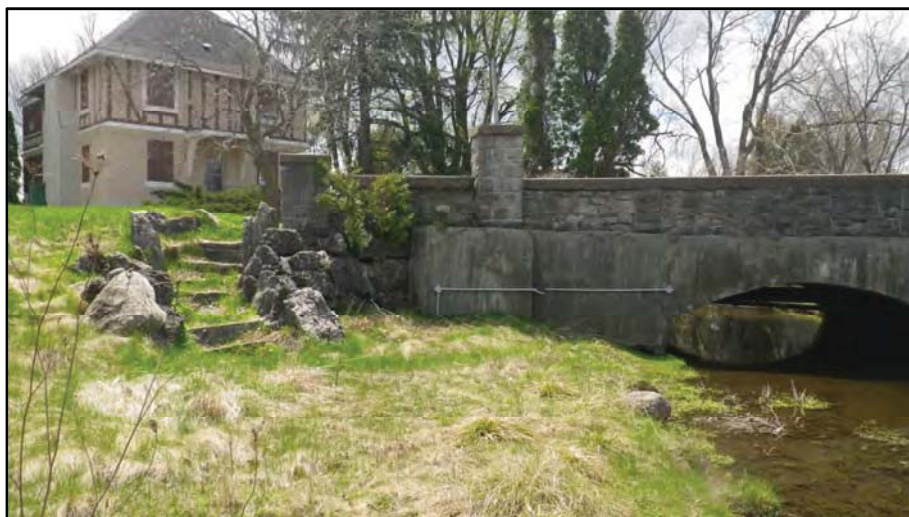
17. Feature #17: Stone and concrete road bridge (listed, non-designated significant feature). The bridge and wing-wall structure is approximately 14 m wide. The inlet to convey Clythe Creek is 4m wide and is considered to be undersized from a geomorphic perspective as the channel has widened and pooled on either side of the inlet.

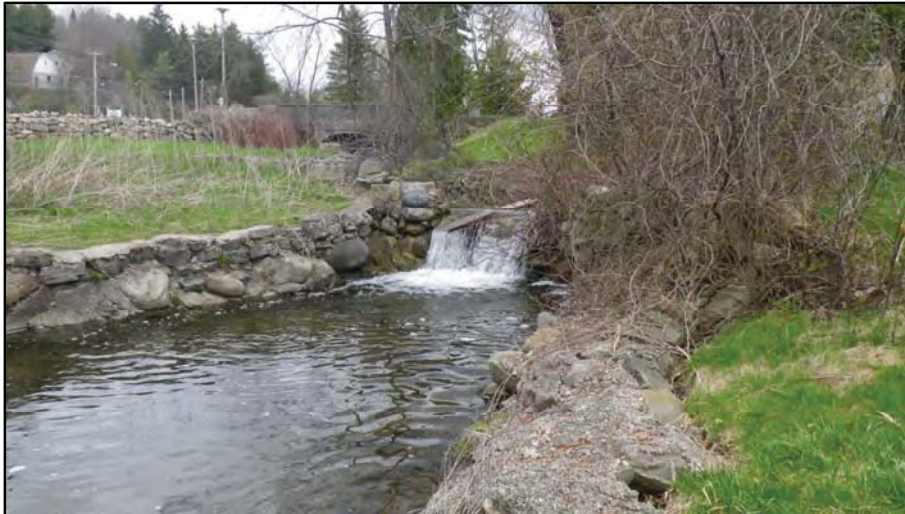
22. Feature #22: Fieldstone weir (listed, non-designated significant feature). The feature is located 6m downstream from Feature #17, and is made from concrete with small boulders protruding which emphasizes the “rushing” waterfall effect. Structure width is 2.5 m along the crest and is 1.5 m height from the downstream bed elevation. The downstream water depth within the associated scour pool is 0.8 m.

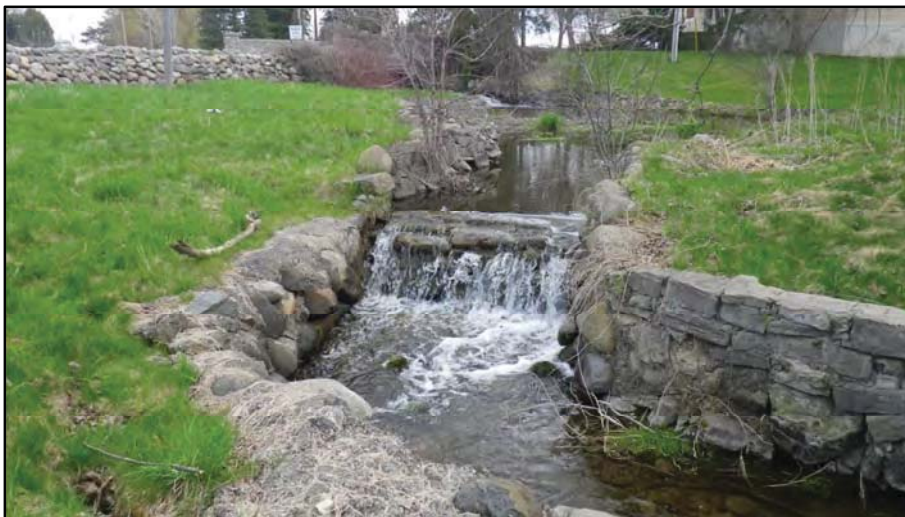
23. Feature #23: Fieldstone weir (listed, non-designated significant feature). This feature is located to the south of a man-made island downstream from the main entrance. The feature is 2m wide and is made out of concrete with small boulders protruding which emphasizes the “rushing” waterfall effect. Channel banks are lined with decorative stone and there is visual evidence of the structure detaching from the bank.

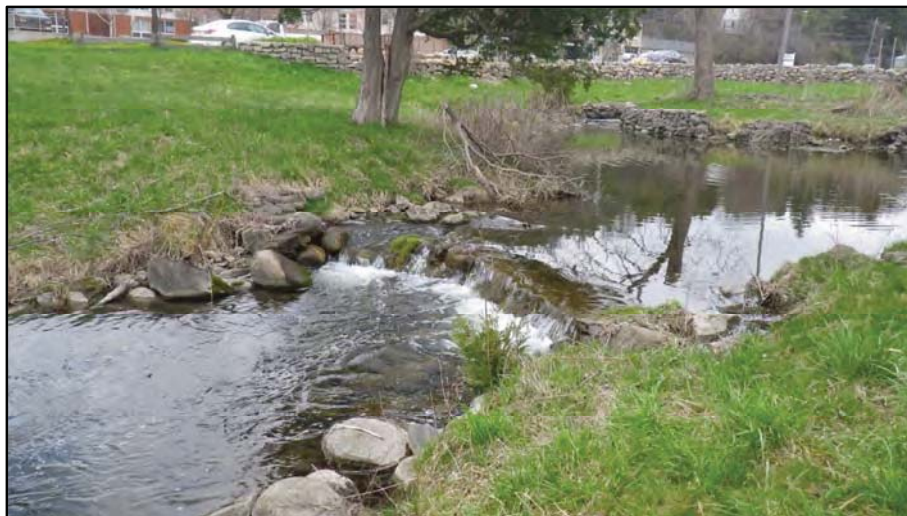
24. Feature #24: Fieldstone weir (listed, non-designated significant feature). This feature is located to the north of a man-made island downstream from the main entrance. The feature is 2.1 m wide and is made out of concrete with small boulders protruding which emphasizes the “rushing” waterfall effect. Channel banks are lined with decorative stone. There are fracture lines present along the northern bank adjacent to the downstream stone wall. The structure is 0.7 m high, with the downstream bank heights/stone wall 1m high. Stone placement along the channel bed limits scour.

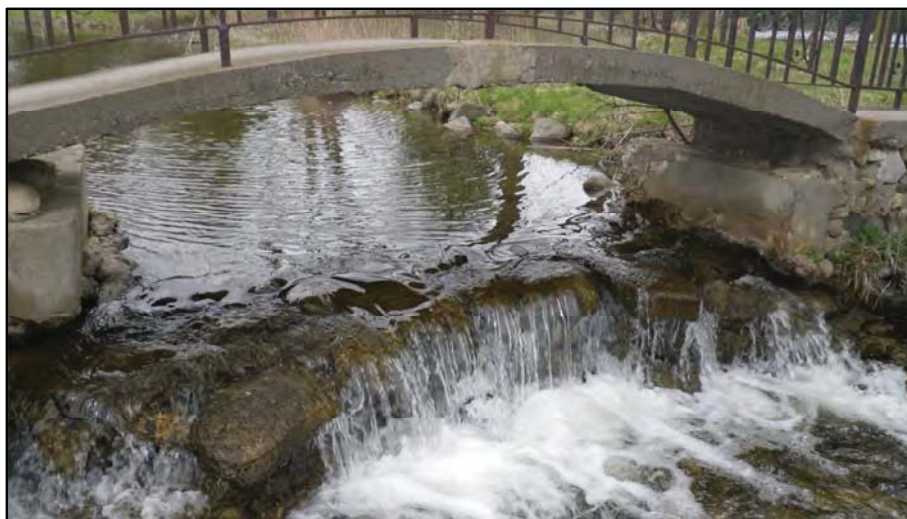
25. Feature #25: Fieldstone weir (listed, non-designated significant feature). This feature is located downstream from the man-made island and 60m downstream from Feature #17 (main bridge). The feature is 5.5 m wide, however active flow width is only 4m over the crest. Height of the structure is 0.8 m from the downstream channel bed, with maximum scour depth of 0.5 m. Water depth upstream from the structure is 0.45 m, and the channel is heavily silted with deposition.

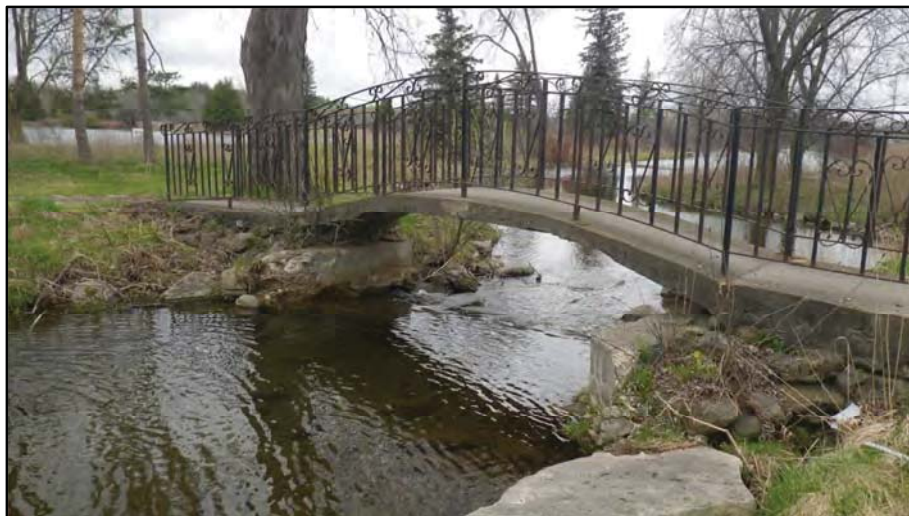
26. Feature #26: Fieldstone weir (listed, non-designated significant feature). The feature height is 1m from the crest to the downstream channel bed, scour depth is 0.4 m. The feature is spanned by Feature #27 and decorative stone is placed along the banks.

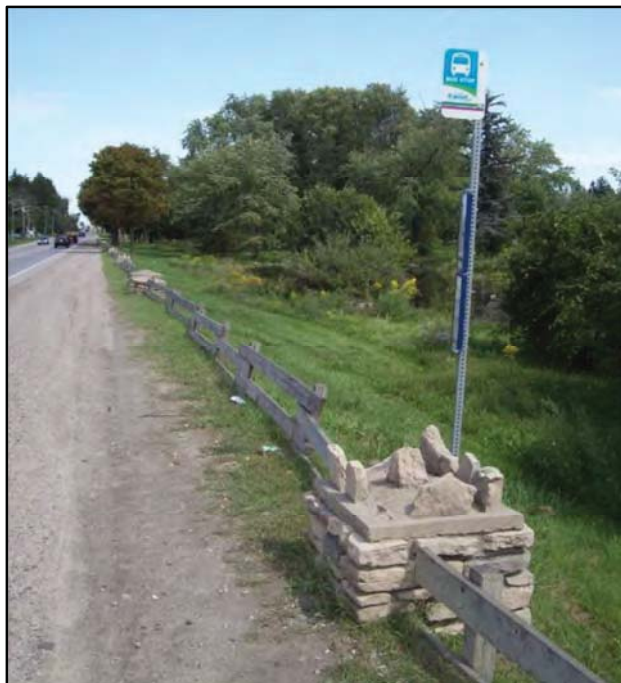
28. Feature #28 and #29: Limestone pillars with wood board fencing leading to main entrance (potential significance). This feature runs parallel to York Road north of Clythe Creek, and extends for 630 m along the edge of the property.

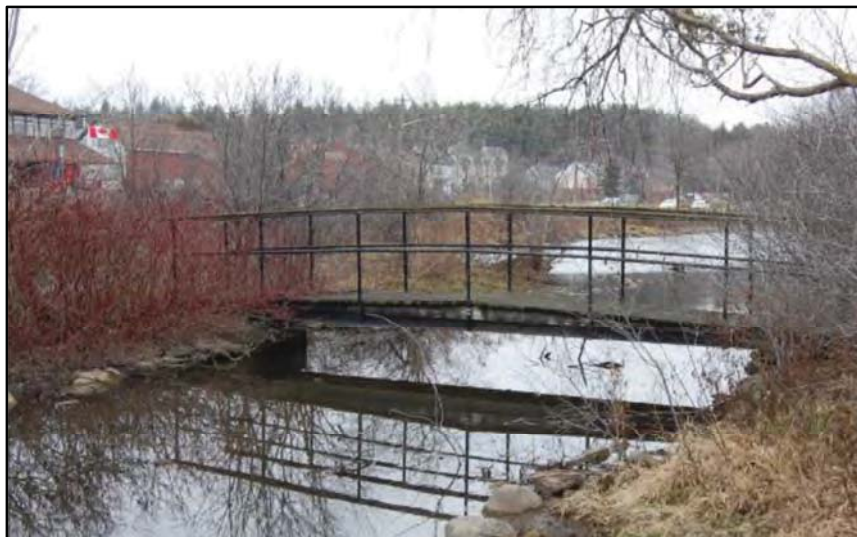
30. Feature #31: metal and wooden pedestrian bridge (potential significance). The bridge is 7m long and 1.8 m wide, with a metal railing and concrete block footings. Water depth under the bridge is 0.65 m with 0.8 m freeboard between the water surface and the bridge deck. Minimum width of the outlet channel is 6.5 m indicating that the bridge is likely undersized.

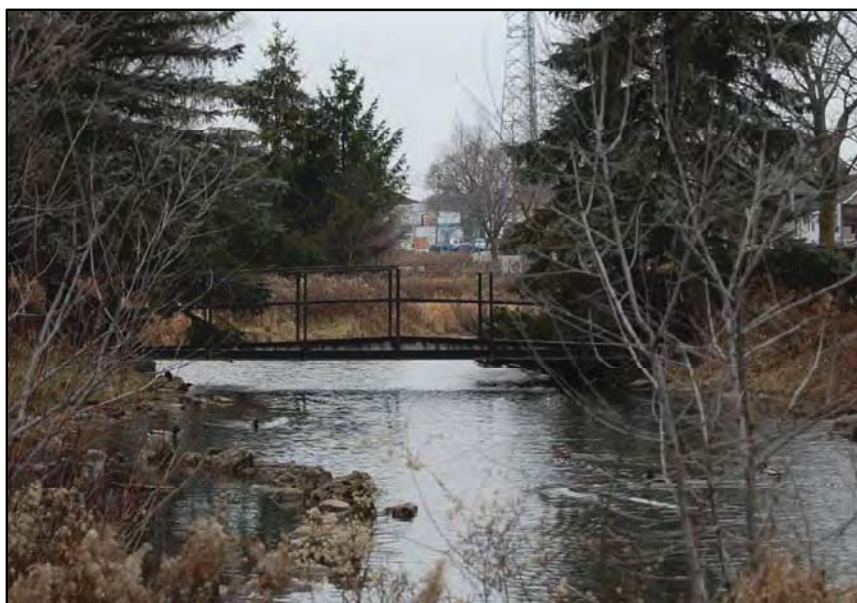
31. Feature #32: Metal and wood pedestrian bridge (potential significance). This pedestrian bridge leads from the south floodplain downstream from Feature #31 to a small island feature within Clythe Creek. The bridge is 9m long and 1.1 m wide sitting on concrete block footings. Wetted depth under the bridge is 0.28 m. Significant sedimentation has occurred within the vicinity of the bridge, with a depth of approximately 0.55 m of soft unconsolidated material present.

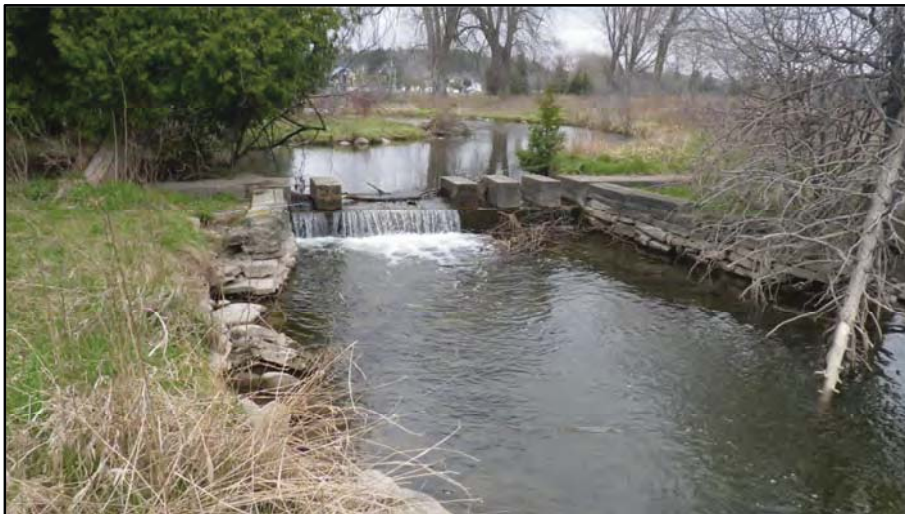
33. Feature #34: Confluence of Clythe Creek and Hadati Creek (potential significance). Hadati Creek flows south-east, crossing perpendicular to York Road through a concrete box culvert.

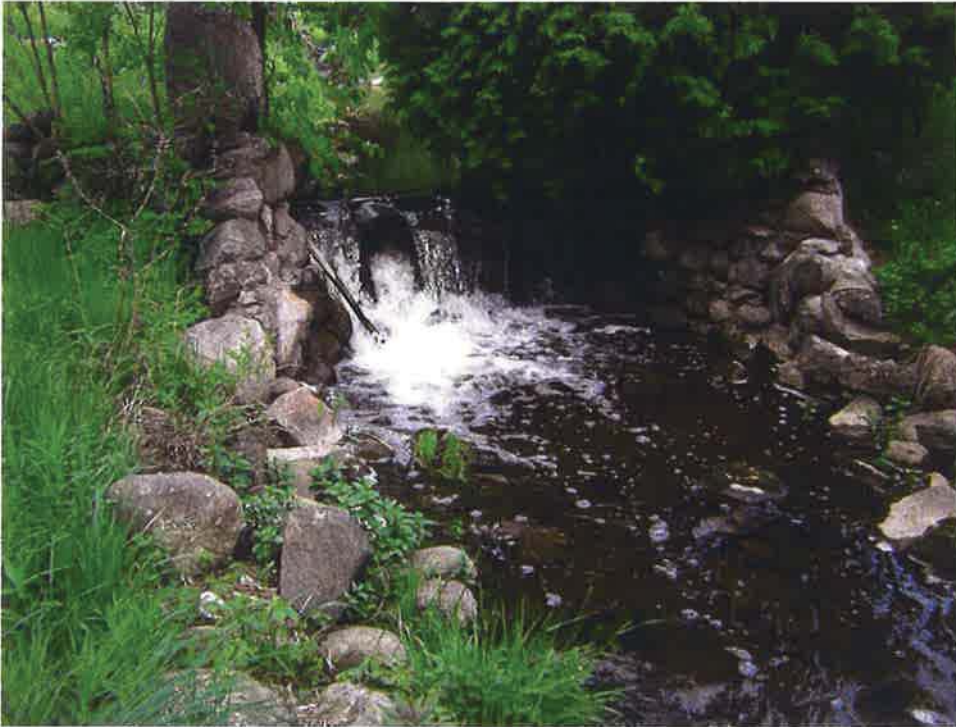
Photo 1 – Clythe Creek, example of the many weirs in the study area

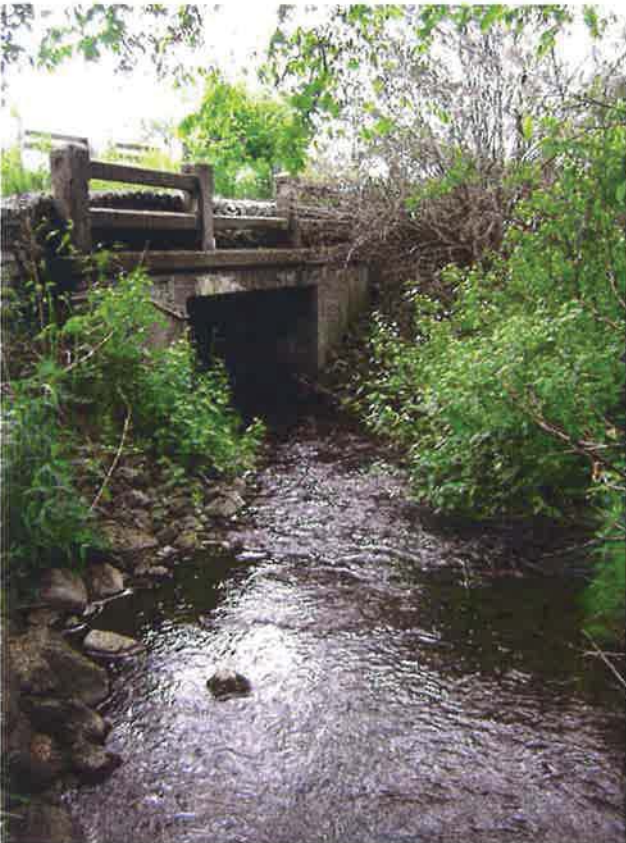
Photo 2 – Clythe Creek, Reach 1, looking downstream

The channel in Reach 1 is approximately 3m wide, and is very entrenched. The bank height ranges from approximately 1.9 to 2.2m, and bank slopes are nearly vertical. Most of the banks are hardened with a concrete bag wall (see Photo 10, Appendix I).

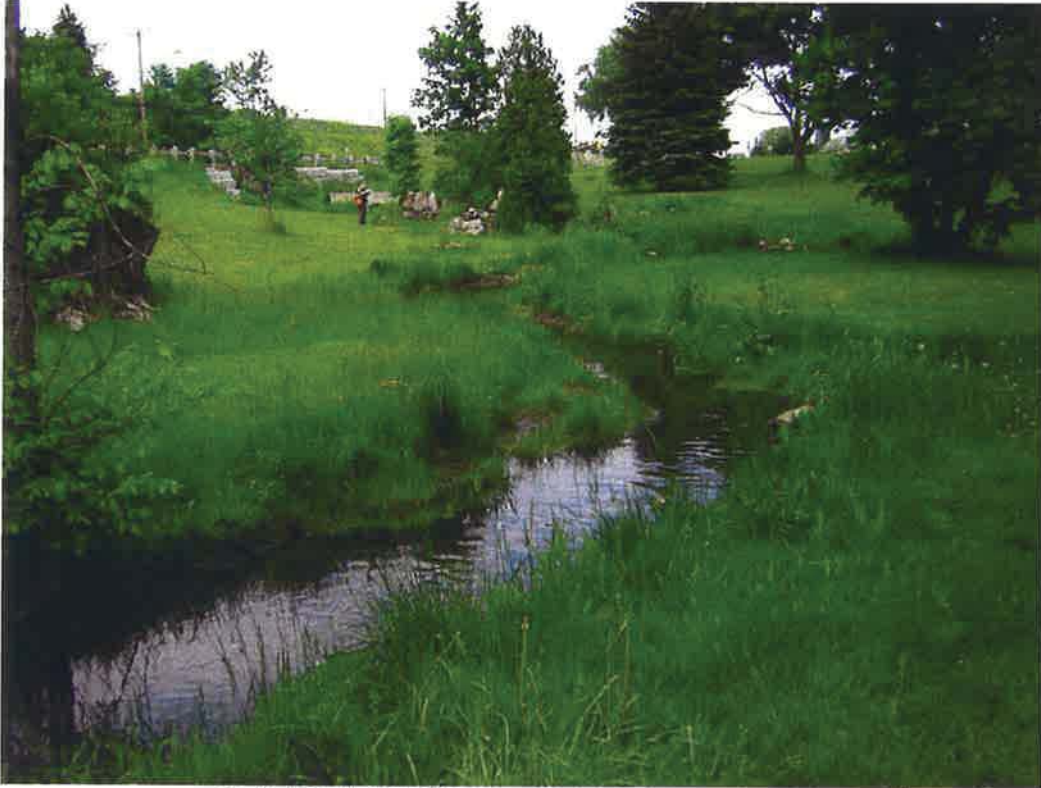
Photo 3 – Clythe Creek, Reach 2, looking upstream toward York Road crossing

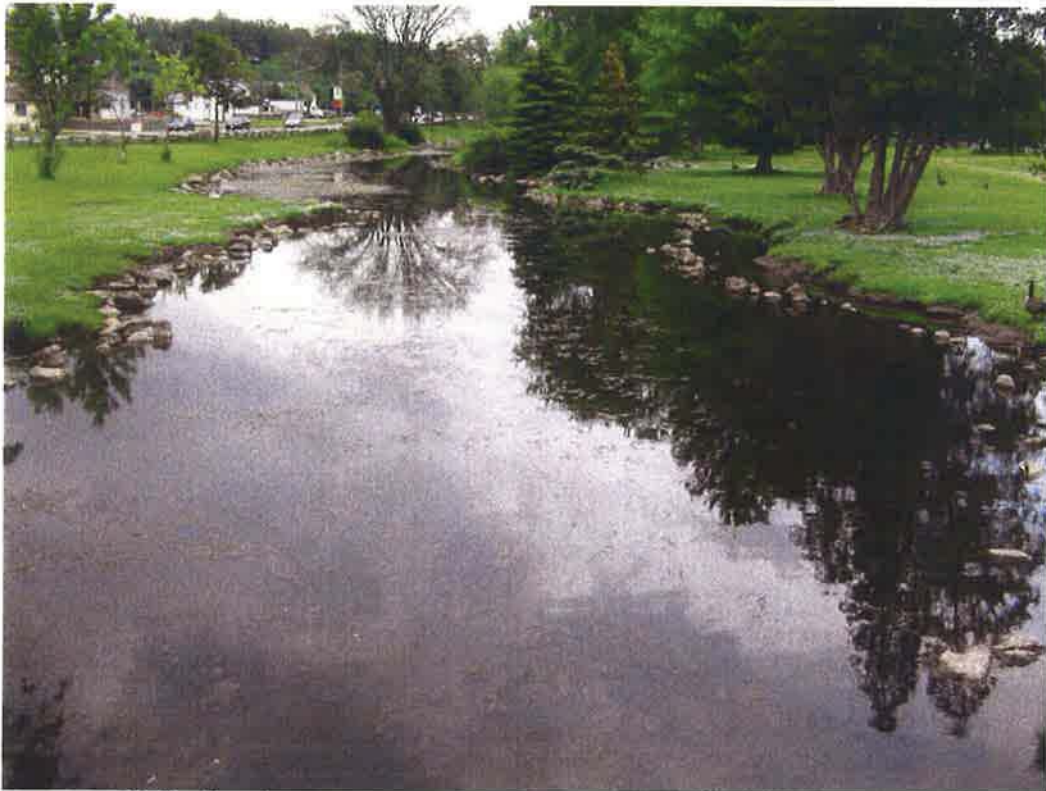
Photo 4 – Clythe Creek, Reach 3, looking upstream
