Environmental Impact Study (EIS)

York Road Environmental Design Study
City of Guelph
Project # TP115100

Re: Final York Road Environmental Impact Study

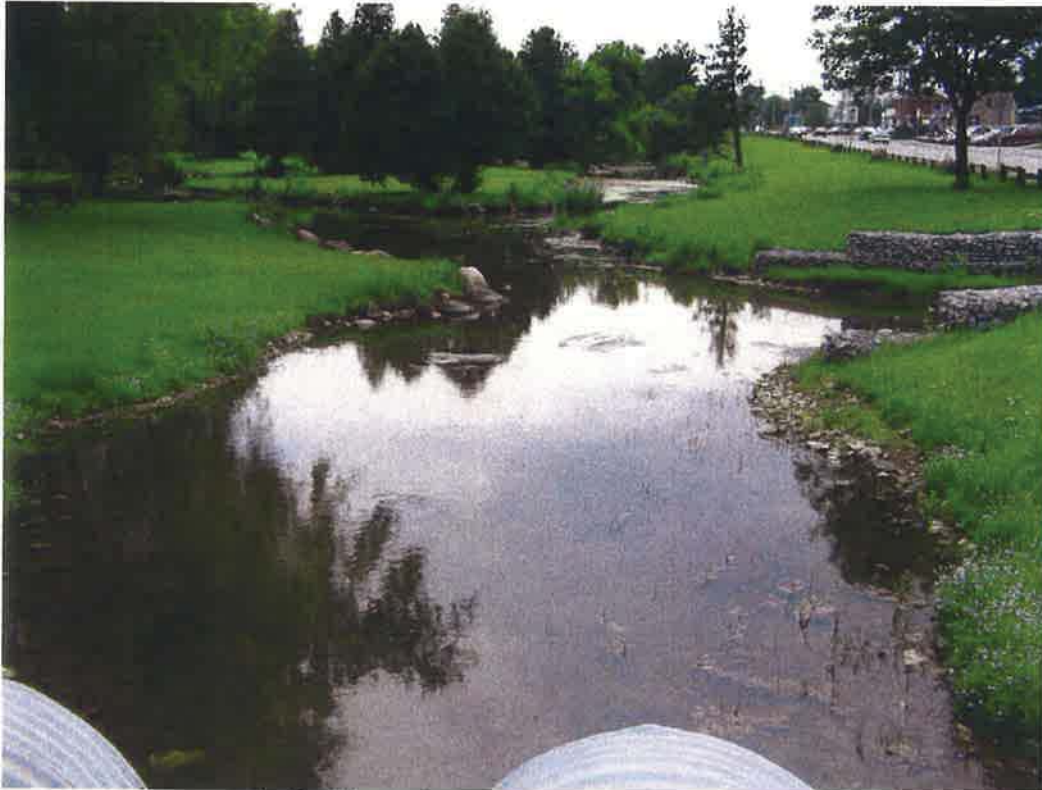
Photo 5 – Clythe Creek, Reach 4, looking downstream toward Hadati Cr. outlet and ponds

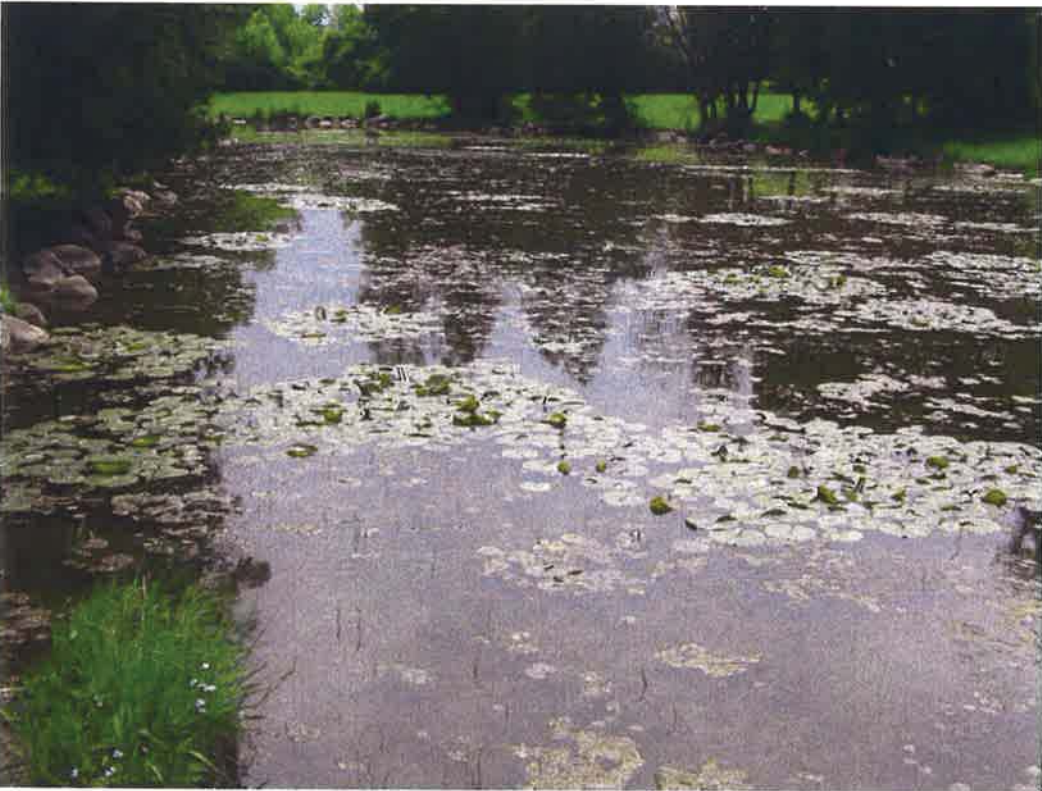
Photo 6 – Clythe Creek, Reach 4, abundant aquatic plants in the online ponds

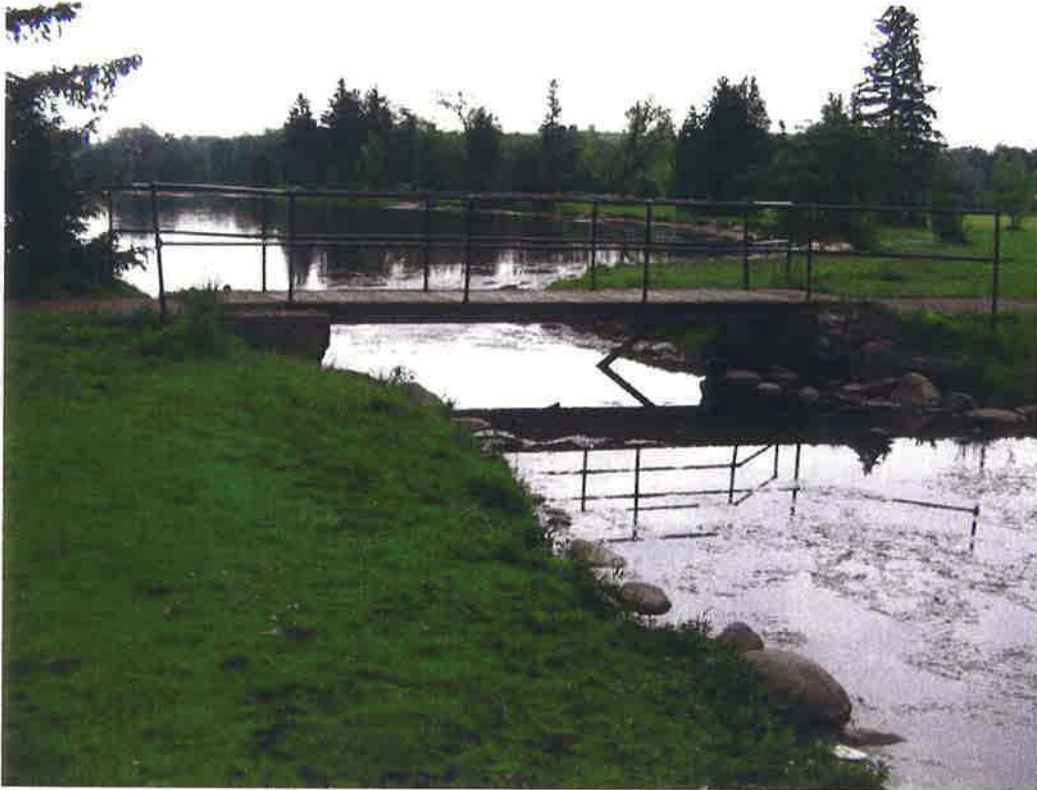
Photo 7 – Connection between the north pond and Reach 3 of Clythe Creek

Some water from the south pond seeps into the north pond. One location in particular was observed where the surface of the water in the north pond was turbulent due to

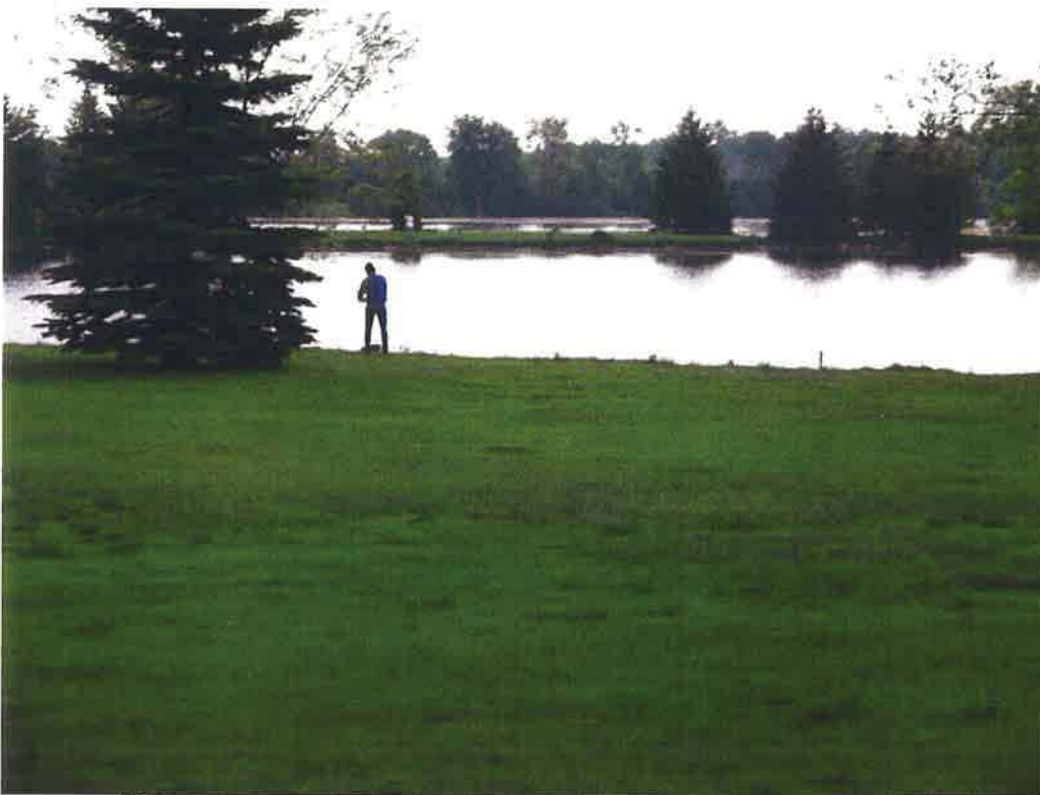
Photo 8 – Fisherman at Guelph Correctional Facility Ponds, looking south from Clythe Cr.

These constructed ponds are known to provide habitat for a variety of game fish and are used as a popular urban fishery (see Photo 8, Appendix I). Manicured grass surrounds much of their shorelines, and various trees and shrubs line the banks in some locations. The two ponds are separated by a narrow strip of land, and the south pond has a higher water level than the north pond (see Photo 9, Appendix I). The south pond is contained by a berm between it and the Eramosa River along its south shoreline. A formal trail has been established along the top of the berm on the south side.

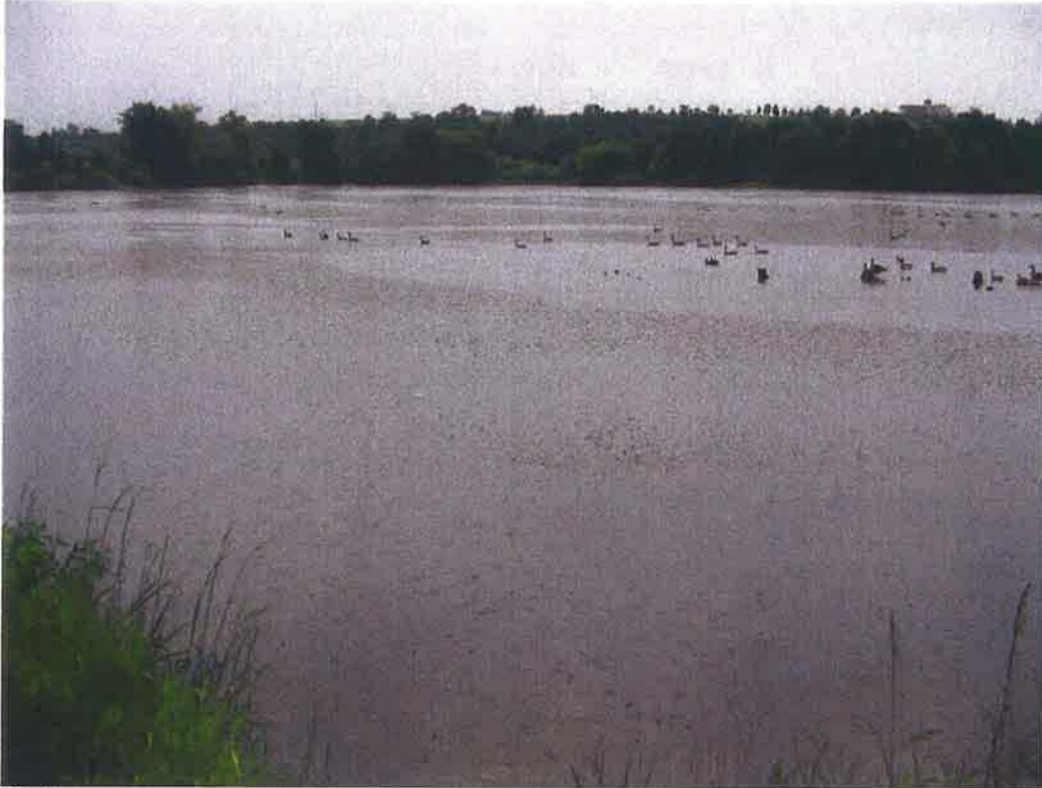
Photo 9 – South Pond, looking southwest

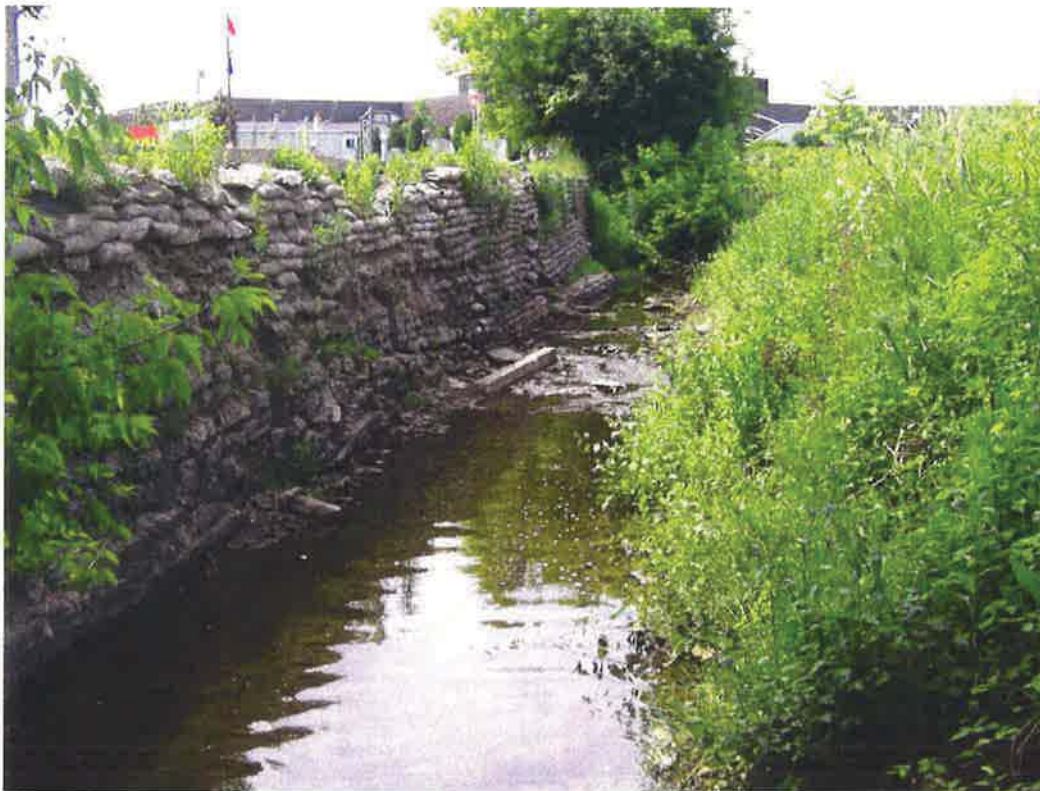
Photo 10 – Hadati Creek, Reach 1, looking upstream

The channel in Reach 1 is approximately 3m wide, and is very entrenched. The bank height ranges from approximately 1.9 to 2.2m, and bank slopes are nearly vertical. Most of the banks are hardened with a concrete bag wall (see Photo 10, Appendix I).

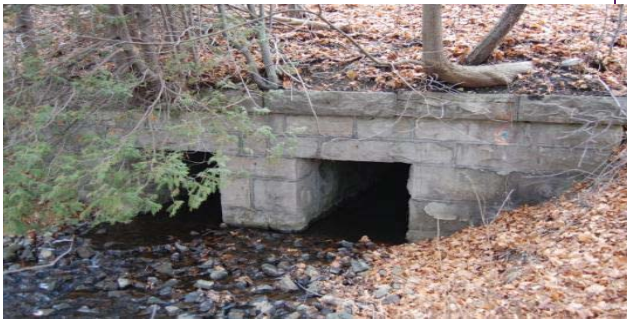
Ashlar stone culvert, of unknown age, on the north side of York Road Clythe Creek passes under this	<u>Removal:</u> <u>Alternative 1&2</u> Culvert will be removed and replaced with a wider arched culvert for the road widening.

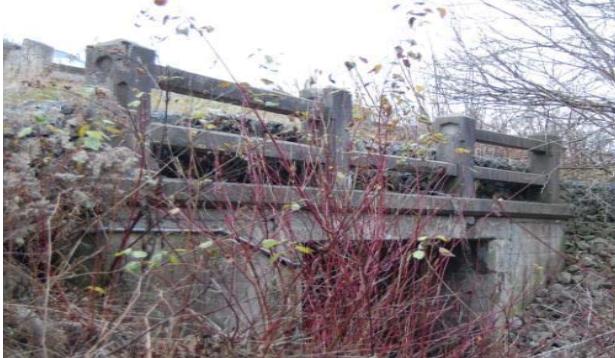
<p>Reinforced concrete road bridge railing (remnant) circa 1920</p>	<p><u>Removal:</u> <u>Alternative 1&2</u></p> <p>This feature will be removed due to road widening and multi-use path.</p>
3

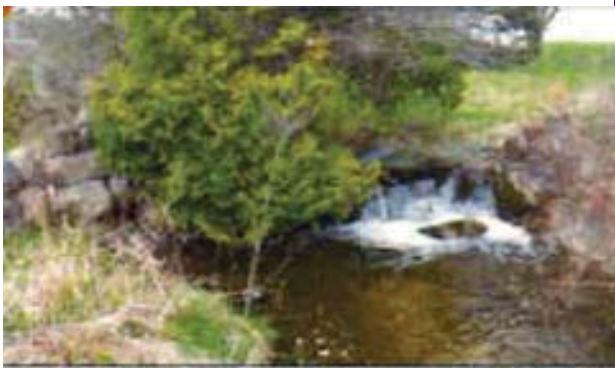
<p>Fieldstone weir with steps and sentinel stones</p> <p>This is a barrier to fish passage</p>	<p><u>Maintained in situ:</u> <u>Alternative 1&2</u></p> <p>This feature will be maintained in landscape but will be impacted by loss of flow as a result of channel realignment.</p>
4

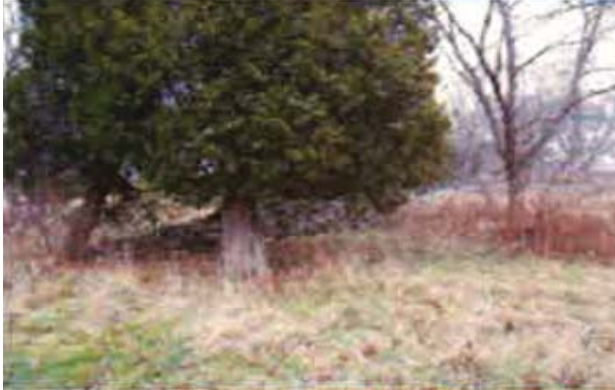
<p>Fieldstone garden wall with sentinel stones</p>	<p><u>No Impact:</u> <u>Alternative 1&2</u></p> <p>Wall to remain in existing condition.</p>
5

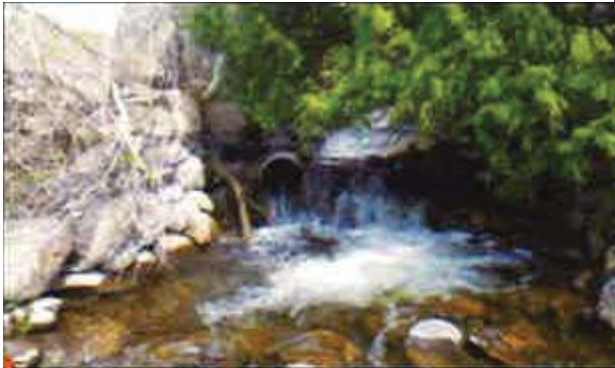
<p>Fieldstone weir with clay pipes</p> <p>This is a barrier to fish passage</p>	<p><u>Maintained in situ:</u> <u>Alternative 1&2</u></p> <p>This feature will be maintained in landscape but will be impacted by loss of flow as a result of channel realignment.</p>

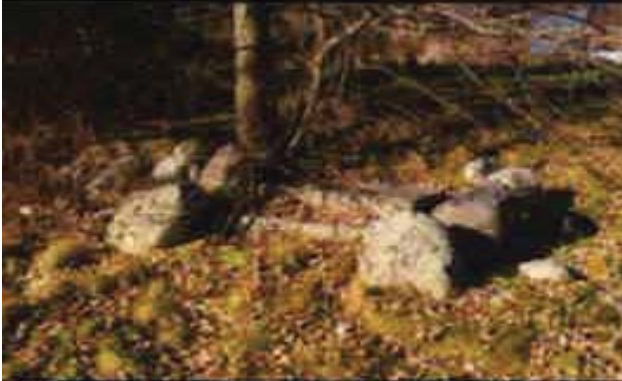
<p>Fieldstone steps</p>	<p><u>Potentially impacted: Alternative 1&2</u></p> <p>The steps may be covered by grading for road and pathway.</p>
7

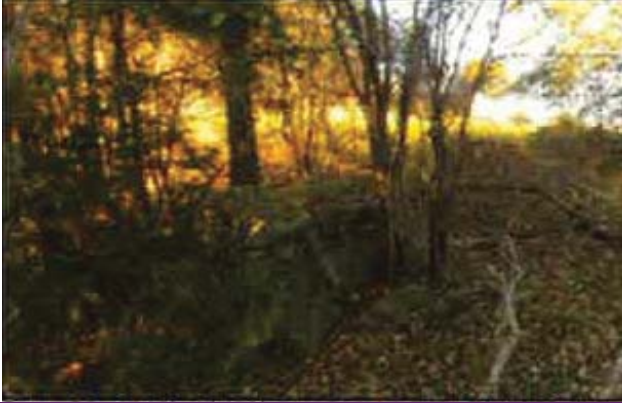
<p>Large Boulder or bedrock outcrop</p>	<p><u>Potentially impacted: Alternative 1&2</u></p> <p>This feature may be covered by grading for road and pathway.</p>
8

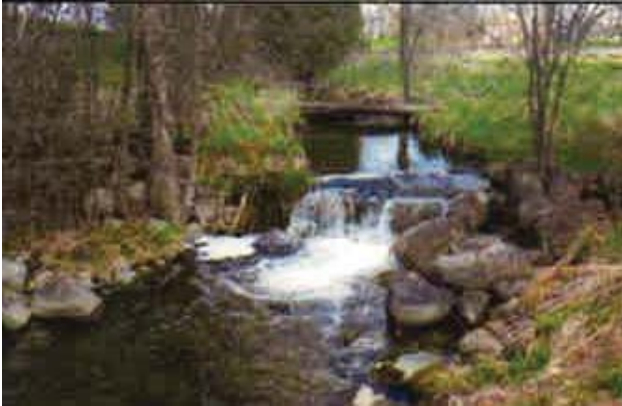
<p>Fieldstone weir</p> <p>This is a barrier to fish passage</p>	<p><u>Maintained in situ: Alternative 1&2</u></p> <p>The weir will be maintained in landscape but will be impacted by loss of flow as a result of channel realignment.</p>

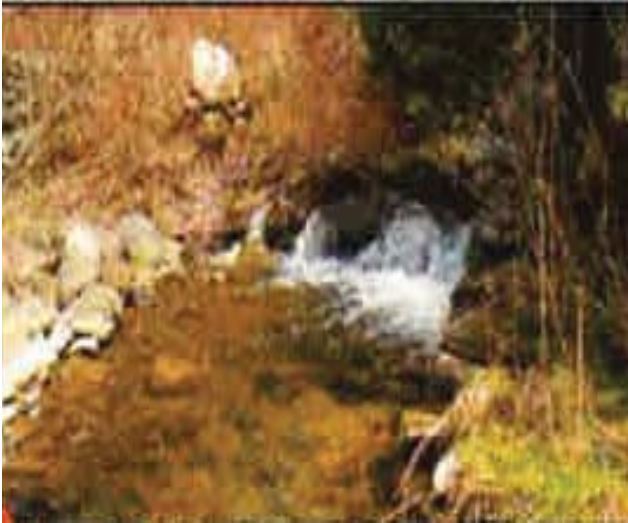
<p>Fieldstone weir beside gabion baskets</p>	<p><u>Removal or possibly maintained in situ: Alternative 1&2</u> This feature will be removed due to grading for road widening and multi-use path. If a proposed retaining wall is built it could be maintained in the landscape but will be impacted by loss of flow.</p>
10

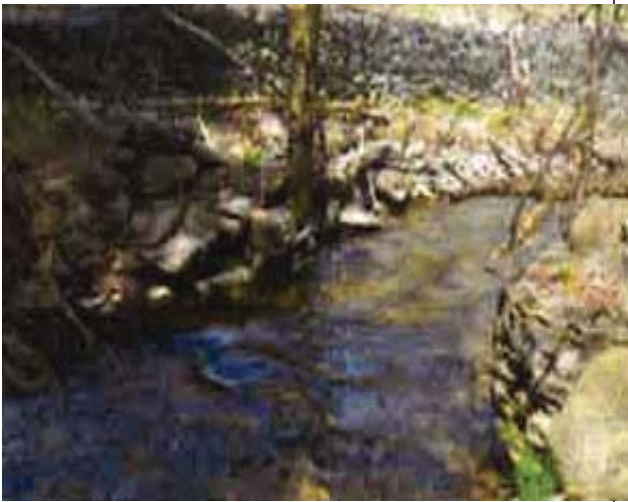
<p>Fieldstone weir</p>	<p><u>Removal or possibly maintained in situ: Alternative 1&2</u> This feature will be removed due to grading needed for road widening and multi-use path. If a proposed retaining wall is built it could be maintained in the landscape but will be impacted by loss of flow.</p>

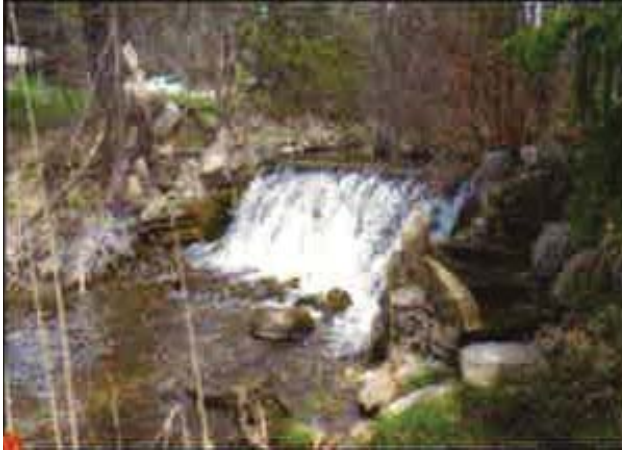
<p>Fieldstone weir, steps and ashlar stone terrace wall</p>	<p><u>Removal or possibly maintained in situ: Alternative 1&2</u> This feature will be removed due to grading needed for road widening and multi-use path. If a proposed retaining wall is built it could be maintained in the landscape but will be impacted by loss of flow.</p>
12

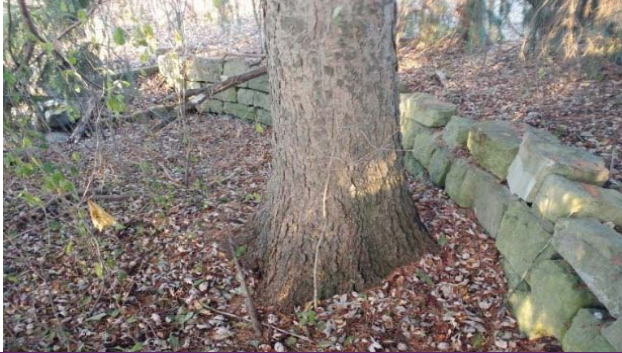
<p>Ashlar cut limestone terrace wall</p>	<p><u>Partial removal: Alternative 1&2</u> Feature will be partially impacted by proposed creek realignment and grading requirements.</p>
13

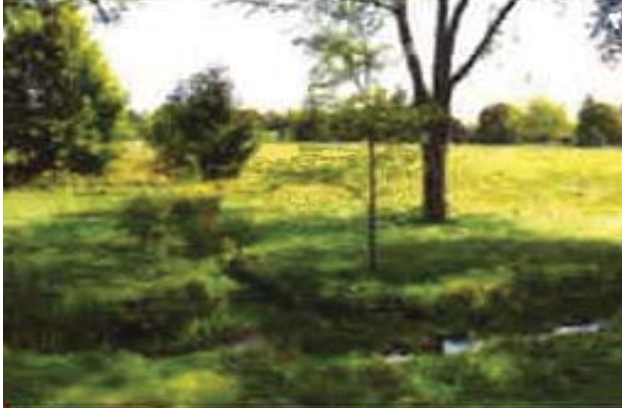
<p>Confluence of creek and intermittent stream</p>	<p><u>Removal: Alternative 1&2</u> The existing intermittent stream will be filled and re-graded.</p>

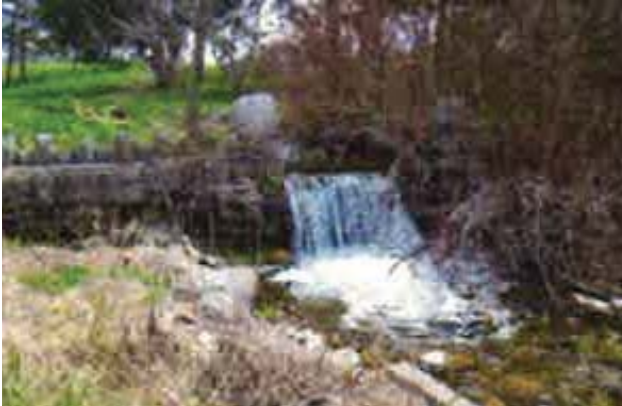
<p>Fieldstone weir with cut stone terrace wall</p> <p>Alternative 1: New channel would be created south of existing creek which would be filled from #14 westward.</p> <p>Alternative 2: New channel would tie into existing creek just west of #14.</p>	<p><u>Removal or possibly maintained in situ: Alternative 1&2</u></p> <p>This feature might be removed due to grading needed for road widening and multi-use path. Or, if left in situ it will be impacted by loss of flow.</p>
15

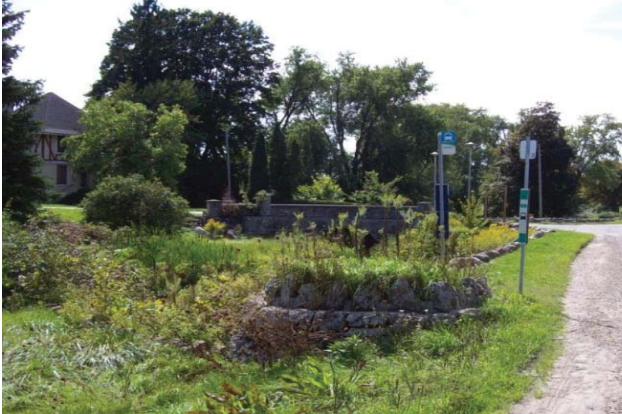
<p>Fieldstone entrance wall</p>	<p><u>Removal: Alternative 1&2</u></p> <p>This feature will be removed due to grading needed for road widening and multi-use path</p>
16

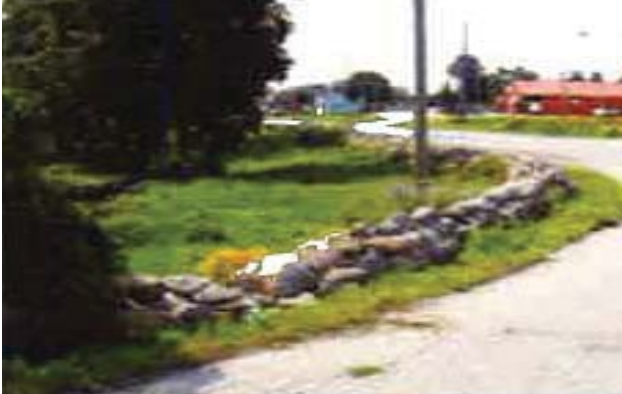
<p>Fieldstone west entrance wall, curved with sentinel stones</p>	<p><u>Removal: Alternative 1&2</u></p> <p>This feature will be removed due to grading needed for road widening and multi-use path</p>

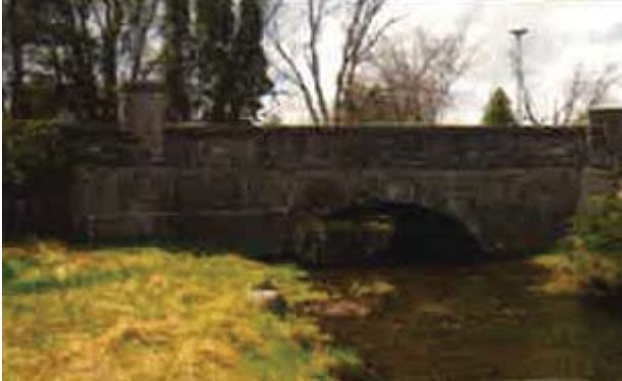
<p>Stone and concrete road bridge</p>	<p><u>No Impact:</u> <u>Alternative 1&2</u></p> <p>Feature to remain in existing condition</p>
18

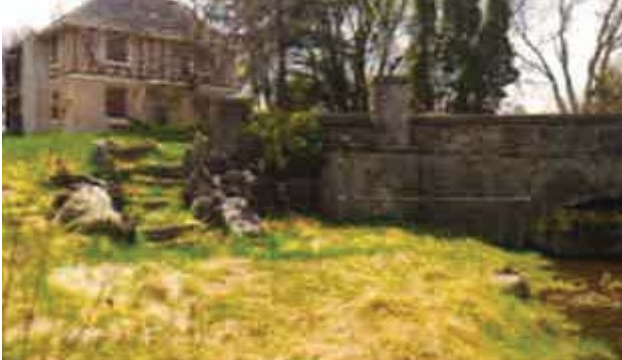
<p>Fieldstone steps to the south of road bridge</p>	<p><u>No Impact:</u> <u>Alternative 1&2</u></p> <p>Feature to remain in existing condition</p>
19

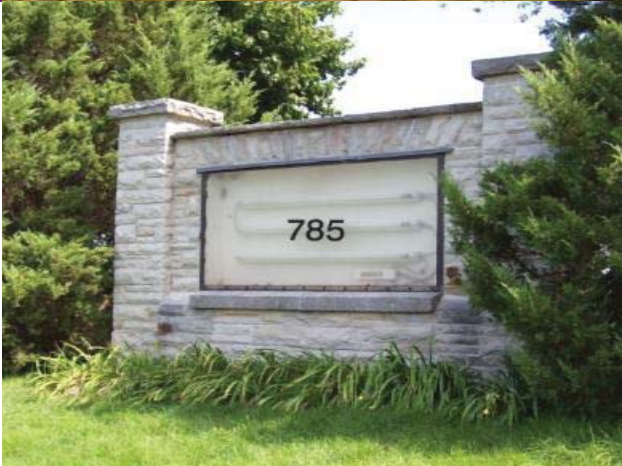
<p>Entrance sign, ashlar, rock-faced limestones with jack arch</p>	<p><u>No Impact:</u> <u>Alternative 1&2</u></p> <p>Feature to remain in existing condition</p>

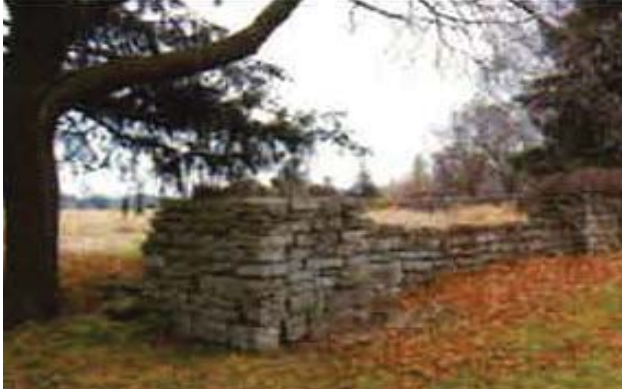
<p>Ashlar dry stone wall</p>	<p><u>No Impact: Alternative 1&2</u></p> <p>Feature to remain in existing condition</p>
21

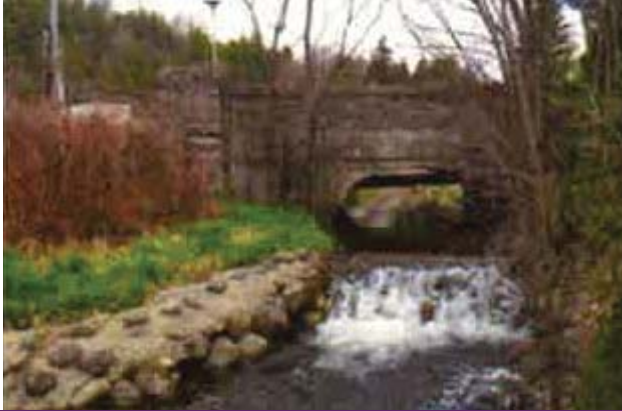
<p>Fieldstone weir</p>	<p><u>Removal: Alternative 1&2</u></p> <p>This feature will be removed as a result of channel work</p>
23

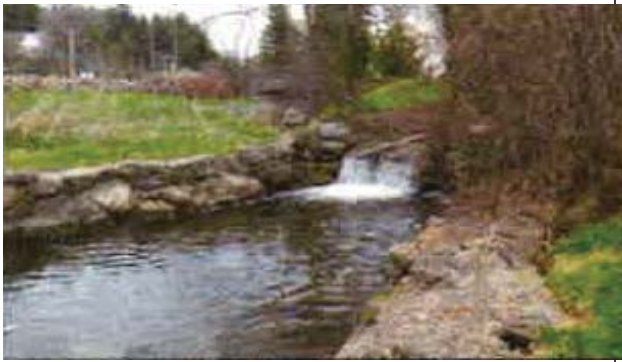
<p>Fieldstone weir and culvert</p>	<p><u>Maintained in situ: Alternative 1&2</u></p> <p>Feature will be maintained in landscape but will be impacted by loss of flow as a result of channel realignment</p>

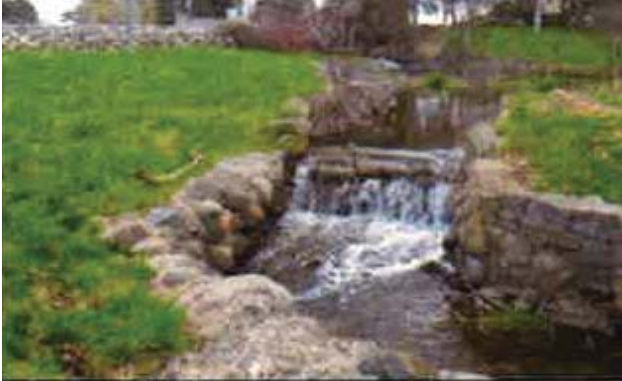
Fieldstone weir and culvert	<p><u>Removal:</u> <u>Alternative 1&2</u></p> <p>This feature will be removed as a result of channel work and grading for roadway and pathway</p>
25

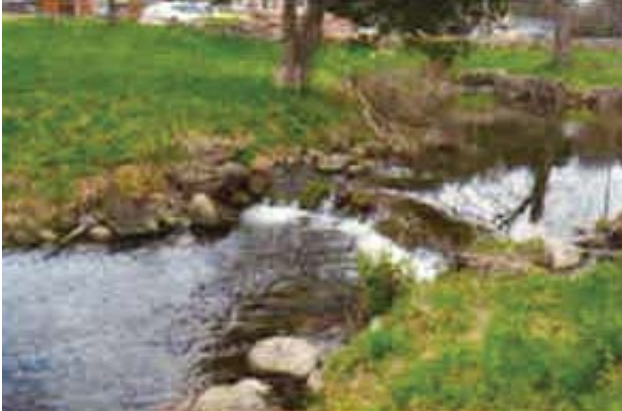
Fieldstone weir	<p><u>Removal:</u> <u>Alternative 1&2</u></p> <p>This feature will be removed as a result of channel work and grading for roadway and pathway</p>
26

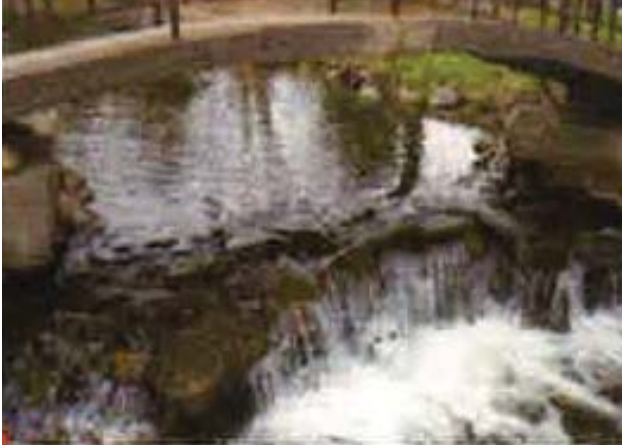
Fieldstone weir	<p><u>Removal:</u> <u>Alternative 1&2</u></p> <p>This feature will be removed as a result of channel work</p>

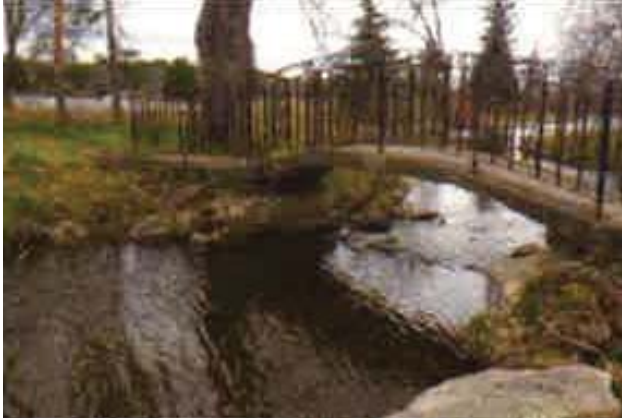
<p>Arched concrete and metal pedestrian bridge with stone abutments</p>	<p><u>Potential Modification: Alternative 1&2</u></p> <p>This feature may need to be modified to accommodate pedestrian traffic and channel work</p>
28

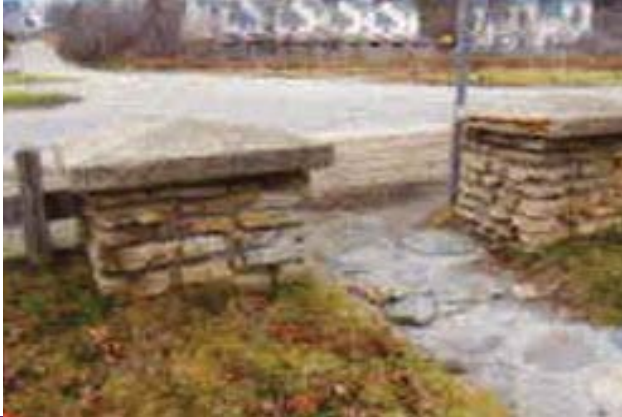
<p>Limestone pillars with wood board fencing leading to main entrance</p>	<p><u>Removal: Alternative 1&2</u></p> <p>This feature will be removed due to grading needed for road widening and multi-use path</p>
29

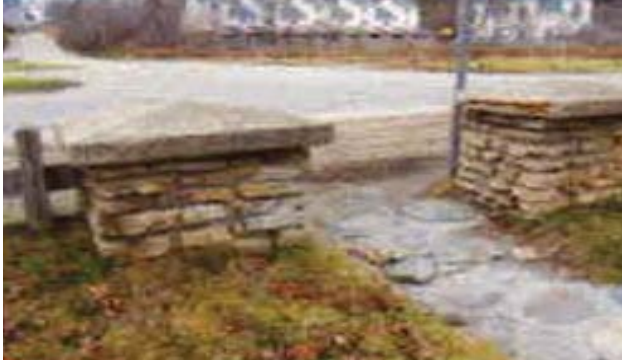
<p>Limestone pillars with wood board fencing leading to main entrance (same as above).</p>	<p><u>Removal: Alternative 1&2</u></p> <p>This feature will be removed due to grading needed for road widening and multi-use path</p>

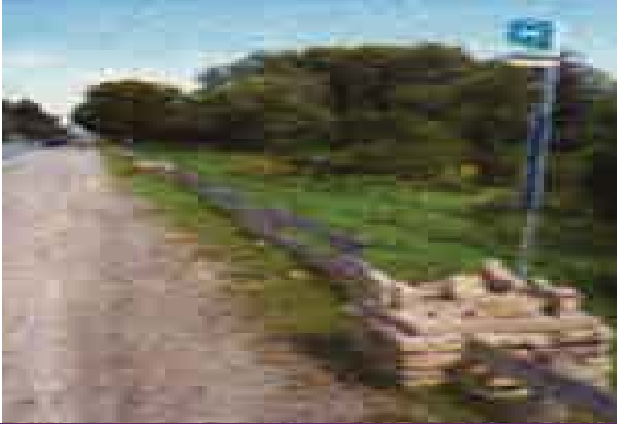
<p>Limestone pillars with wood board fencing leading to main entrance</p>	<p><u>Removal:</u> <u>Alternative 1&2</u></p> <p>This feature will be removed due to grading needed for road widening and multi-use path</p>
31

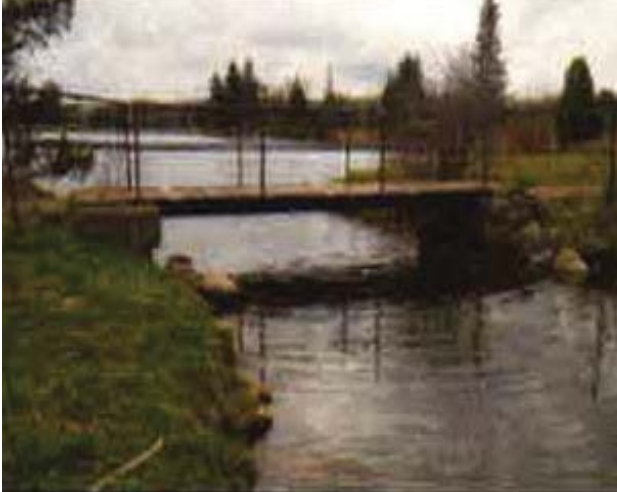
<p>Metal and wood pedestrian bridge</p>	<p><u>Potential Modification or Removal:</u> <u>Alternative 1&2</u></p> <p>Potential for feature to be modified to accommodate pedestrian traffic or removed due to channel works</p>
32

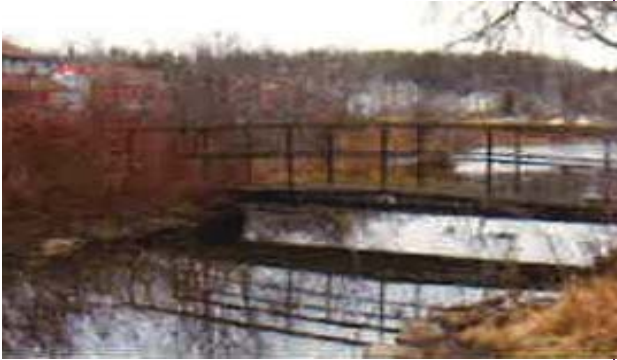
<p>Metal and wood pedestrian bridge</p>	<p><u>Potential Modification or Removal:</u> <u>Alternative 1&2</u></p> <p>Potential for feature to be modified to accommodate pedestrian traffic or removed due to channel works</p>

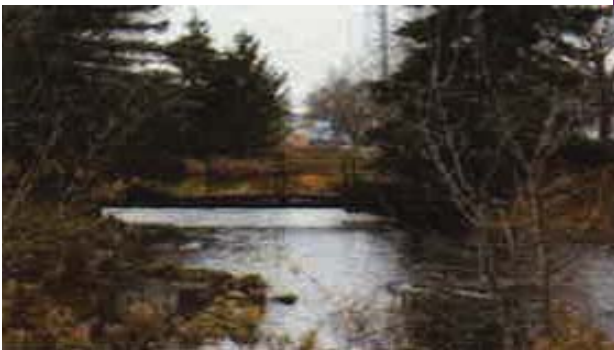
Metal and wood pedestrian bridge	<u>Potential Modification or Removal: Alternative 1&2</u> Potential for feature to be modified to accommodate pedestrian traffic or removed due to channel works
34

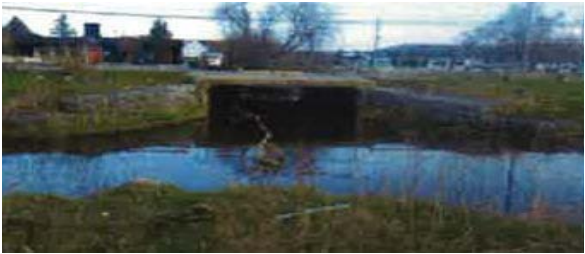
Box culvert at confluence of Clythe Creek and Hadati Creek	<u>Potential Modification: Alternative 1&2</u> Culvert may be extended to accommodate roadway grading requirement and CSP replacement
35

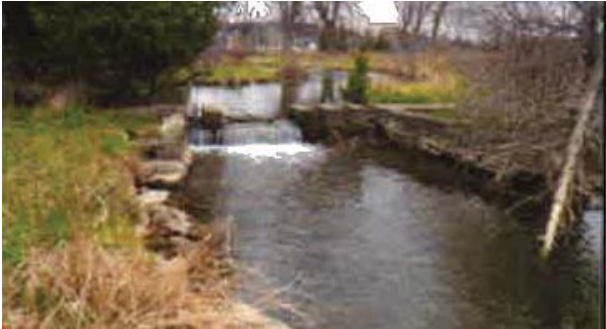
Concrete and stone weir	<u>Maintained in situ: Alternative 1&2</u> Feature will be maintained in landscape but will be impacted by loss of flow as a result of channel realignment
36

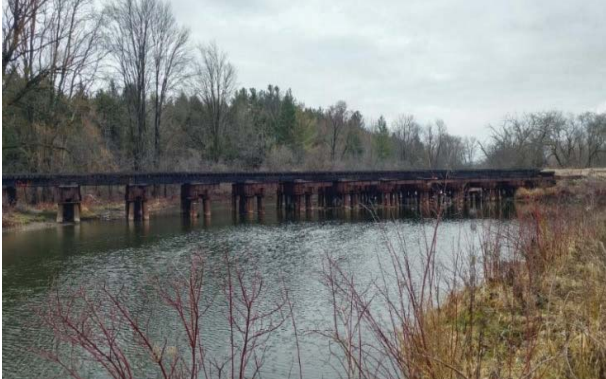
GJR railroad bridge	<u>No Impact: Alternative 1&2</u> Feature to remain in existing condition

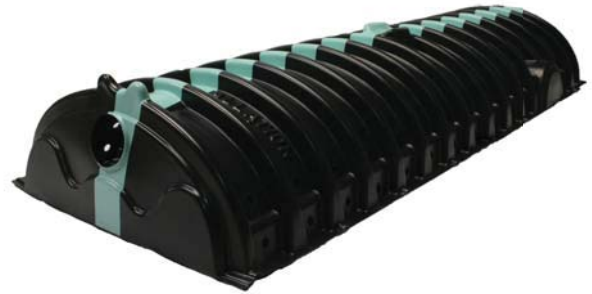
CULTEC Contactor® 100HD Stormwater Chamber

The Contactor® 100HD is a 12.5" (318 mm) tall, low profile chamber and is typically used for installations with depth restrictions or when a larger infiltrative area is required. The Contactor 100HD has the side portal internal manifold feature. The HVLV® SFCx2 Feed Connector is inserted into the side portal of the Contactor 100HD to create the internal manifold.

Size (L x W x H)	8' x 36" x 12.5" 2.44 m x 914 mm x 318 mm
Installed Length	7.5' 2.29 m
Length Adjustment per Run	0.5' 0.15 m
Chamber Storage	1.87 ft ³ /ft 0.17 m ³ /m 14.00 ft ³ /unit 0.40 m ³ /unit
Min. Installed Storage	3.84 ft ³ /ft 0.36 m ³ /m 28.81 ft ³ /unit 0.82 m ³ /unit
Min. Area Required	25 ft ² 2.32 m ²
Min. Center to Center Spacing	3.33' 1.02 m
Max. Allowable Cover	12' 3.66 m
Max. Inlet Opening in End Wall	10" 250 mm
Max. Allowable O.D. in Side Portal	6.9" 175 mm
Compatible Feed Connector	HVLV SFCx2 Feed Connector

Both the infiltration trenches and filtration trenches could be designed to allow drainage to overflow through the top of the trenches to a Cultec™ Contractor™ 0.32 m height and 0.92 m wide underground storage chamber system (or equivalent). The underground chamber system (ref. Appendix D) would be 3 units wide and would fit under the multi-use trail. Each filtration trench would have a controlled outlet. Infiltration trenches would rely on infiltration with an overflow to the Cultec™ chamber system. Using the combined method of trench and chamber system, would provide both water quality and erosion control and would reduce the overall storm sewer length and sizing required. The combined trench and chamber system could replace portions of the typical storm sewer system, for west of the Clythe Creek crossing, while east of the crossing, due to large contributing area, sewers would be required.

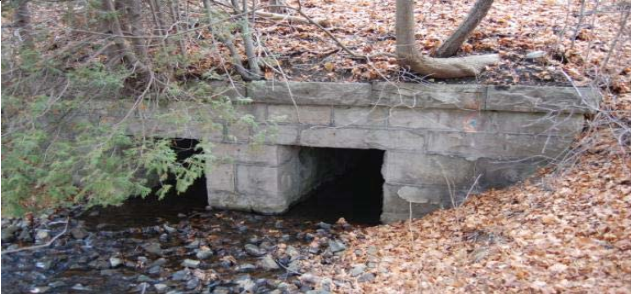
<p>Rock faced ashlar culvert, of unknown age, on the north side of York Road. Clythe Creek passes under this.</p>	<p>Removal: Culvert under tracks would be remain in place.</p>	<p>Protect culvert while replacing York Road culvert downstream.</p>

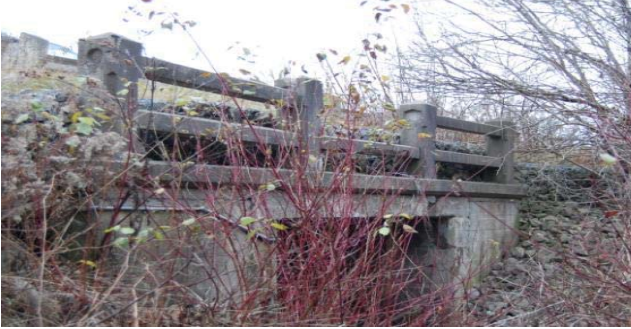
<p>Reinforced concrete road bridge railing (remnant) circa 1920 on the north side of York Road.</p>	<p>Removal: This feature would be removed due to road widening and multi-use path.</p>	<p>Partial salvage, documentation through measured drawings and high-resolution digital photographs, and/or historical plaquing. If possible, relocation within the GCC or to other parts of Guelph in order to better accommodate conservation and adaptive reuse. The appropriate context of the resource must be considered in relocation.</p>
3

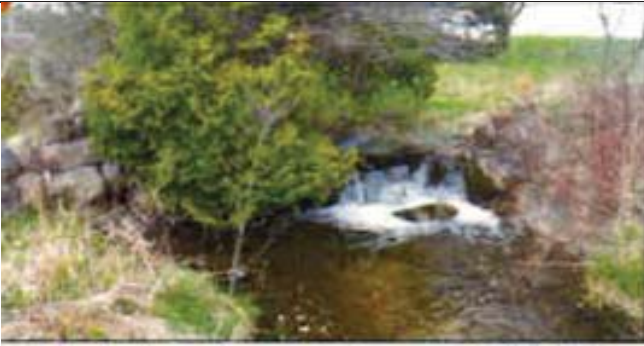
<p>Fieldstone weir with steps and sentinel stones. This is a barrier to fish passage.</p>	<p>Maintained in situ: This feature would be maintained in landscape but will be impacted by loss of flow as a result of channel realignment.</p>	<p>May require repairs. This would be decided during the preparation of a Conservation Plan by a qualified heritage consultant. Where possible, creek realignment design should incorporate the 'high-flow' channel to convey higher flows over the weir structure.</p>

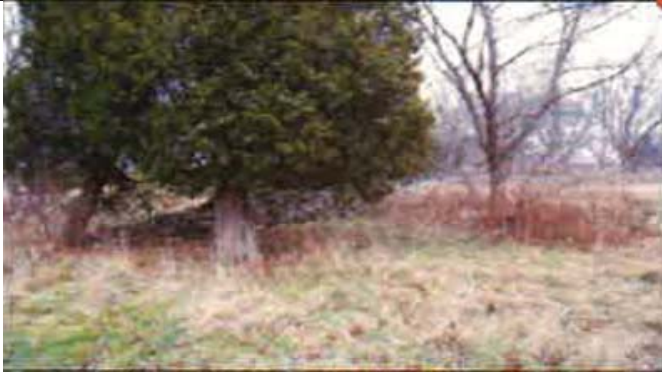
<p>Fieldstone garden wall with sentinel stones.</p>	<p>No Impact: Wall to remain in existing condition</p>	<p>May require repairs. This would be decided during the preparation of a Conservation Plan by a qualified heritage consultant.</p>
5

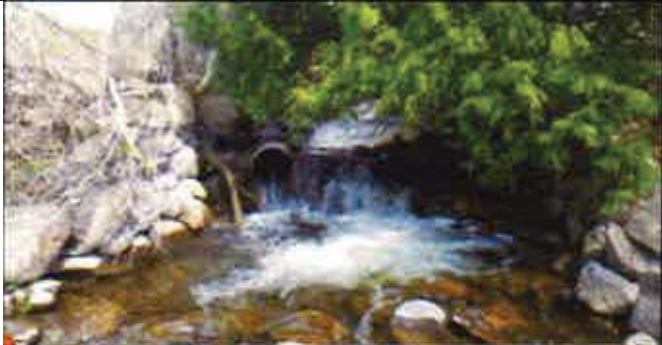
<p>Fieldstone weir with clay pipes. This is a barrier to fish passage.</p>	<p>Maintained in situ: This feature would be maintained in landscape but would be impacted by loss of flow as a result of channel realignment</p>	<p>May require repairs. This would be decided during the preparation of a Conservation Plan by a qualified heritage consultant. Where possible, creek realignment design should incorporate the 'high-flow' channel to convey higher flows over the weir structure.</p>
6

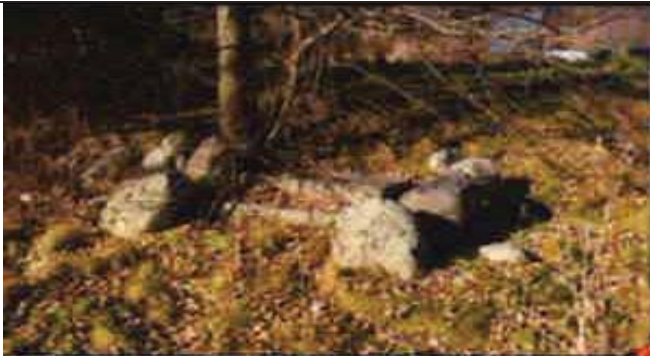
<p>Fieldstone steps.</p>	<p>Potentially impacted: The steps may be covered by grading for road and pathway.</p>	<p>Partial salvage, documentation through measured drawings and high-resolution digital photographs, and/or historical plaquing. If possible, relocation within the GCC or to other parts of Guelph in order to better accommodate conservation and adaptive reuse. The</p>

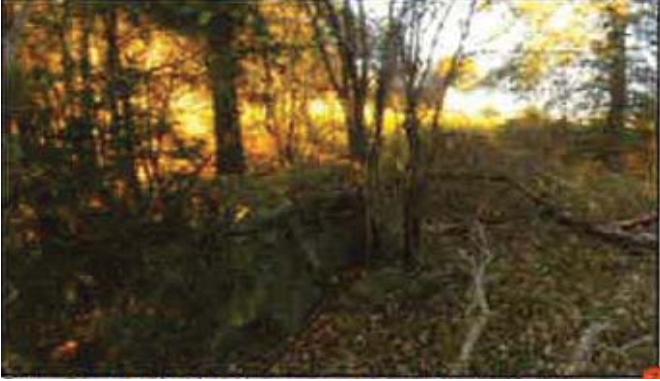
<p>Large Boulder or bedrock outcrop.</p>	<p>Potentially impacted: This feature may be covered by grading for road and pathway</p>	<p>Partial salvage, documentation through measured drawings and high-resolution digital photographs, and/or historical plaquing. If possible, relocation within the GCC or to other parts of Guelph in order to better accommodate conservation and adaptive reuse. The appropriate context of the resource must be considered in relocation.</p>
8

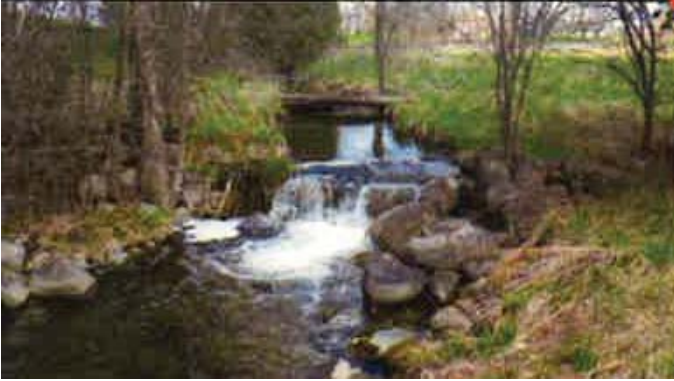
<p>Fieldstone weir. This is a barrier to fish passage</p>	<p>Maintained in situ: The weir would be maintained in landscape but would be impacted by loss of flow as a result of channel realignment.</p>	<p>May require repairs. This would be decided during the preparation of a Conservation Plan by a qualified heritage consultant. Where possible, creek realignment design should incorporate the 'high-flow' channel to convey higher flows over the weir structure.</p>

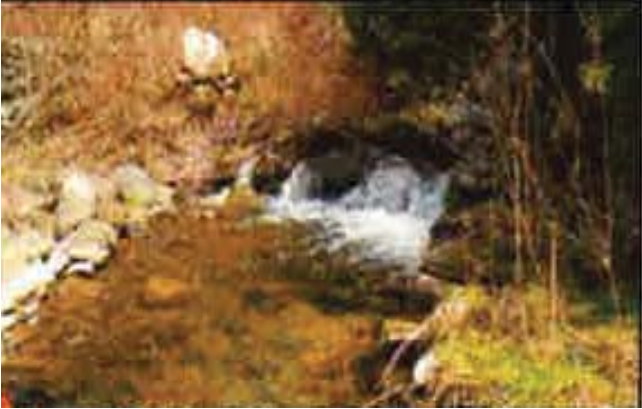
<p>Fieldstone weir beside gabion baskets. (Gabion baskets are not part of listed heritage resource).</p>	<p>Removal or possibly maintained in situ: This feature would be removed due to grading for road widening and multi-use path. If a proposed retaining wall is built it could be maintained in the landscape but will be impacted by loss of flow.</p>	<p>Partial salvage, documentation through measured drawings and high-resolution digital photographs, and/or historical plaquing. If possible, relocation within the GCC or to other parts of Guelph in order to better accommodate conservation and adaptive reuse. The appropriate context of the resource must be considered in relocation.</p>
10

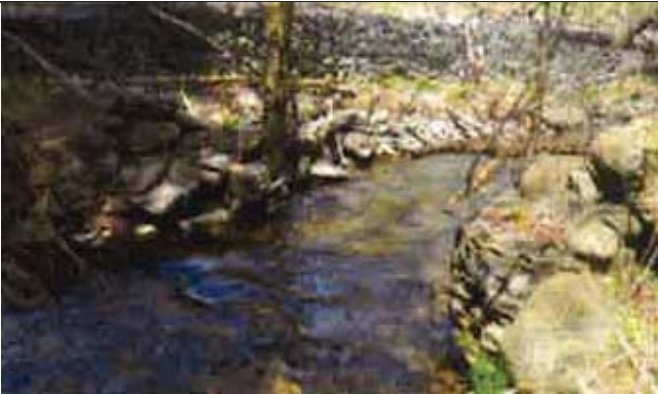
<p>Fieldstone weir.</p>	<p>Removal or possibly maintained in situ: This feature would be removed due to grading needed for road widening and multi-use path. If a proposed retaining wall is built it could be maintained in the landscape but will be impacted by loss of flow.</p>	<p>Partial salvage, documentation through measured drawings and high-resolution digital photographs, and/or historical plaquing. If possible, relocation within the GCC or to other parts of Guelph in order to better accommodate conservation and adaptive reuse. The appropriate context of the resource must be considered in relocation.</p>

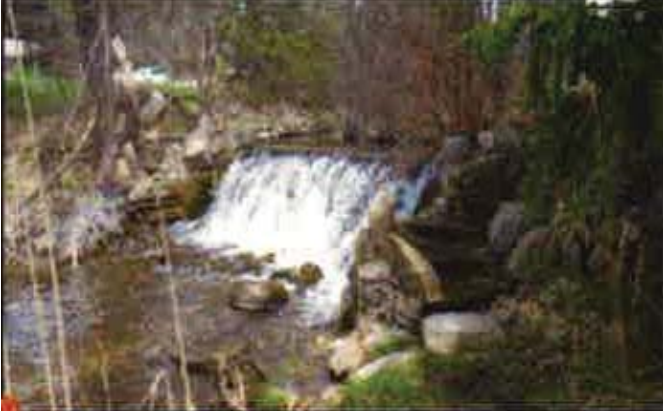
<p>Fieldstone weir, steps and ashlar stone terrace wall.</p>	<p>Removal or possibly maintained in situ: This feature would be removed due to grading needed for road widening and multi-use path. If a proposed retaining wall is built it could be maintained in the landscape but would be impacted by loss of flow.</p>	<p>Partial salvage, documentation through measured drawings and high-resolution digital photographs, and/or historical plaquing. If possible, relocation within the GCC or to other parts of Guelph in order to better accommodate conservation and adaptive reuse. The appropriate context of the resource must be considered in relocation.</p>
12

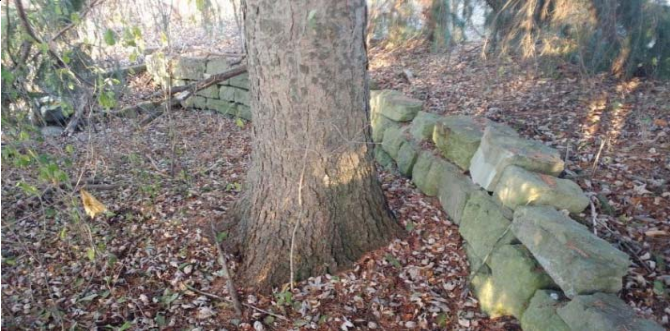
<p>Ashlar cut limestone terrace wall.</p>	<p>Removal or possibly maintained in situ: Feature would be partially impacted by proposed creek realignment and grading requirements.</p>	<p>Partial salvage, documentation through measured drawings and high-resolution digital photographs, and/or historical plaquing. If possible, relocation within the GCC or to other parts of Guelph in order to better accommodate conservation and adaptive reuse. The appropriate context of the resource must be considered in relocation.</p>

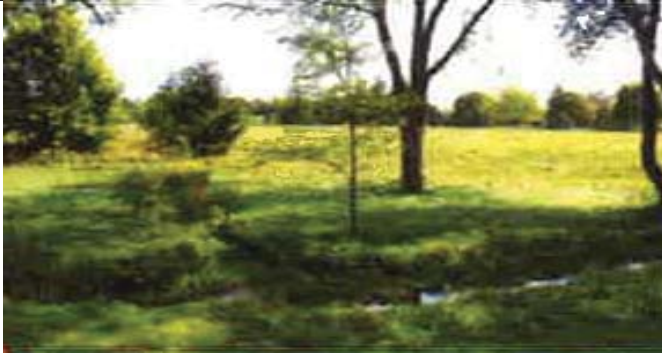
<p>Confluence of creek and intermittent stream.</p>	<p>Removal: The existing intermittent stream would be filled and re-graded.</p>	<p>The confluence will be relocated.</p>
14

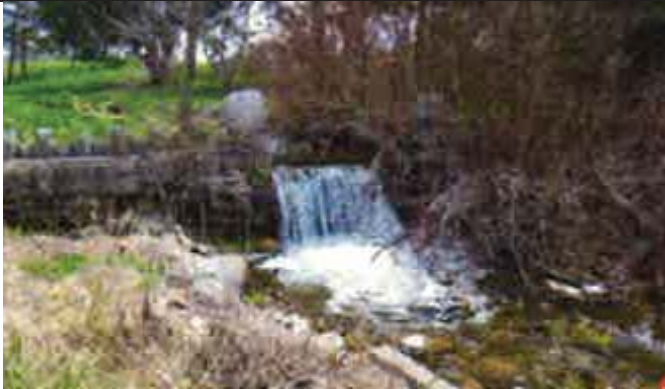
<p>Fieldstone weir with cut stone terrace wall. New channel would tie into existing creek just west of #14.</p>	<p>Removal or possibly maintained in situ: This feature might be removed due to grading needed for road widening and multi-use path. The feature is a substantial barrier to fish passage and limiting factor in overall channel function and health. Feature to be taken off-line and disconnected during low-flow stages. An overflow channel would be incorporated so that the feature will be reconnected during high-flow stages (i.e., flows greater than the 2-year discharge).</p>	<p>If removal is required, partial salvage, documentation through measured drawings and high-resolution digital photographs, and/or historical plaquing. If possible, relocation within the GCC or to other parts of Guelph in order to better accommodate conservation and adaptive reuse. The appropriate context of the resource must be considered in relocation.</p>

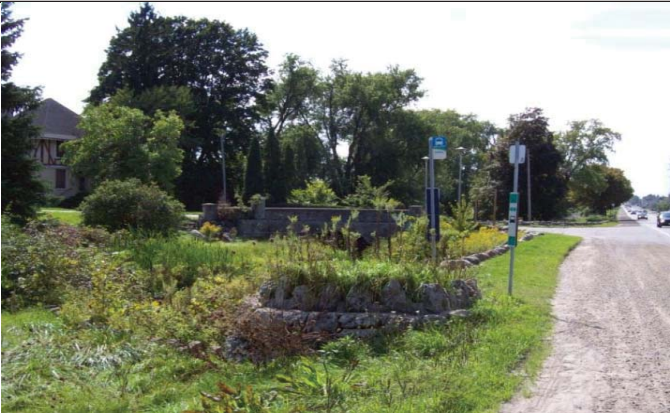
<p>Fieldstone east entrance wall, curved with sentinel stones.</p>	<p>Removal: This feature would be removed due to grading needed for road widening and multi-use path. Road widening without moving this feature would result in less visibility of feature, potential damage due to grading requirements, snow and salt issues.</p>	<p>This structure would be removed and rebuilt back further from the road by skilled heritage masons. The details of the reconstruction would be decided during the preparation of a Conservation Plan by a qualified heritage consultant.</p>
16

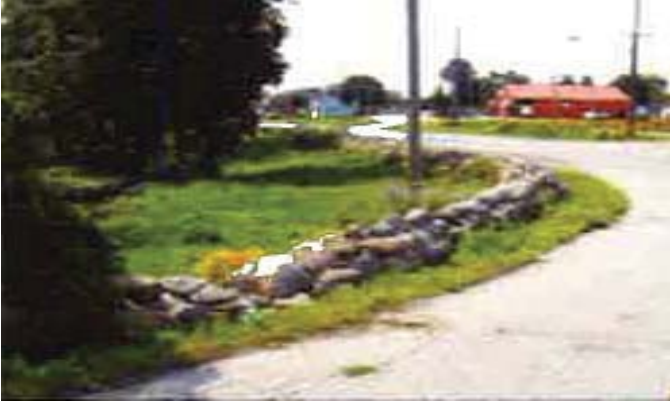
<p>Fieldstone west entrance wall, curved with sentinel stones.</p>	<p>Removal: This feature would be removed due to grading needed for road widening and multi-use path.</p>	<p>This structure would be removed and rebuilt back further from the road by skilled heritage masons. The details of the reconstruction would be decided during the preparation of a Conservation Plan by a qualified heritage consultant.</p>
