Environmental Impact Study (EIS)

York Road Environmental Design Study
City of Guelph
Project # TP115100

Re: Final York Road Environmental Impact Study

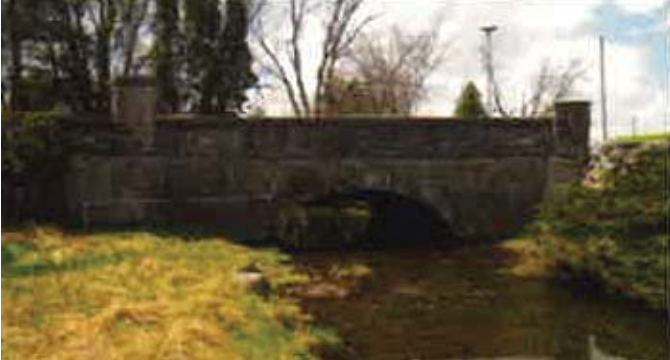
<p>Stone and concrete road bridge.</p>	<p>No Impact: Feature to remain in existing location.</p>	<p>May require repairs. This would be decided during the preparation of a Conservation Plan by a qualified heritage consultant.</p>

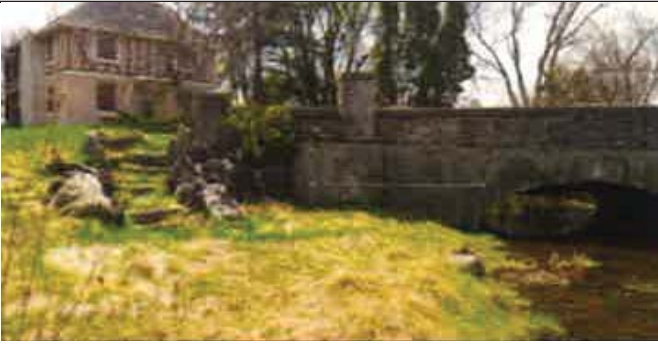
<p>Fieldstone steps to the south of road bridge.</p>	<p>No Impact: Feature to remain in existing location.</p>	<p>May require repairs. This would be decided during the preparation of a Conservation Plan by a qualified heritage consultant.</p>
19

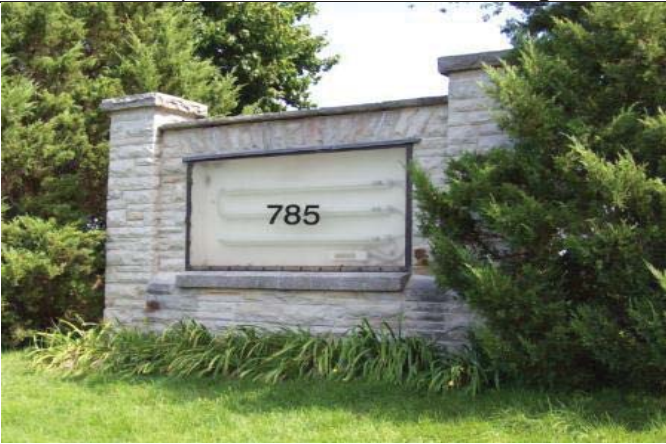
<p>Entrance sign, ashlar, rock-faced limestones with jack arch.</p>	<p>No Impact: Feature to remain in existing location.</p>	<p>May require repairs. This would be decided during the preparation of a Conservation Plan by a qualified heritage consultant.</p>
20

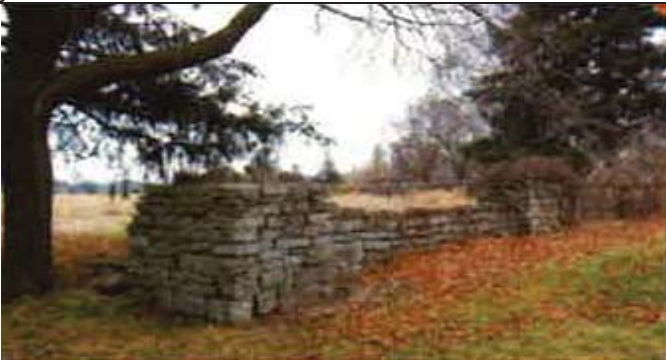
<p>Ashlar dry stone wall.</p>	<p>No Impact: Feature is located within the floodplain and will not be impacted by proposed channel works. Feature is to remain in existing location.</p>	<p>May require repairs. This would be decided during the preparation of a Conservation Plan by a qualified heritage consultant.</p>

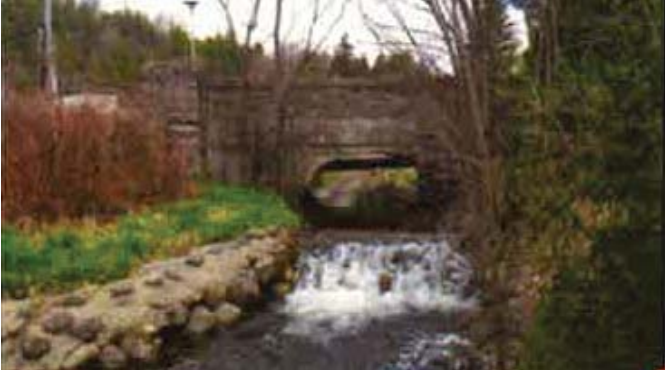
<p>Fieldstone weir.</p>	<p>Removal: This feature would be removed as a result of channel work.</p>	<p>Partial salvage, documentation through measured drawings and high-resolution digital photographs, and/or historical plaquing. If possible, relocation within the GCC or to other parts of Guelph in order to better accommodate conservation and adaptive reuse. The appropriate context of the resource must be considered in relocation.</p>
23

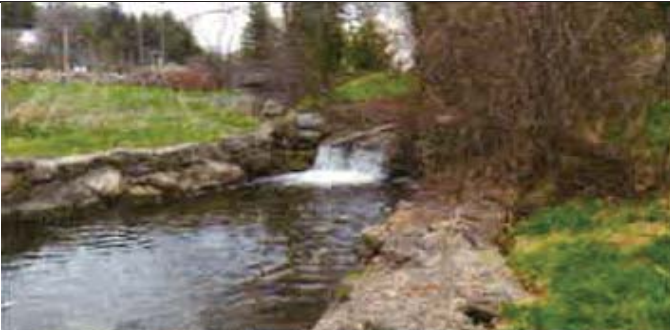
<p>Fieldstone weir and culvert.</p>	<p>Maintained in situ: Feature would be maintained in landscape but would be impacted by loss of flow as a result of channel realignment.</p>	<p>May require repairs. This would be decided during the preparation of a Conservation Plan by a qualified heritage consultant. Where possible, creek realignment design should incorporate</p>

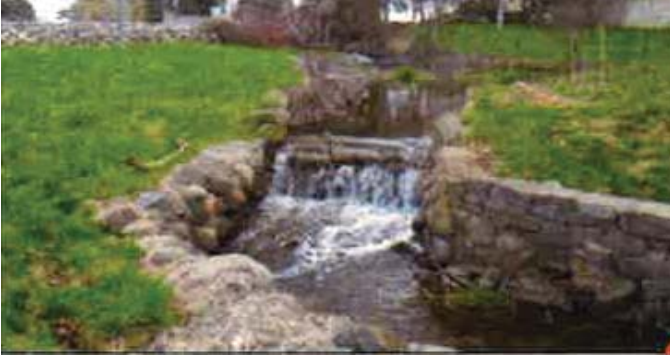
<p>Fieldstone weir and culvert.</p>	<p>Removal: This feature would be removed as a result of channel work and grading for roadway and pathway.</p>	<p>Partial salvage, documentation through measured drawings and high-resolution digital photographs, and/or historical plaquing. If possible, relocation within the GCC or to other parts of Guelph in order to better accommodate conservation and adaptive reuse. The appropriate context of the resource must be considered in relocation.</p>
25

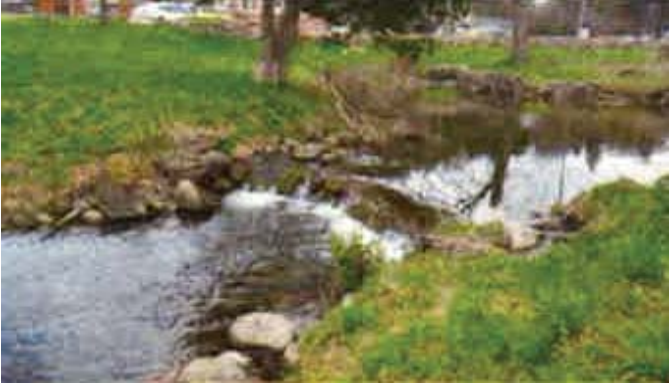
<p>Fieldstone weir.</p>	<p>Removal: This feature would be removed as a result of channel work and grading for roadway and pathway.</p>	<p>Partial salvage, documentation through measured drawings and high-resolution digital photographs, and/or historical plaquing. If possible, relocation within the GCC or to other parts of Guelph in order to better accommodate conservation and adaptive reuse. The appropriate context of the resource must</p>

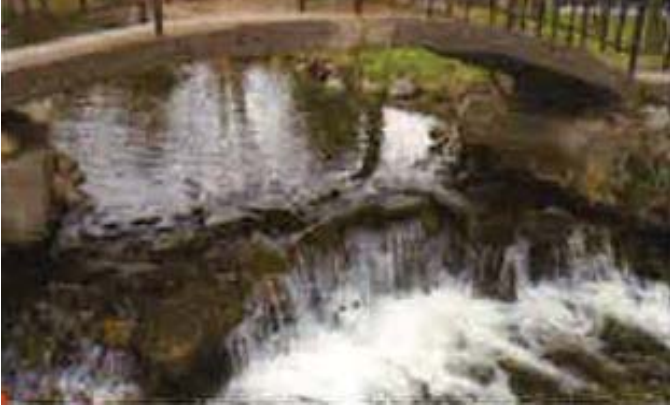
<p>Fieldstone weir.</p>	<p>Removal: This feature would be removed as a result of channel work.</p>	<p>Partial salvage, documentation through measured drawings and high-resolution digital photographs, and/or historical plaquing. If possible, relocation within the GCC or to other parts of Guelph in order to better accommodate conservation and adaptive reuse. The appropriate context of the resource must be considered in relocation.</p>
27

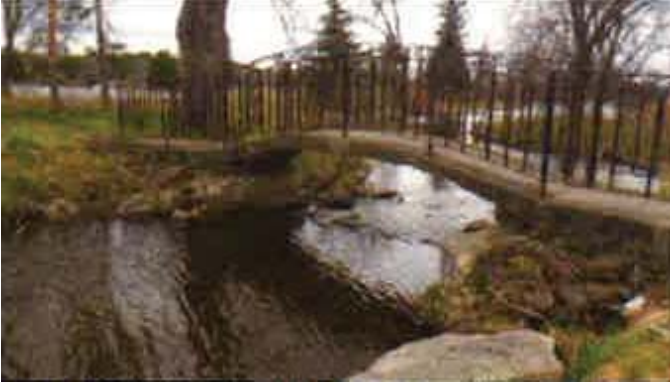
<p>Arched concrete and metal pedestrian bridge with stone abutments.</p>	<p>Potential Modification: This feature may need to be modified to accommodate pedestrian traffic and channel work.</p>	<p>May require repairs. This would be decided during the preparation of a Conservation Plan by a qualified heritage consultant.</p>

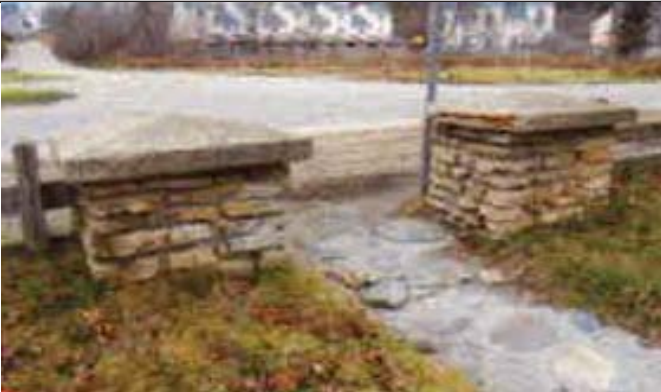
<p>Limestone pillars with wood board fencing leading to main entrance.</p>	<p>Removal: This feature would be removed due to grading needed for road widening and multi-use path.</p>	<p>Partial salvage, documentation through measured drawings and high-resolution digital photographs, and/or historical plaquing. If possible, relocation within the GCC or to other parts of Guelph in order to better accommodate conservation and adaptive reuse. The appropriate context of the resource must be considered in relocation.</p>
29

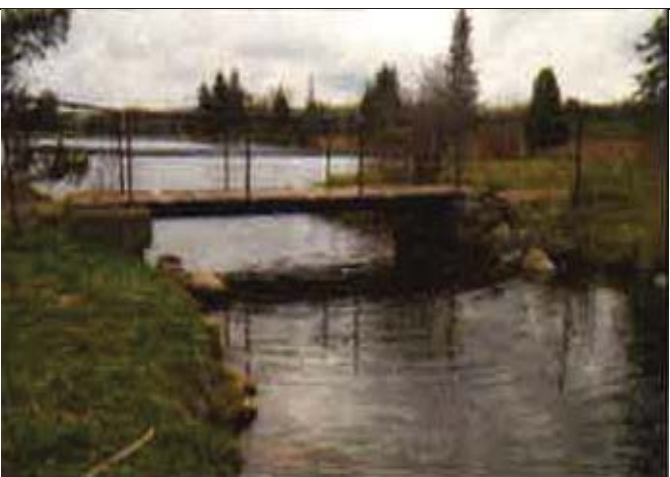
<p>Metal and wood pedestrian bridge.</p>	<p>Potential Modification or Removal: Potential for feature to be modified to accommodate pedestrian traffic or removed due to channel works.</p>	<p>The modifications to be developed during the preparation of a Conservation Plan by a qualified heritage consultant. If removal is required, partial salvage, documentation through measured drawings and high-resolution digital photographs, and/or historical plaquing. If possible, relocation within the GCC or to other parts of Guelph in order to better accommodate conservation and adaptive reuse. The</p>

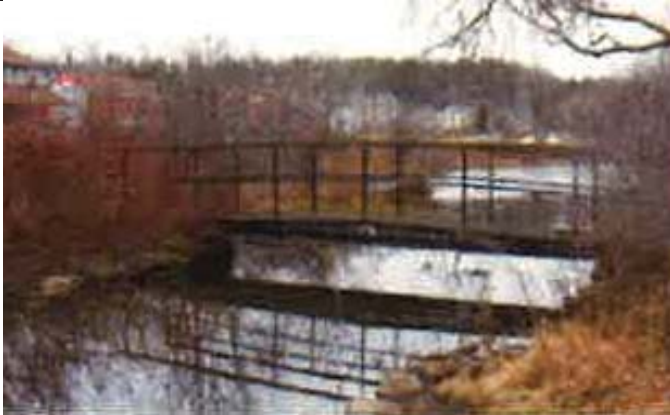
<p>Metal and wood pedestrian bridge.</p>	<p>Potential Modification or Removal Potential for feature to be modified to accommodate pedestrian traffic or removed due to channel works. IO has recommended removal of this feature.</p>	<p>The modifications to be developed during the preparation of a Conservation Plan by a qualified heritage consultant. If removal is required, partial salvage, documentation through measured drawings and high-resolution digital photographs, and/or historical plaquing. If possible, relocation within the GCC or to other parts of Guelph in order to better accommodate conservation and adaptive reuse. The appropriate context of the resource must be considered in relocation.</p>

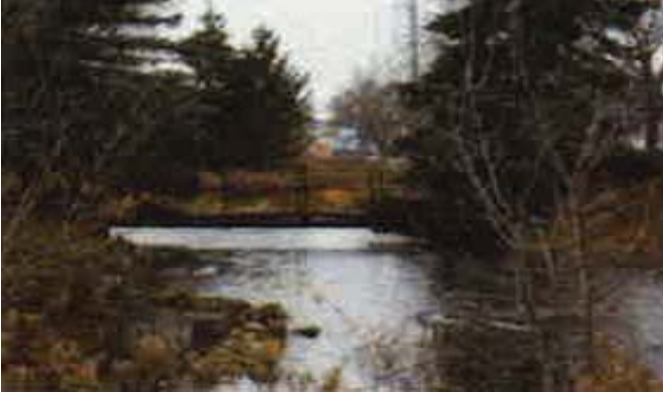
<p>Metal and wood pedestrian bridge.</p>	<p>Potential Modification or Removal: Potential for feature to be modified to accommodate pedestrian traffic or removed due to channel works. IO has recommended removal of this feature.</p>	<p>The modifications to be developed during the preparation of a Conservation Plan by a qualified heritage consultant. If removal is required, partial salvage, documentation through measured drawings and high-resolution digital photographs, and/or historical plaquing. If possible, relocation within the GCC or to other parts of Guelph in order to better accommodate conservation and adaptive reuse. The appropriate context of the resource must be considered in relocation.</p>
32

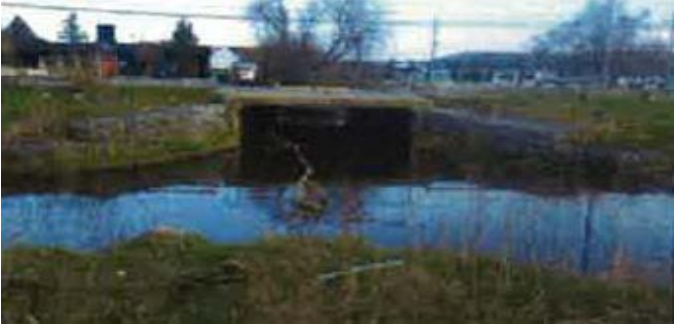
<p>Box culvert at confluence of Clythe Creek and Hadati Creek.</p>	<p>Potential Modification: Culvert may be extended to accommodate roadway grading requirement and CSP replacement.</p>	<p>The modifications may be developed during the preparation of a Conservation Plan by a qualified heritage consultant.</p>

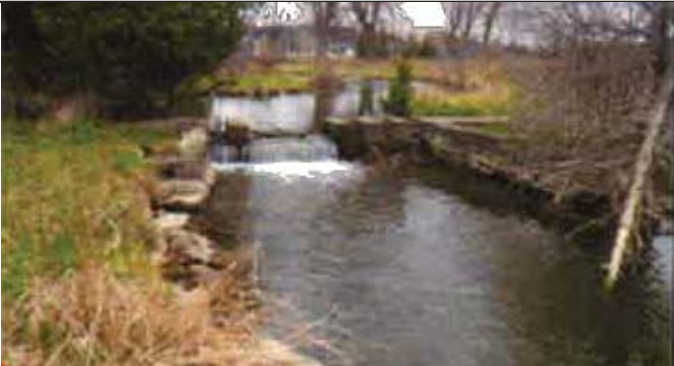
<p>Concrete and stone weir.</p>	<p>Maintained in situ: Feature would be maintained in landscape but would be impacted by loss of flow as a result of channel realignment.</p>	<p>May require repairs. This would be decided during the preparation of a Conservation Plan by a qualified heritage consultant. Were possible, creek realignment design should incorporate the 'high-flow' channel to convey higher flows over the weir structure.</p>
34

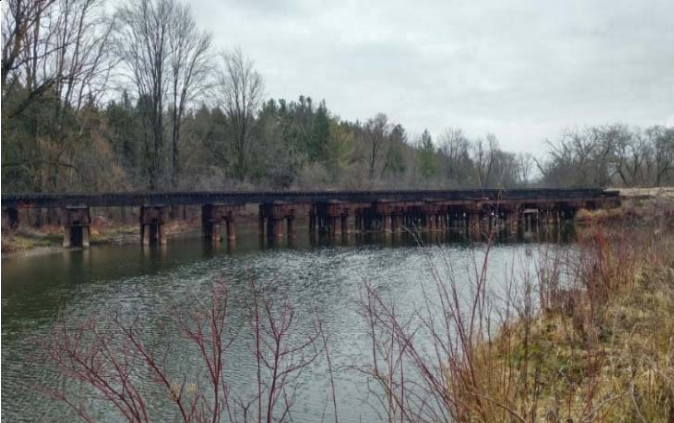
<p>GJR railroad bridge.</p>	<p>No Impact: Feature to remain in existing condition.</p>

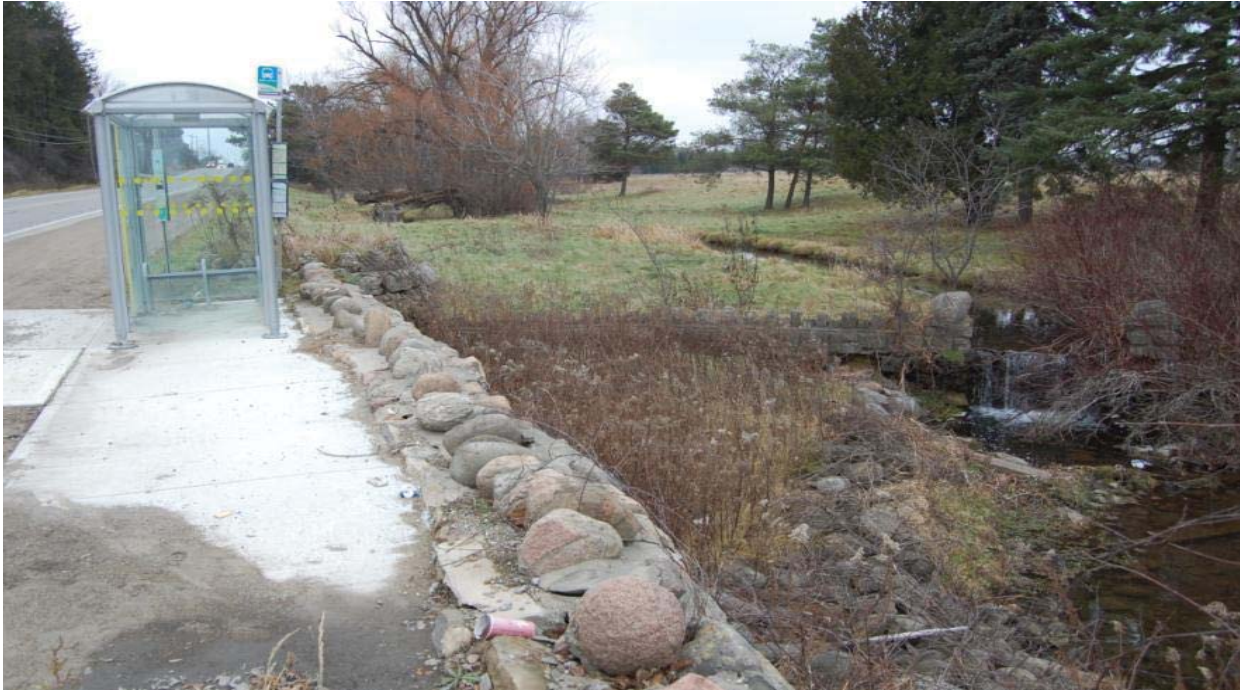
Photograph 1A: East side of entrance bridge. Only top of wall is visible.

The ring walls at the entrance off York Road to the GCC would need to be removed and rebuilt further south, away from the roadway (ref. Section 5. Mitigation, Revised Heritage Impact Assessment). If the walls were to be left in the current locations, a guiderail would need to be placed approximately 0.5 m to 1.5 m in front of the walls, and with the walls remaining partially buried, the view of the walls would be greatly diminished. There would also be a possibility of damage to the walls during the road construction and snow would be piled up next to the walls due to the lack of space from the road and multi-use pathway. This could potentially also result in structural damage to the walls.

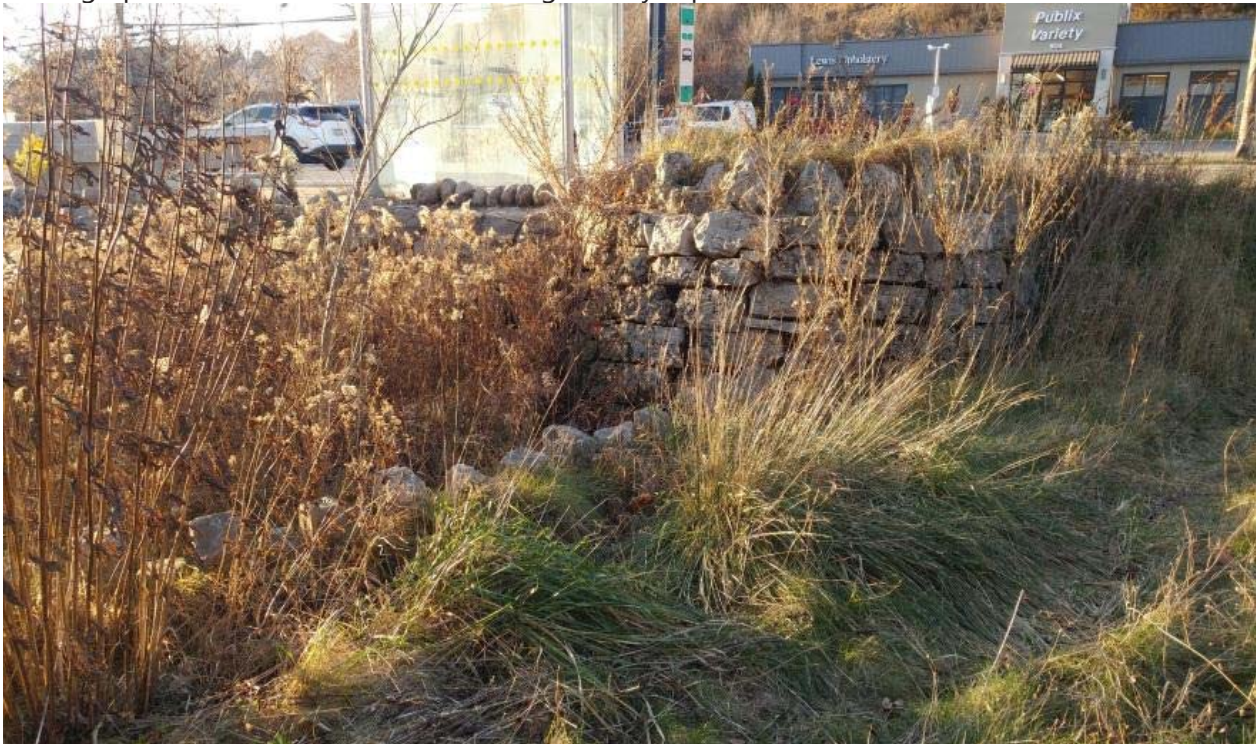
Photograph 2A: Taken from inside the property with wall more visible.

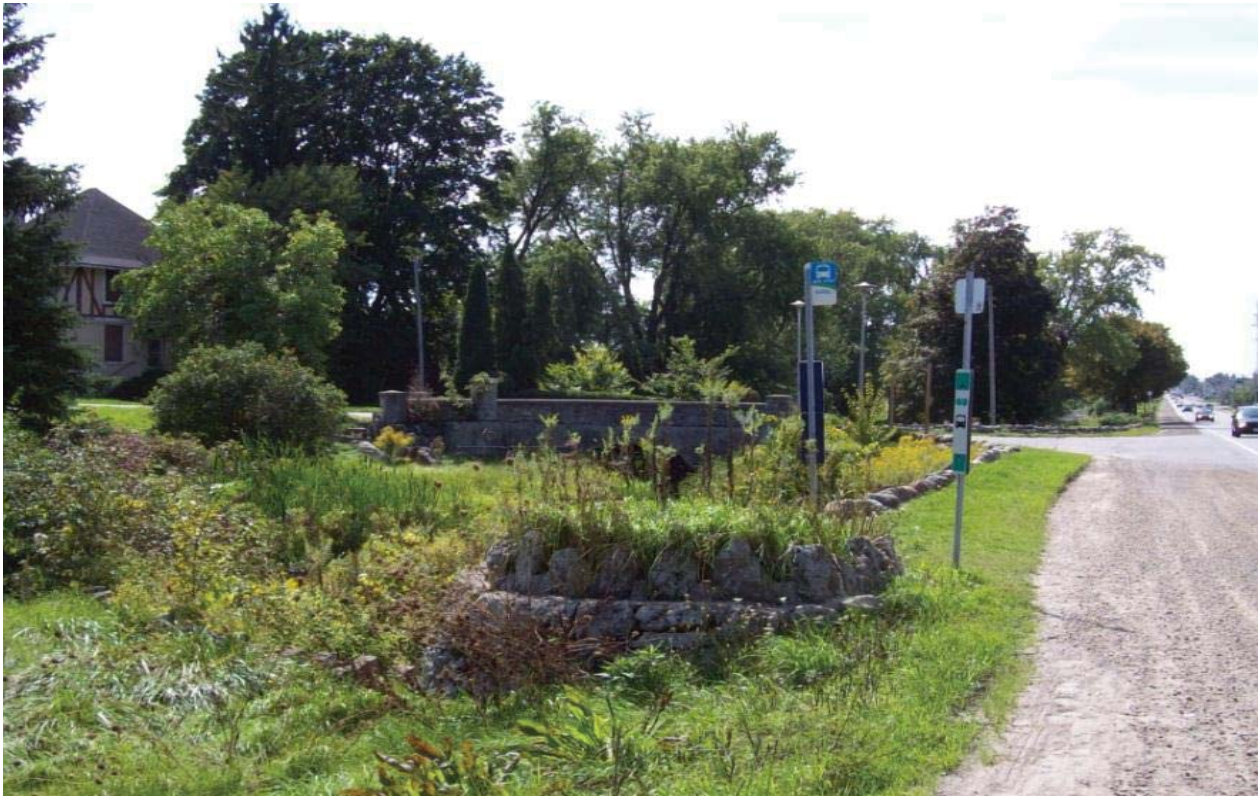
Photograph 3A: The circular end treatment east of the entrance bridge.

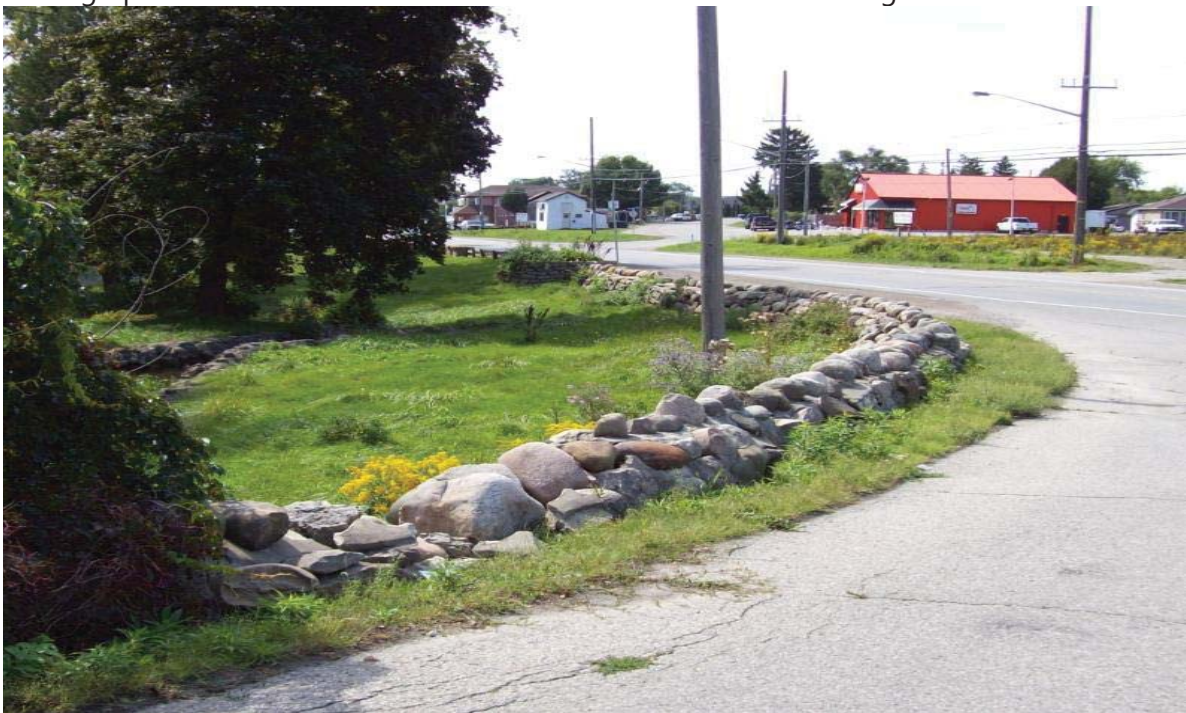
Photograph 4A: West of the entrance. Only the top of the wall is visible.

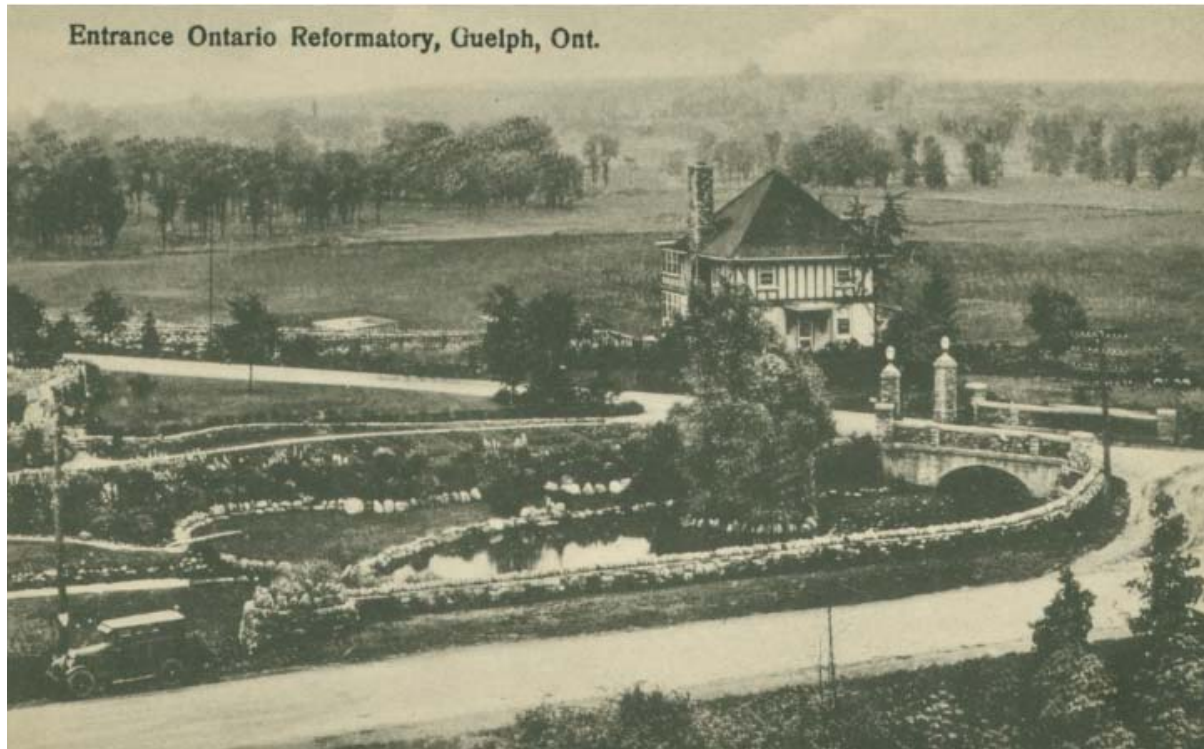
Photograph 5A: 1920 picture of dry stone wing wall with circular end treatment. The height of the wall is noticeably taller. The existing wall has been partially buried due to road grading.

Three (3) heritage masons were contacted regarding the cost of the removal and replacement of the fieldstone entrance wing walls on both sides of the entrance way. They were provided an explanation of the work that was required; photos of the current walls, including a 1920's photo of how the wall looked originally; and the plan and cross-sections illustrating the extent of the wall relocations (full wall relocation, not partial relocation as per plans provided in Appendix E).

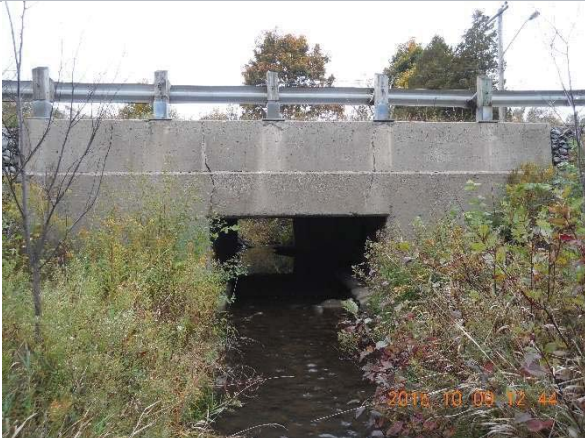
<p>Bridge shown from the south side of York Road. Clythe Creek passes through the culvert under the road at this location.³</p>	<p>Relocation or Removal: Bridge/culvert would be removed and replaced with a wider arched culvert for the road widening.</p>	<p>No mitigation</p>
2

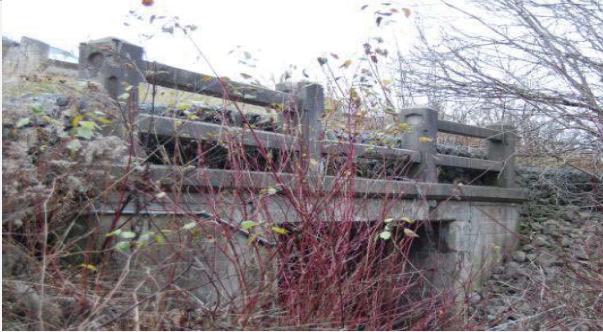
<p>Reinforced concrete road bridge railing (remnant) circa 1920 on the north side of York Road.</p>	<p>Relocation or Removal: This feature would be removed due to road widening and multi-use path.</p>	<p>If possible, relocation within the GCC or to other parts of Guelph in order to better accommodate conservation and adaptive reuse. The appropriate context of the resource must be considered in relocation. Partial salvage, documentation through measured drawings and high-resolution digital photographs, and/or historical plaquing.</p>

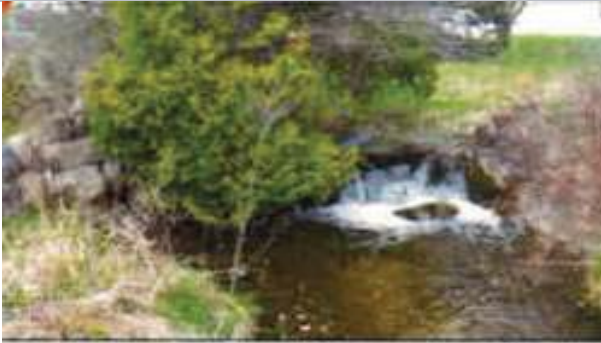
<p>Fieldstone weir with steps and sentinel stones. This is a barrier to fish passage.</p>	<p>Maintained in situ: This feature would be maintained in landscape but will be impacted by loss of flow as a result of channel realignment.</p>	<p>May require repairs. This would be decided during the preparation of a Conservation Plan by a qualified heritage consultant. Where possible, creek realignment design should incorporate the 'high-flow' channel to convey higher flows over the weir structure.</p>
4

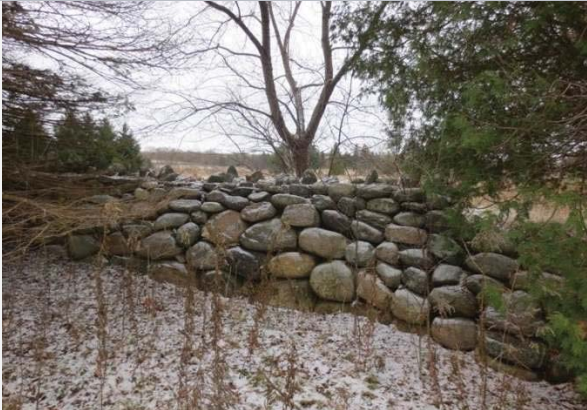
<p>Fieldstone garden wall with sentinel stones.</p>	<p>No Impact: Wall to remain in existing condition</p>	<p>May require repairs. This would be decided during the preparation of a Conservation Plan by a qualified heritage consultant.</p>
5

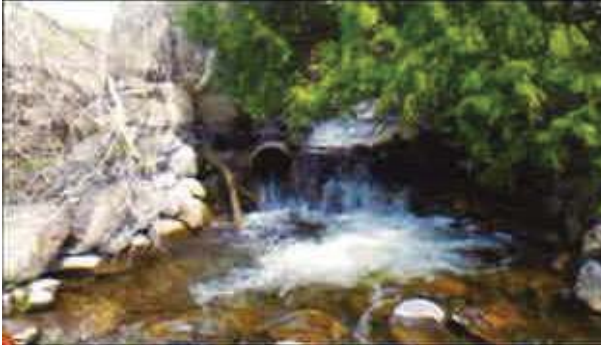
<p>Fieldstone weir with clay pipes. This is a barrier to fish passage.</p>	<p>Maintained in situ: This feature would be maintained in landscape but would be impacted by loss of flow as a result of channel realignment</p>	<p>May require repairs. This would be decided during the preparation of a Conservation Plan by a qualified heritage consultant. Where possible, creek realignment design should incorporate the 'high-flow' channel to convey higher flows over the weir structure.</p>

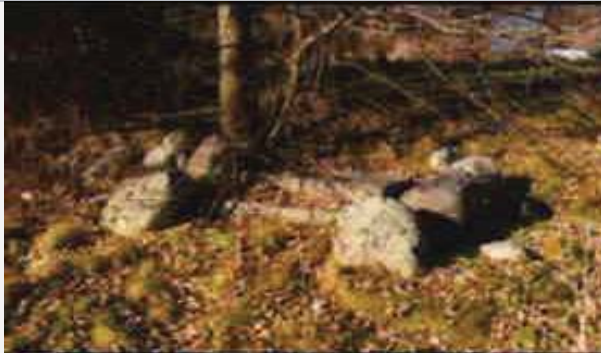
<p data-bbox="298 674 493 705">Fieldstone steps.</p>	<p data-bbox="911 317 1045 380">Potentially impacted:</p> <p data-bbox="911 380 1138 499">The steps may be covered by grading for road and pathway.</p>	<p data-bbox="1170 317 1414 926">If possible, relocation within the GCC or to other parts of Guelph in order to better accommodate conservation and adaptive reuse. The appropriate context of the resource must be considered in relocation. Partial salvage, documentation through measured drawings and high-resolution digital photographs, and/or historical plaquing.</p>
7

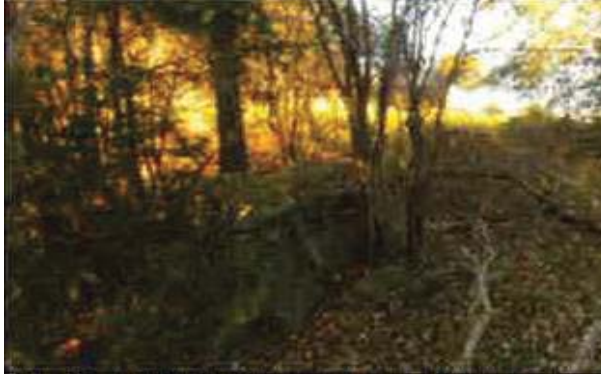
<p data-bbox="298 1346 699 1377">Large Boulder or bedrock outcrop.</p>	<p data-bbox="911 968 1045 1031">Potentially impacted:</p> <p data-bbox="911 1031 1105 1150">This feature may be covered by grading for road and pathway</p>	<p data-bbox="1170 968 1414 1577">If possible, relocation within the GCC or to other parts of Guelph in order to better accommodate conservation and adaptive reuse. The appropriate context of the resource must be considered in relocation. Partial salvage, documentation through measured drawings and high-resolution digital photographs, and/or historical plaquing.</p>

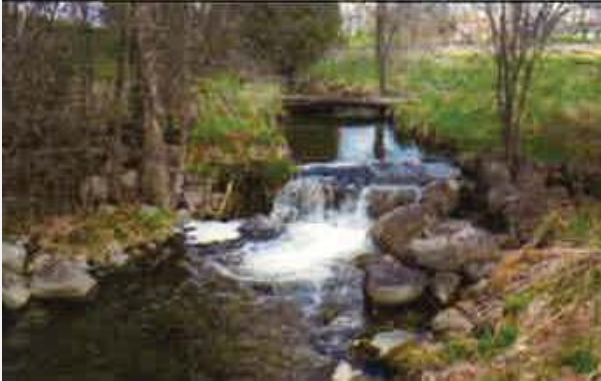
<p>Fieldstone weir. This is a barrier to fish passage</p>	<p>Maintained in situ: The weir would be maintained in landscape but would be impacted by loss of flow as a result of channel realignment.</p>	<p>May require repairs. This would be decided during the preparation of a Conservation Plan by a qualified heritage consultant. Where possible, creek realignment design should incorporate the 'high-flow' channel to convey higher flows over the weir structure.</p>
9

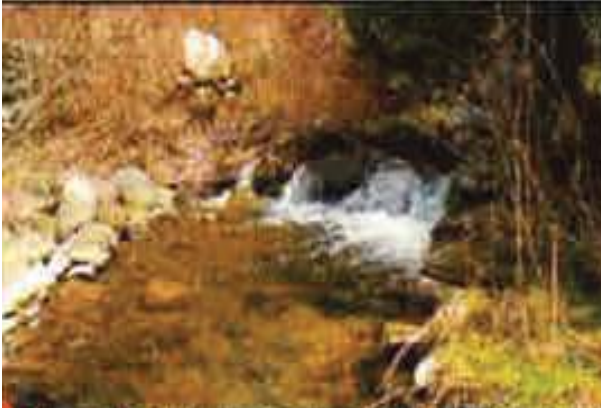
<p>Fieldstone weir beside gabion baskets. (Gabion baskets are not part of listed heritage resource).</p>	<p>Removal or possibly maintained in situ: This feature would be removed due to grading for road widening and multi-use path. If a proposed retaining wall is built it could be maintained in the landscape but will be impacted by loss of flow.</p>	<p>If possible, relocation within the GCC or to other parts of Guelph in order to better accommodate conservation and adaptive reuse. The appropriate context of the resource must be considered in relocation. Partial salvage, documentation through measured drawings and high-resolution digital photographs, and/or historical plaquing.</p>

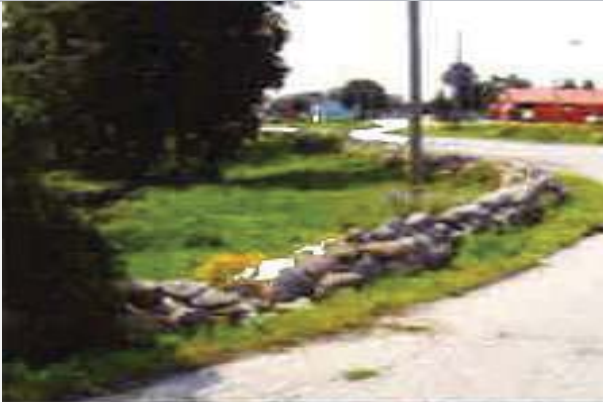
<p>Roughly squared stones cut from the limestone quarry and fieldstone west entrance wall, curved with sentinel stones.</p>	<p>Relocation: This feature would be removed due to grading needed for road widening and multi-use path.</p>	<p>This structure would be removed and reconstructed back further from the road by skilled heritage masons. The details of the reconstruction would be decided during the preparation of a Conservation Plan by a qualified heritage consultant. See Drawing 1 on page 4.</p>
17

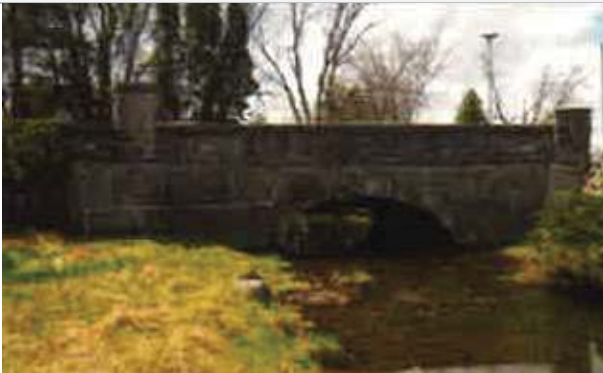
<p>Stone and concrete road bridge.</p>	<p>No Impact: Feature to remain in existing location.</p>	<p>May require repairs. This would be decided during the preparation of a Conservation Plan by a qualified heritage consultant.</p>
18

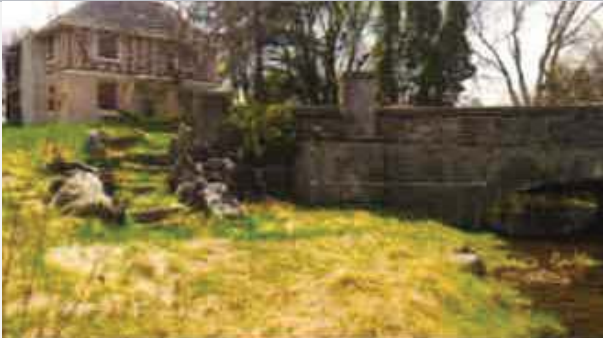
<p>Fieldstone steps to the south of road bridge.</p>	<p>No Impact: Feature to remain in existing location.</p>	<p>May require repairs. This would be decided during the preparation of a Conservation Plan by a qualified heritage consultant.</p>

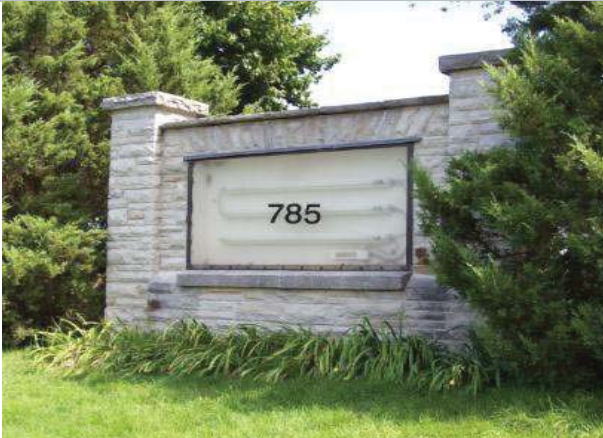
<p>Entrance sign, ashlar, rock-faced limestones with jack arch.</p>	<p>No Impact: Feature to remain in existing location.</p>	<p>May require repairs. This would be decided during the preparation of a Conservation Plan by a qualified heritage consultant.</p>
20

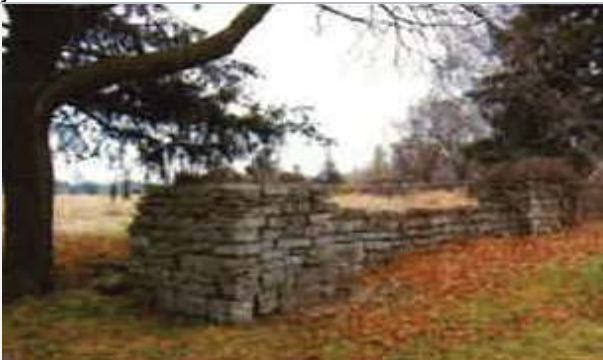
<p>Ashlar dry stone wall.</p>	<p>No Impact: Feature is located within the floodplain and will not be impacted by proposed channel works. Feature is to remain in existing location.</p>	<p>May require repairs. This would be decided during the preparation of a Conservation Plan by a qualified heritage consultant.</p>
21	  <p>Willowbank Hall (B13498) - North-East Elevation Willowbank Hall.</p>	<p>No Impact: Feature to remain in existing location.</p>	<p>If it is to be part of the Conservation Plan, it may be rehabilitated. This would be decided during the preparation of a Conservation Plan by a qualified heritage consultant.</p>

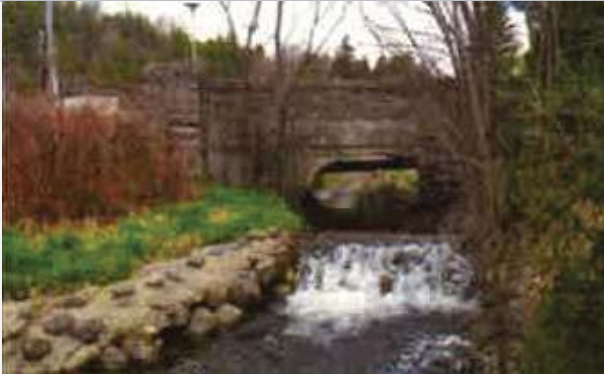
<p data-bbox="300 688 899 961">Fieldstone weir.</p>	<p data-bbox="911 317 1133 380">Relocation or Removal:</p> <p data-bbox="911 380 1133 499">This feature would be removed as a result of channel work.</p>	<p data-bbox="1170 317 1416 926">If possible, relocation within the GCC or to other parts of Guelph in order to better accommodate conservation and adaptive reuse. The appropriate context of the resource must be considered in relocation. Partial salvage, documentation through measured drawings and high-resolution digital photographs, and/or historical plaquing.</p>
23

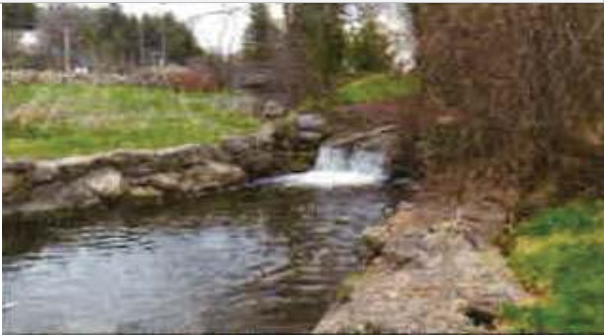
<p data-bbox="300 1293 899 1493">Fieldstone weir and culvert.</p>	<p data-bbox="911 961 1133 1024">Maintained in situ:</p> <p data-bbox="911 1024 1133 1241">Feature would be maintained in landscape but would be impacted by loss of flow as a result of channel realignment.</p>	<p data-bbox="1170 961 1416 1486">May require repairs. This would be decided during the preparation of a Conservation Plan by a qualified heritage consultant. Where possible, creek realignment design should incorporate the 'high-flow' channel to convey higher flows over the weir structure.</p>

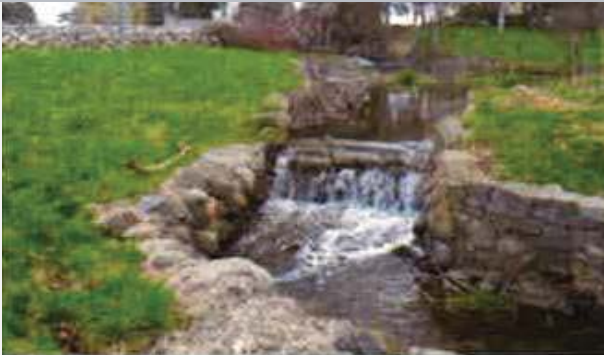
<p data-bbox="300 1845 899 1873">Fieldstone weir and culvert.</p>	<p data-bbox="911 1493 1133 1556">Relocation or Removal:</p> <p data-bbox="911 1556 1133 1738">This feature would be removed as a result of channel work and grading for roadway and pathway.</p>	<p data-bbox="1170 1493 1416 1709">Partial salvage, documentation through measured drawings and high-resolution digital photographs, and/or historical plaquing.</p>

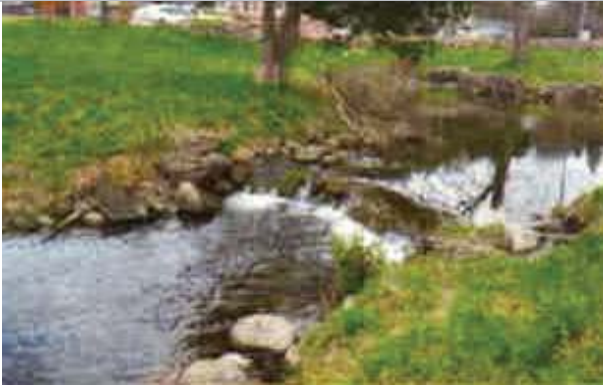
<p>Fieldstone weir.</p>	<p>Relocation or Removal: This feature would be removed as a result of channel work and grading for roadway and pathway.</p>	<p>If possible, relocation within the GCC or to other parts of Guelph in order to better accommodate conservation and adaptive reuse. The appropriate context of the resource must be considered in relocation. Partial salvage, documentation through measured drawings and high-resolution digital photographs, and/or historical plaquing.</p>
26

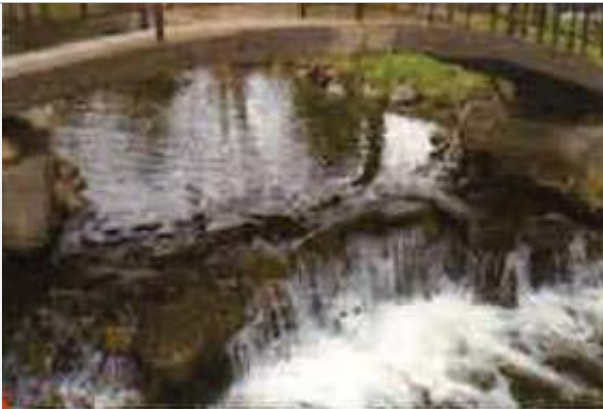
<p>Fieldstone weir.</p>	<p>Relocation or Removal: This feature would be removed as a result of channel work.</p>	<p>If possible, relocation within the GCC or to other parts of Guelph in order to better accommodate conservation and adaptive reuse. The appropriate context of the resource must be considered in relocation. Partial salvage, documentation through measured drawings and high-resolution digital photographs, and/or historical plaquing.</p>

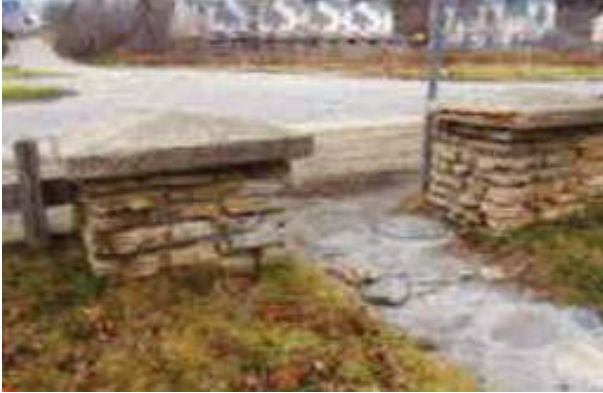
<p data-bbox="300 709 898 926">Limestone pillars with wood board fencing leading to main entrance.</p>	<p data-bbox="914 319 1143 380">Relocation or Removal:</p> <p data-bbox="914 380 1143 533">This feature would be removed due to grading needed for road widening and multi-use path.</p>	<p data-bbox="1175 319 1404 926">If possible, relocation within the GCC or to other parts of Guelph in order to better accommodate conservation and adaptive reuse. The appropriate context of the resource must be considered in relocation. Partial salvage, documentation through measured drawings and high-resolution digital photographs, and/or historical plaquing.</p>
28

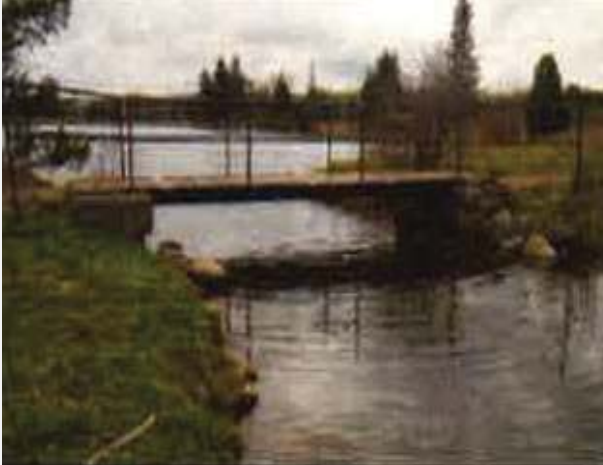
<p data-bbox="300 1396 898 1845">Metal and wood pedestrian bridge.</p>	<p data-bbox="914 934 1143 1016">Potential Modification or Removal:</p> <p data-bbox="914 1016 1143 1234">Potential for feature to be modified to accommodate pedestrian traffic or removed due to channel works.</p>	<p data-bbox="1175 934 1404 1816">The modifications to be developed during the preparation of a Conservation Plan by a qualified heritage consultant. If possible, relocation within the GCC or to other parts of Guelph in order to better accommodate conservation and adaptive reuse. The appropriate context of the resource must be considered in relocation. If removal is required, partial salvage, documentation through measured drawings and high-resolution digital photographs, and/or historical plaquing.</p>

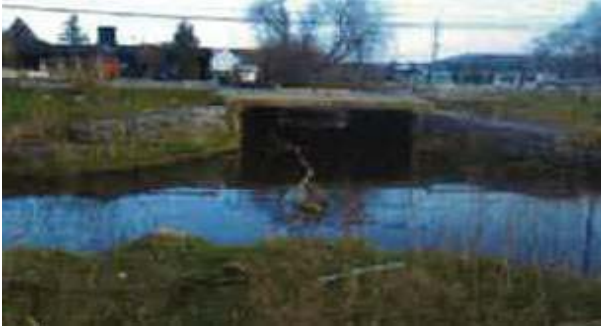
<p>Box culvert at confluence of Clythe Creek and Hadati Creek.</p>	<p>Potential Modification: Culvert may be extended to accommodate roadway grading requirement and CSP replacement.</p>	<p>No Mitigation required.</p>
30

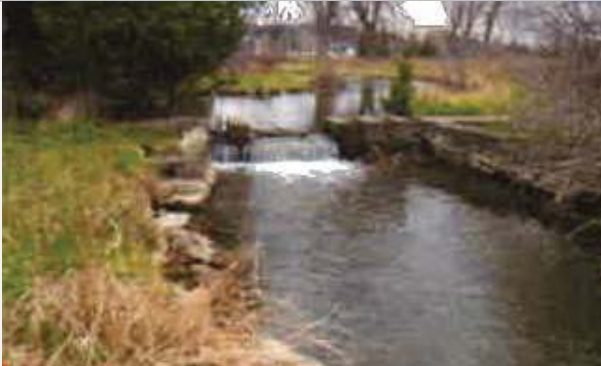
<p>Concrete and stone weir.</p>	<p>Maintained in situ: Feature would be maintained in landscape but would be impacted by loss of flow as a result of channel realignment.</p>	<p>May require repairs. This would be decided during the preparation of a Conservation Plan by a qualified heritage consultant. Were possible, creek realignment design should incorporate the 'high-flow' channel to convey higher flows over the weir structure.</p>
31

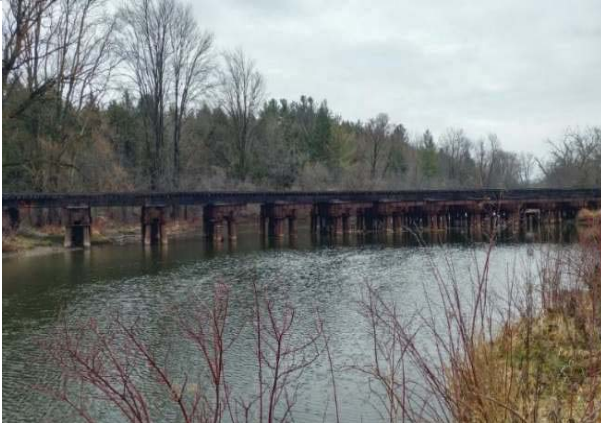
<p>GJR railroad bridge.</p>	<p>No Impact: Feature to remain in existing condition.</p>

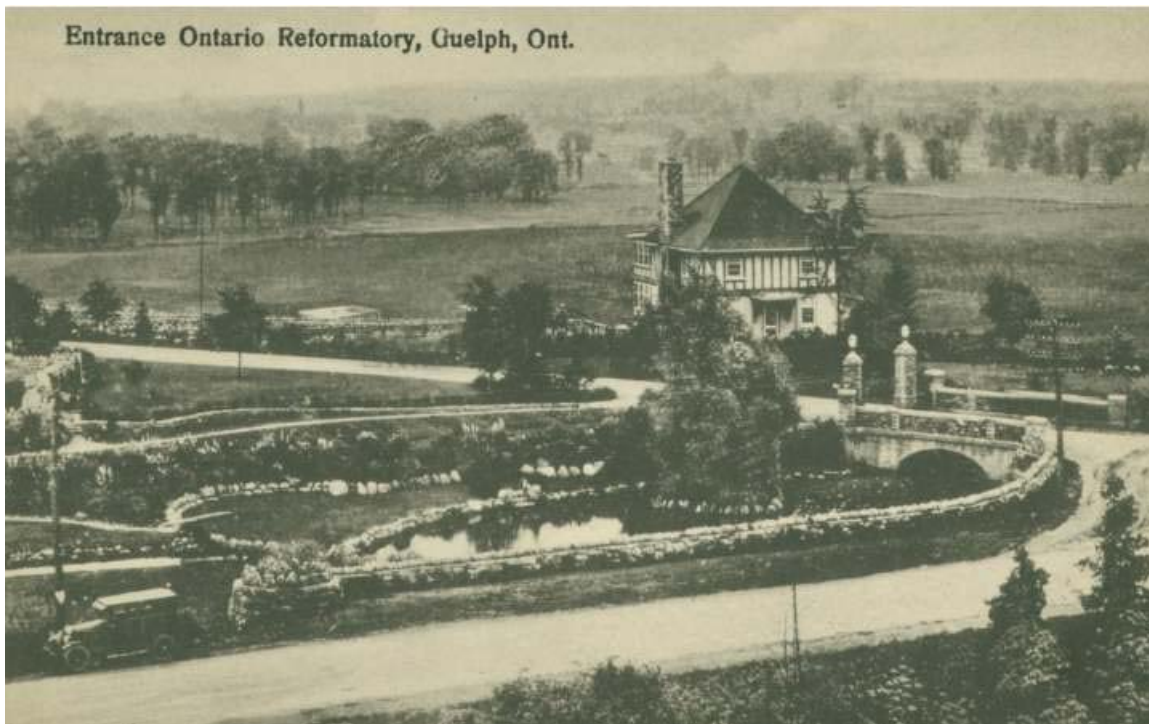
Photograph 4: 1920's Picture of Dry Stone Wing Wall with Circular End Treatment. The height of the wall is noticeably taller. The existing wall has been partially buried due to road grading. Photo from the Guelph Civic Museum.

Although the west wall would be further south and the east wall would be extended, the rebuilding of the two walls would bring the walls closer to the original 1920 appearance. This, along with

interpretive signage, would improve the public's view and understanding of the history of the entranceway.
