**Environmental Input to the EA
for the Widening of York Road,
Victoria Road to the East City Limit,
Guelph, Ontario**

Project No. 658

Date: September 2006

EXISTING CONDITIONS

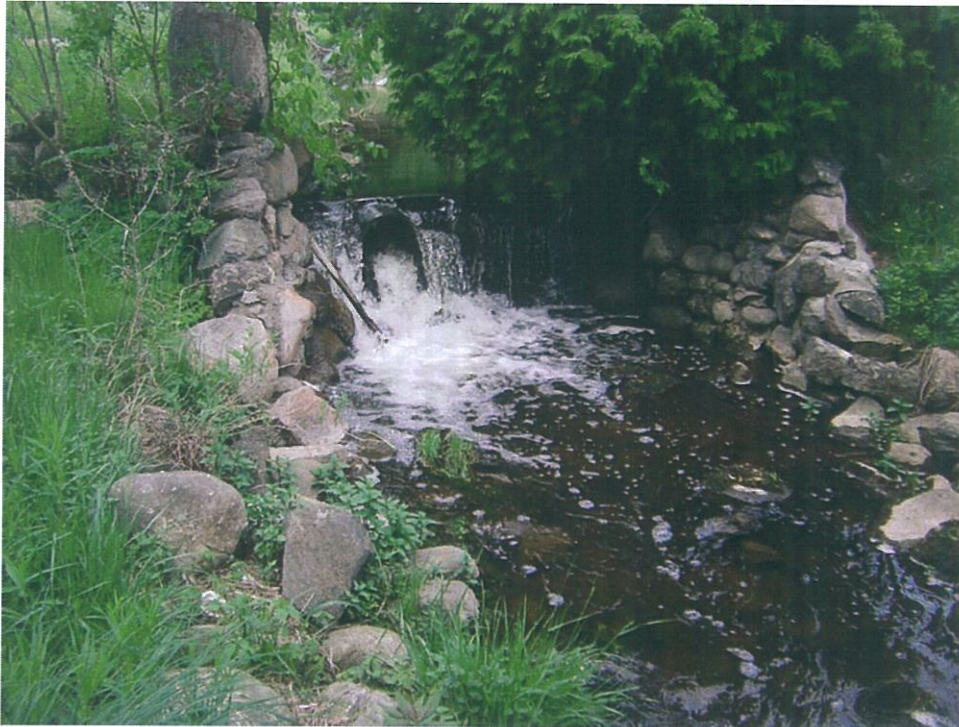
Photo 1 – Clythe Creek, example of the many weirs in the study area

Within the study area, there are numerous weirs and dams on Clythe Creek that create barriers to fish movement (See Photo 1, Appendix I)

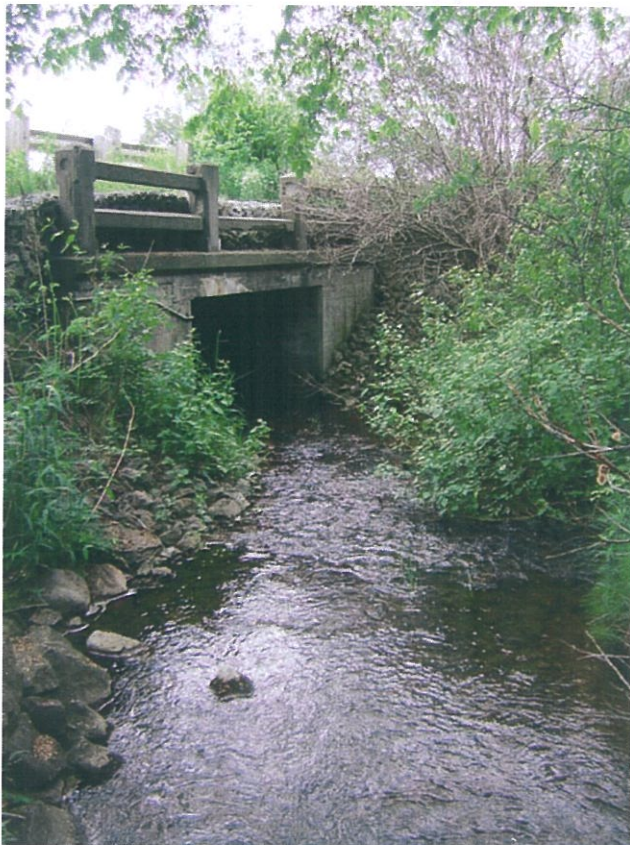
Photo 2 – Clythe Creek, Reach 1, looking downstream

The bank vegetation is composed of grasses, other herbaceous plants, and shrubs. The high vegetation density affords good bank stability. Bank-full width ranged from approximately 3.1 to 3.5m. The channel substrate is dominated by coarse materials, consisting of approximately 10% boulder, 60% cobble, 10% pebble, 10% gravel, and 10% sand. Cover for fish includes pools (at the York Road culvert), boulders, and cobble. Most of this section is considered riffle habitat (See Photo 2, Appendix I).

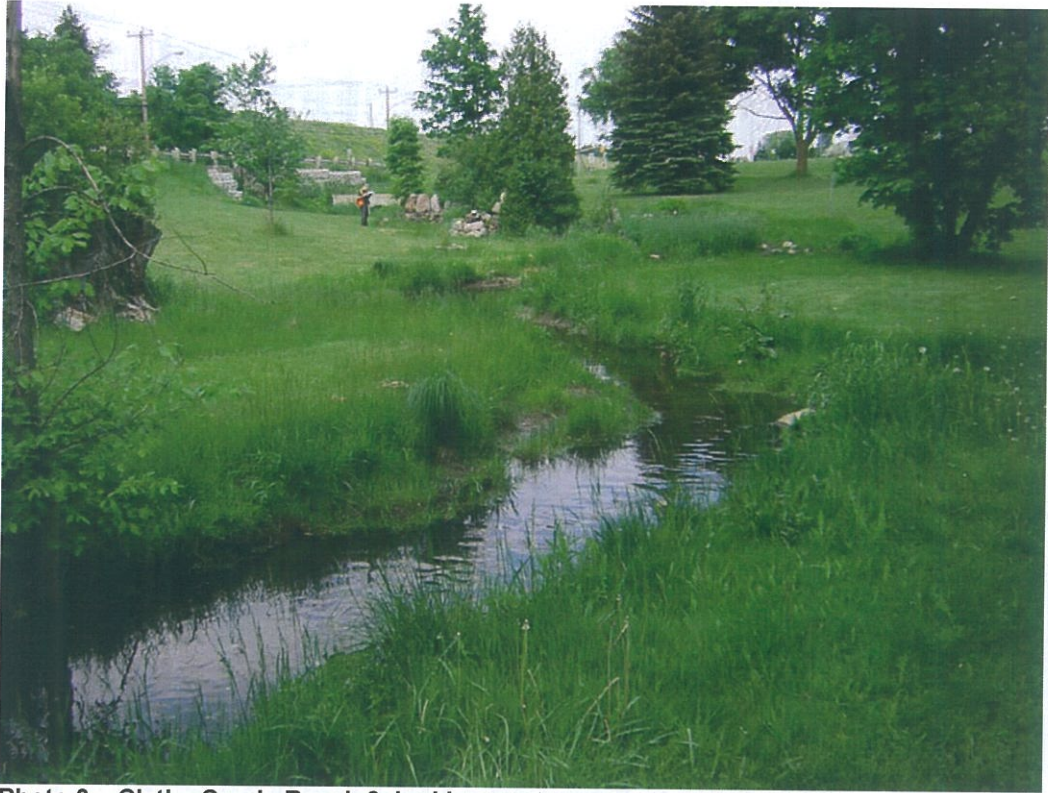
Photo 3 – Clythe Creek, Reach 2, looking upstream toward York Road crossing

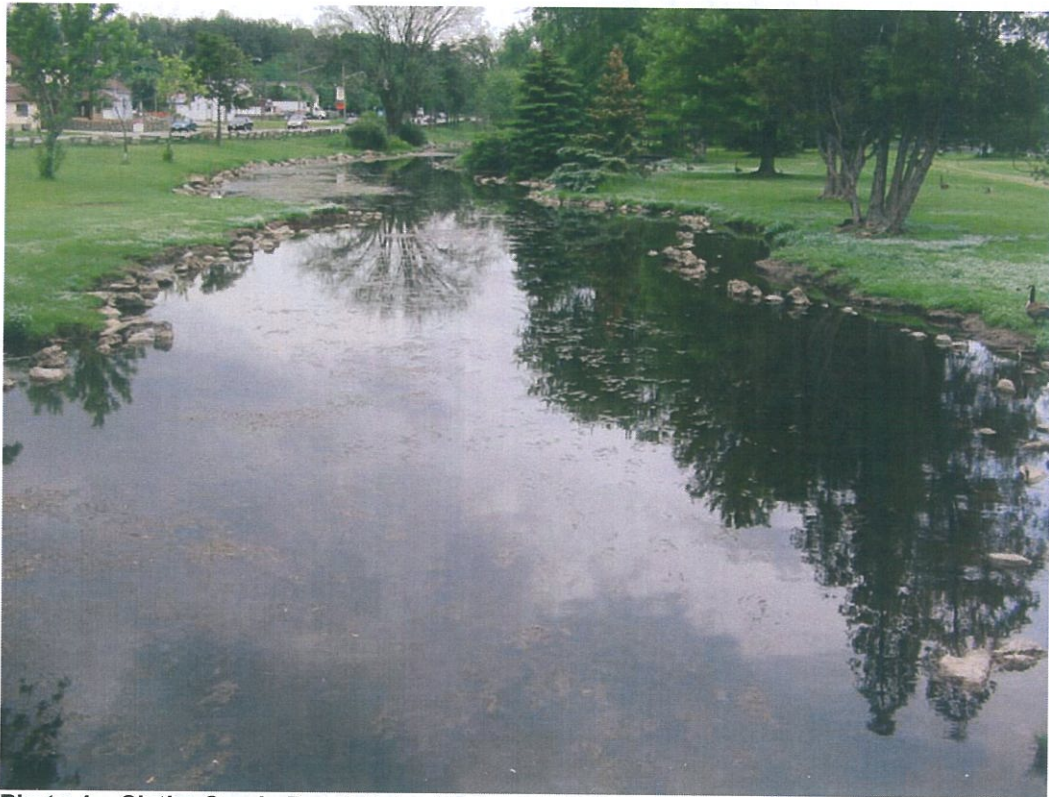
Photo 4 – Clythe Creek, Reach 3, looking upstream

The bank height ranges from approximately 0.1 to 0.3m, and the bank-full channel width varies between 7 and 12m. This widened section of Clythe Creek has some meandering form, but intensive modifications have left it with a low gradient. As a result, the water becomes ponded during low flow (see Photo 4, Appendix I). The substrate reflects the depositional nature of the slow, diffused flows. It is approximately 50% silt, 30% boulder, and 20% muck.

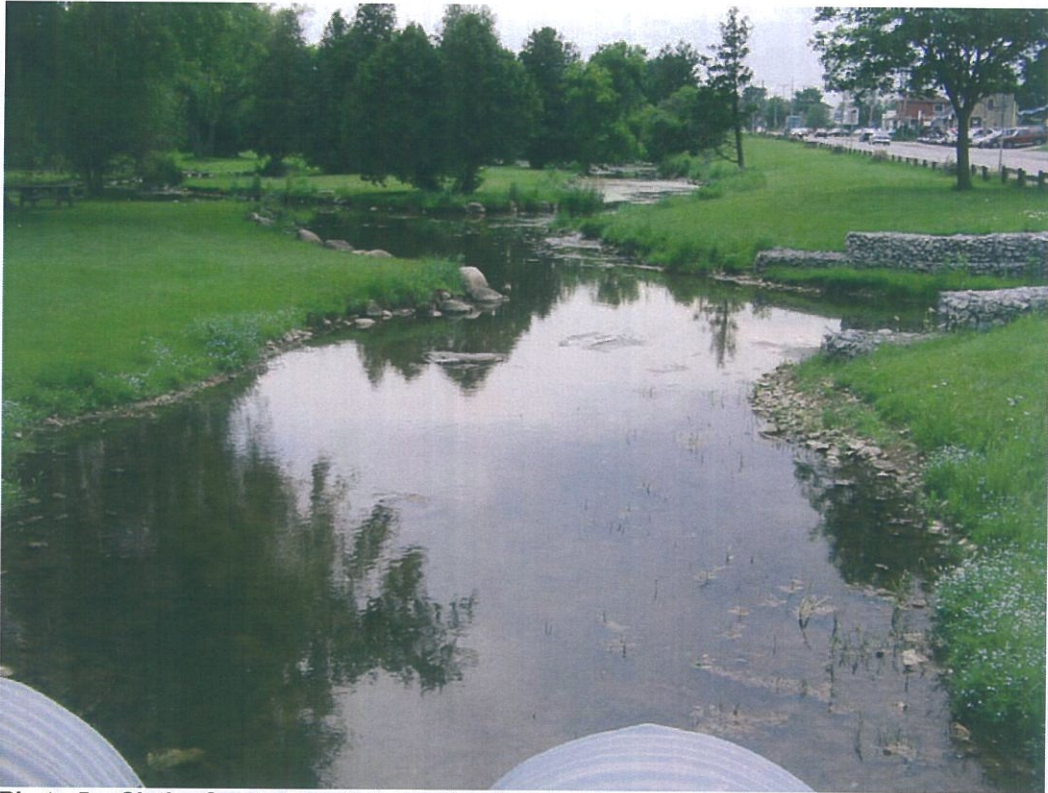
Photo 5 – Clythe Creek, Reach 4, looking downstream toward Hadati Cr. outlet and ponds

This reach lies between the outlet of Hadati Creek and the downstream limit of two online ponds (Figure 2). The flow diverges downstream of the Hadati Creek outlet to flow into the two ponds, which are located side-by-side (see Photo 5, Appendix I). The east online pond is at a lower elevation and is the larger of the two. The land on the east side of this pond is wooded. The land in between the two ponds and west of the ponds is manicured grass with occasional trees. Boulders were used as a landscaping feature along the banks, and there is abundant aquatic vegetation throughout both ponds.

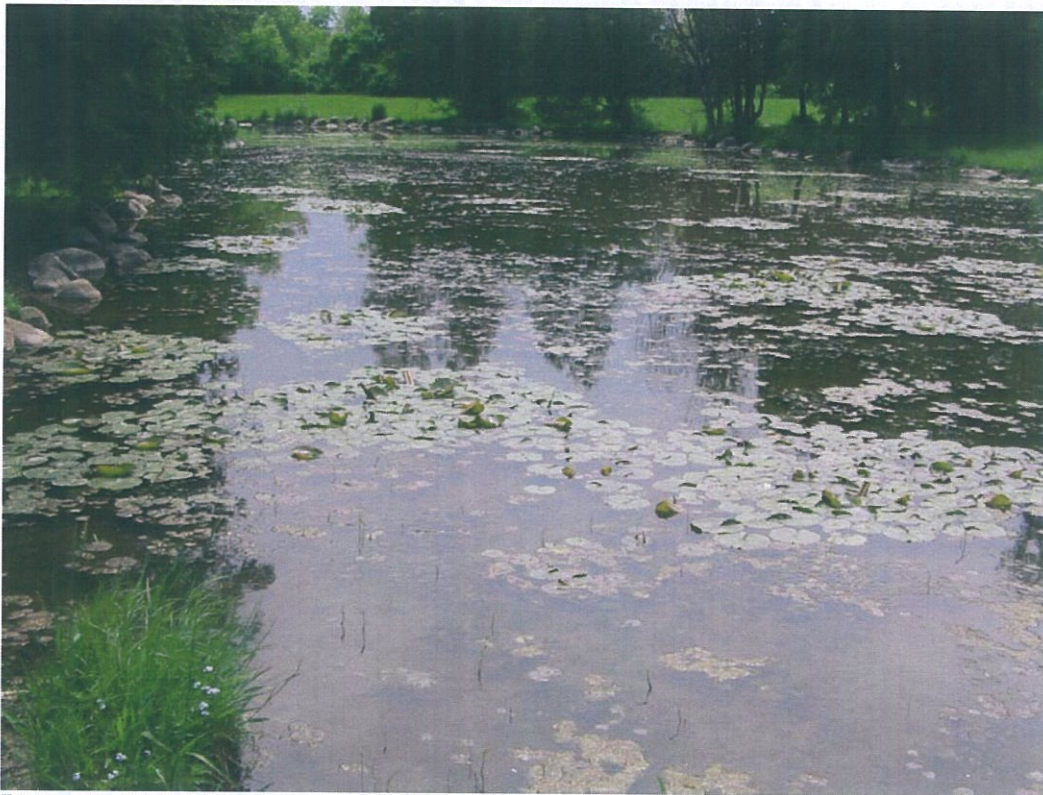
Photo 6 – Clythe Creek, Reach 4, abundant aquatic plants in the online ponds

On June 8, 2006, the water was relatively shallow (approximately 0.3m deep) throughout most of the area of the ponds. Water temperature was measured where the flow from the upper (west) pond joins the lower (east) pond. At 2:45pm, the water temperature was 23.5°C and the air temperature was 24°C. The pH at this location was 7.80 and the conductivity was 812µs/cm. The dissolved oxygen level was 9.3ppm, indicating supersaturated conditions (approximately 110% at 23.5°C). This was likely a result of the prolific growth of aquatic plants (see Photo 6, Appendix I). Fish from the families Centrarchidae (*Lepomis* sp.) and Cyprinidae were observed in the ponds.

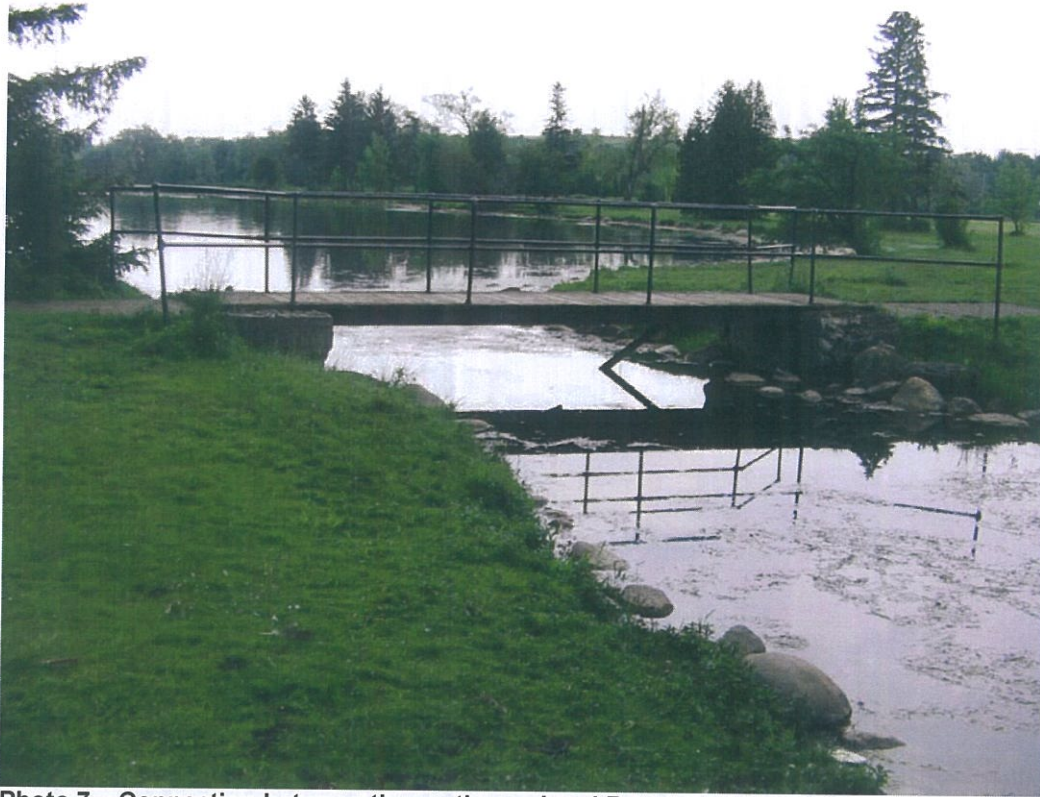
Photo 7 – Connection between the north pond and Reach 3 of Clythe Creek

The ponds at the Guelph Correctional Centre consist of two large ponds to the south of York Road and Clythe Creek (Figure 2). The north pond is closer to Clythe Creek, and is connected via a short channel approximately 10m long and 3 to 4m wide (see Photo 7, Appendix I). The flow of water moves slowly out of the pond as it joins the slow-moving water of this widened section of Clythe Creek. The south pond is not directly connected to Clythe Creek.

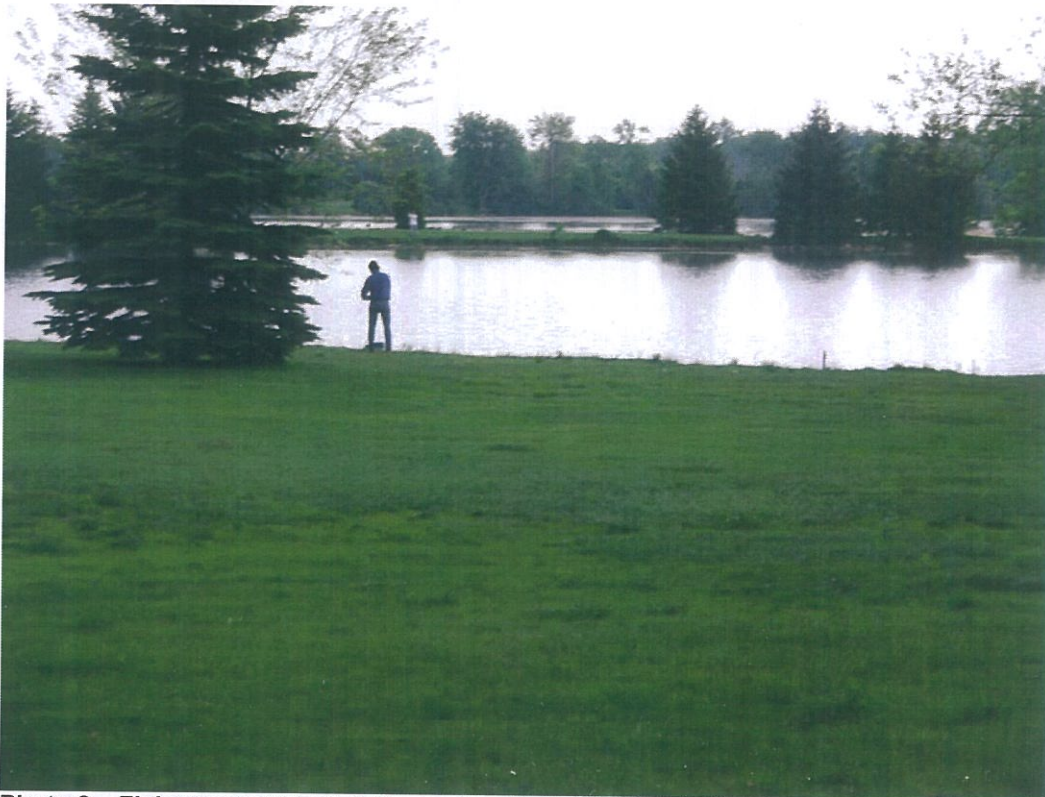
Photo 8 – Fisherman at Guelph Correctional Facility Ponds, looking south from Clythe Cr.

These constructed ponds are known to provide habitat for a variety of game fish and are used as a popular urban fishery (see Photo 8, Appendix I). Manicured grass surrounds much of their shorelines, and various trees and shrubs line the banks in some locations. The two ponds are separated by a narrow strip of land, and the south pond has a higher water level than the north pond (see Photo 9, Appendix I). The south pond is contained by a berm between it and the Eramosa River along its south shoreline. A formal trail has been established along the top of the berm on the south side.

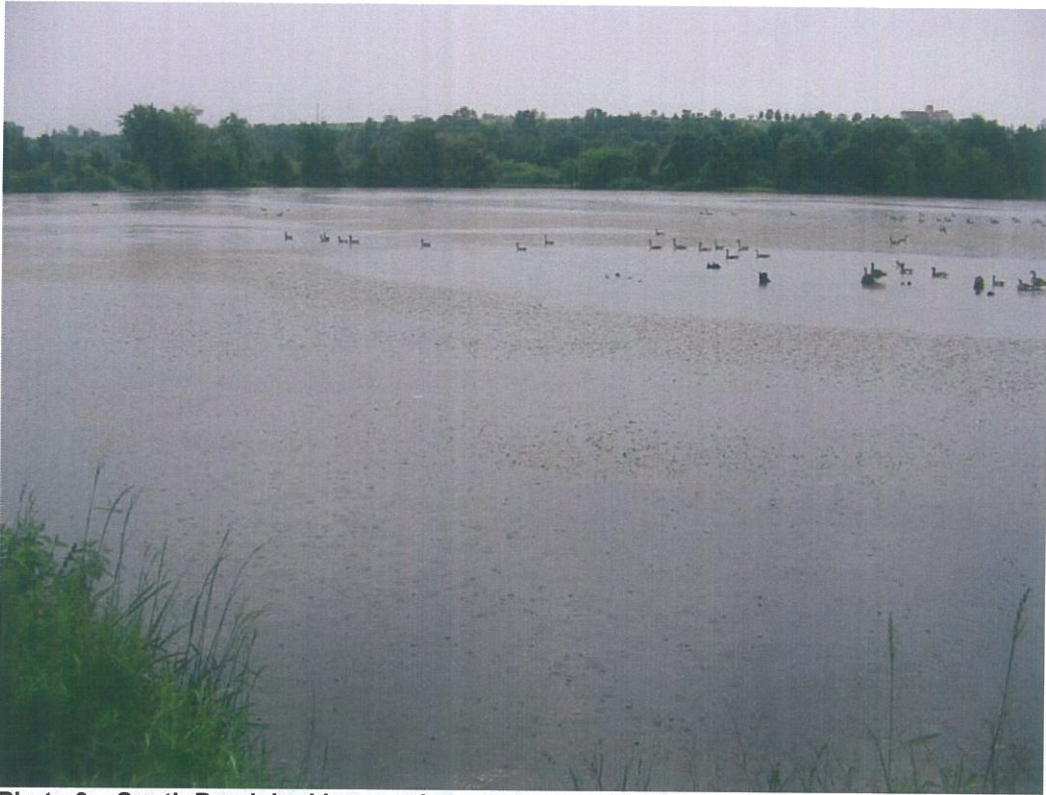
Photo 9 – South Pond, looking southwest

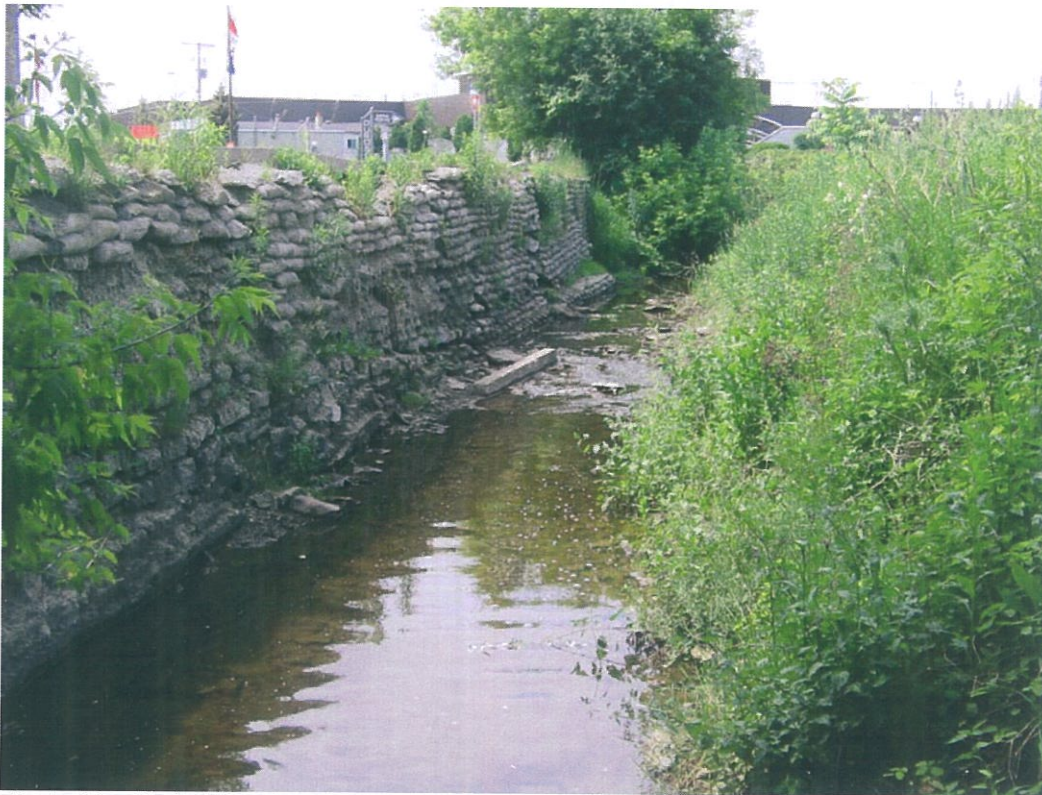
Photo 10 – Hadati Creek, Reach 1, looking upstream

The channel in Reach 1 is approximately 3m wide, and is very entrenched. The bank height ranges from approximately 1.9 to 2.2m, and bank slopes are nearly vertical. Most of the banks are hardened with a concrete bag wall (see Photo 10, Appendix I). Elsewhere, vegetation consists of grasses and other herbaceous plants that provide a moderate vegetation density for bank stability. Some minor bank scour is occurring on the west bank immediately upstream of the York Road culvert, likely resulting from flow patterns at the culvert inlet. The varied channel substrate is the most important habitat
