January 27, 2021

Project Name: Baker Street Project Number: CE751900 .A.CS.EV.A2 Filed: \\KWO\Proj\Guelph\CE751900\500\530\02\01

Subject: Update to the Phase One Environmental Site Assessment for 55 Baker Street, 152, 160 Wyndham Street North, and Park Lane, Guelph, Ontario, dated October 18, 2018

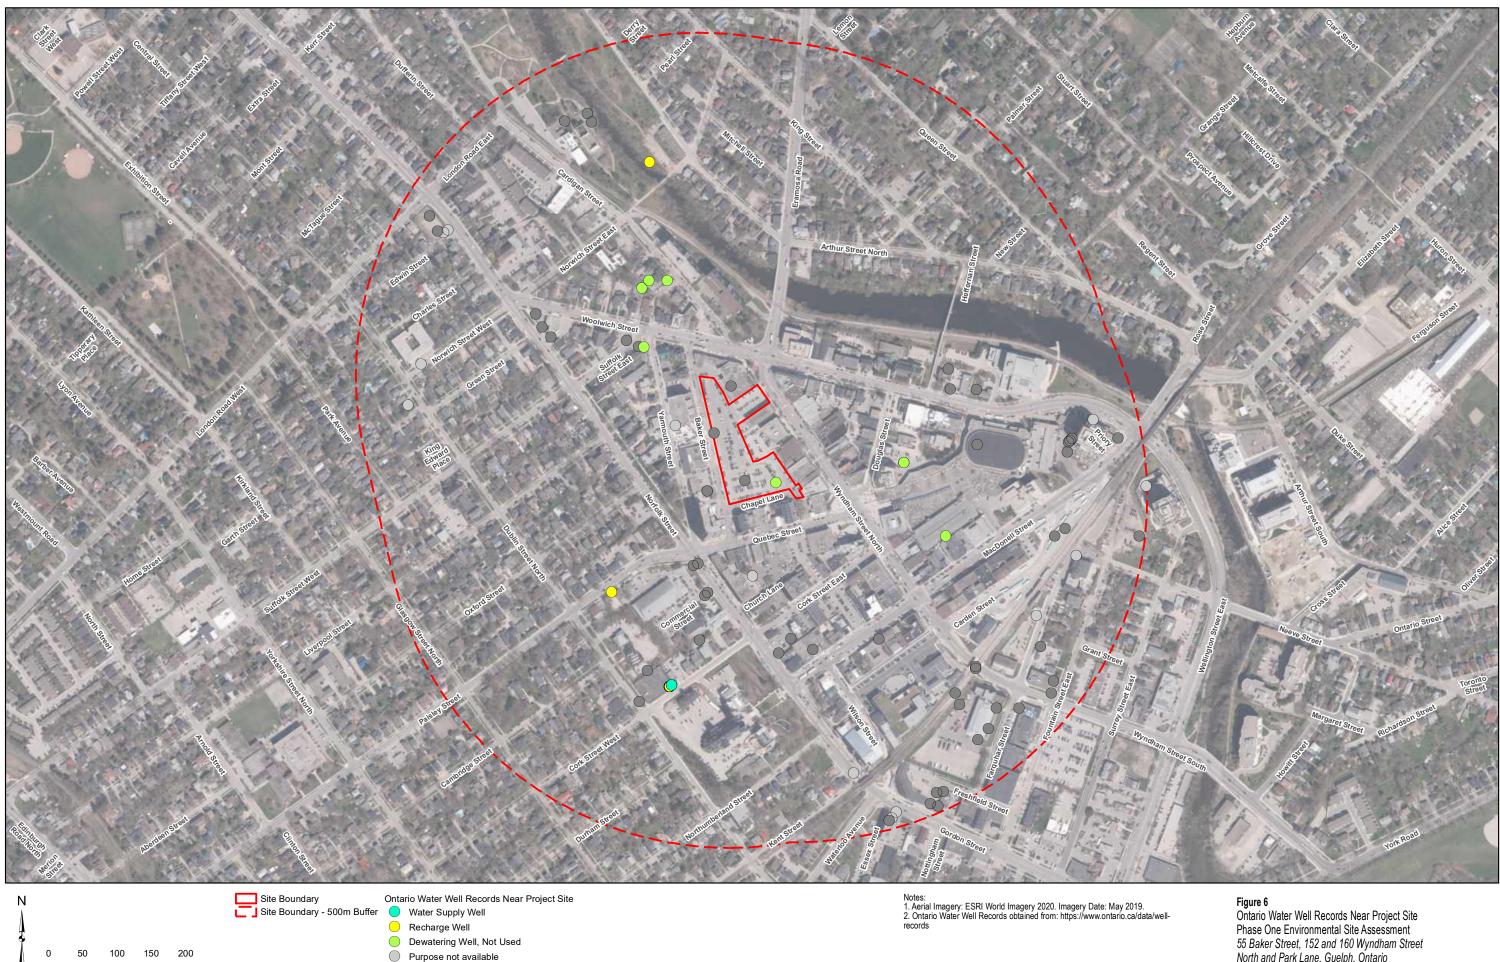
Figure 6 Ontario Water Well Records Near Project Site Phase One Environmental Site Assessment 55 Baker Street, 152 and 160 Wyndham Street North and Park Lane, Guelph, Ontario Date Exported: 12/18/2020

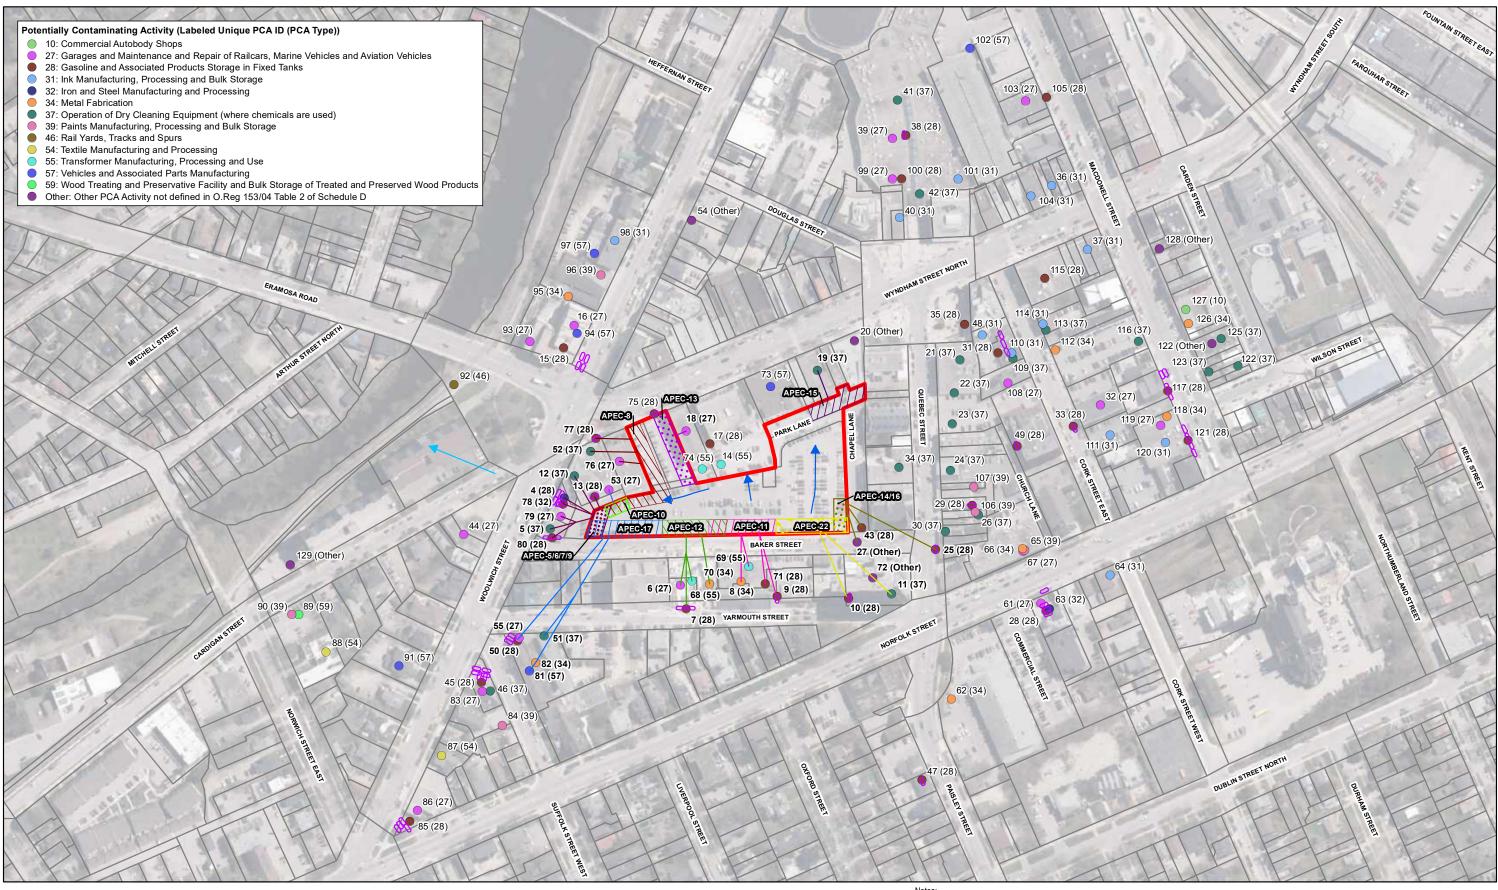
Figure 9

Potentially Contaminating Activities (PCAs) - Offsite Phase One Environmental Site Assessment 55 Baker Street. 152 and 160 Wyndham Street North and Park Lane, Guelph, Ontario Date Exported: 1/5/2021

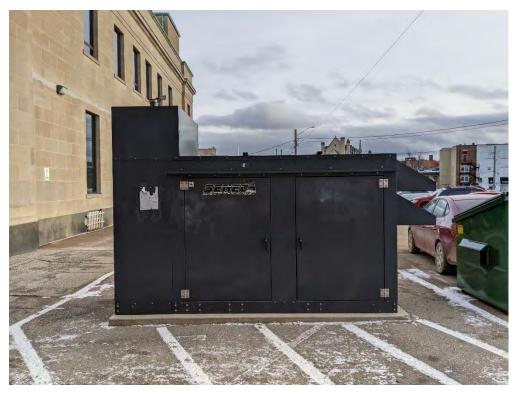
Photograph 1: Generator at 138 Wyndham, east of the Property

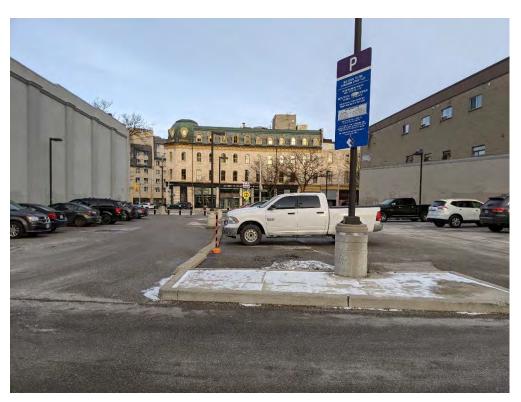
Photograph 2: Wyndham Street parking lot, looking east

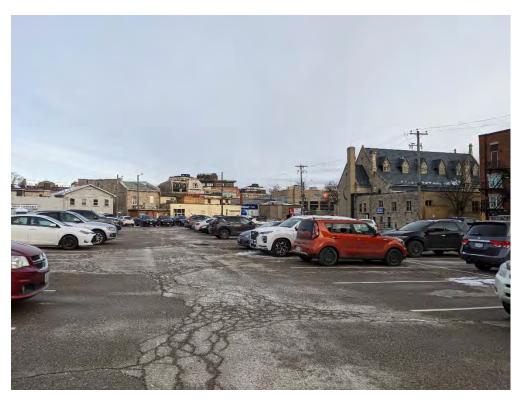
No notable staining was observed during the previous Site reconnaissance completed in spring 2017. During the winter Site reconnaissance, salt stains from winter parking lot maintenance and snow storage were observed at the Property. This is consistent with PCA 56 / APEC-4 – use of road salts.

Photograph 3: South portion of the Baker Street parking lot, looking east

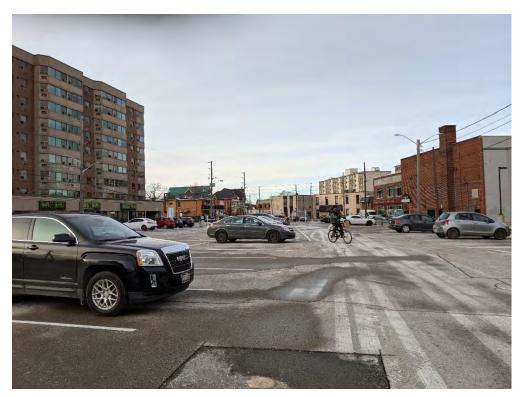
Photograph 4: South end of the Baker Street parking lot, looking northTaken by:Brandi WilsonDate taken:December 15, 2020

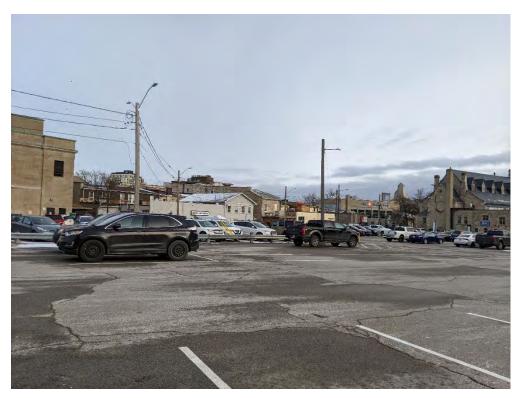
Photograph 5: Baker Street parking lot, looking southeast

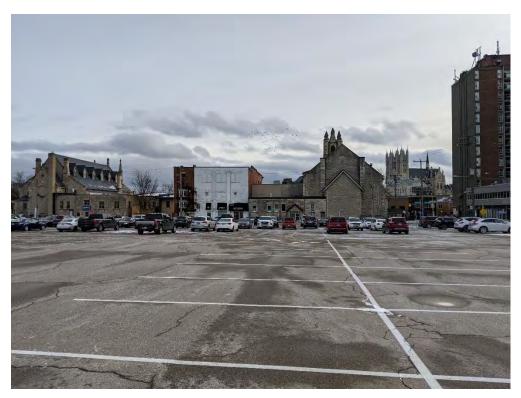
Photograph 6: Baker Street parking lot, looking south

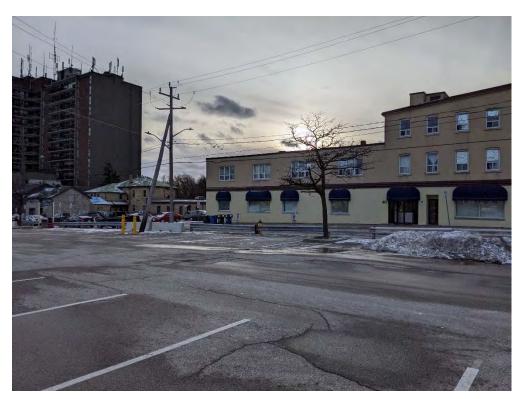
Photograph 7: Looking southwest to Baker Street

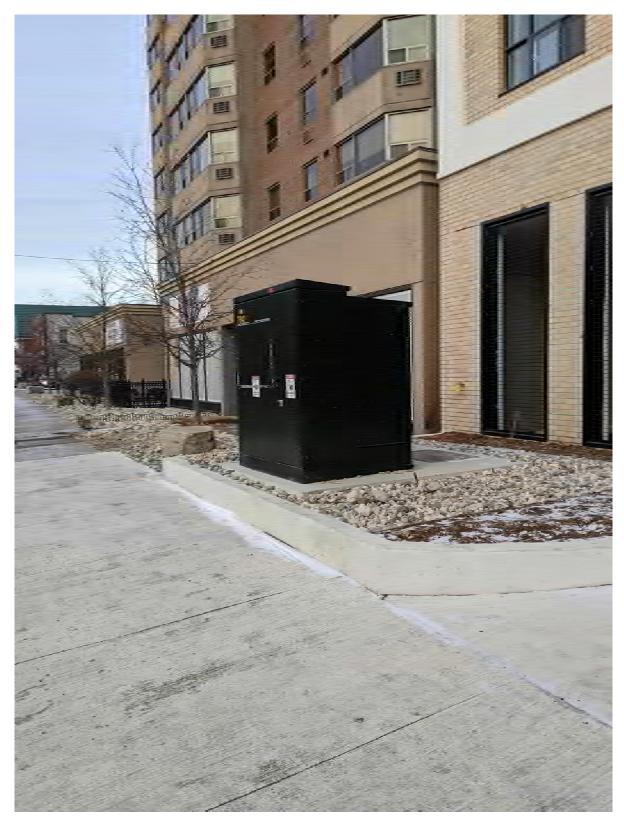
Photograph 8: New pad-mounted transformer located behind the building at 45 Yarmouth Street (west of the Property)

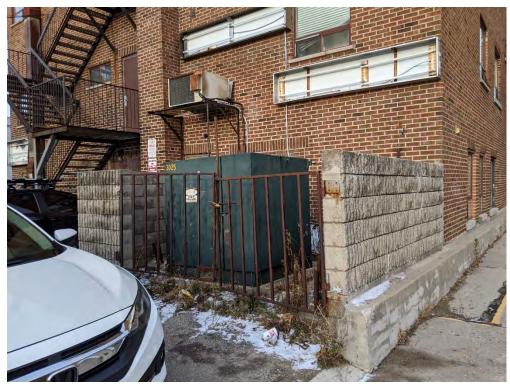
- Transformer located directly behind the 146 Wyndham Street North building. The pad-mounted transformer is located approximately 15 m east and is situated hydraulically downgradient of the Property. No concrete staining was observed during Site reconnaissance.
- Transformer located in the parking lot of 40 Baker Street. The pad-mounted transformer is located approximately 25 m west and is situated hydraulically upgradient of the Property. No concrete staining was observed during Site reconnaissance.
- Transformer located adjacent to a new condo building at 45 Yarmouth Street. The pad-mounted transformer is located approximately 50 m west and is situated hydraulically upgradient of the Property. No concrete staining was observed during Site reconnaissance.

Photograph 9: Transformer located at 146 Wyndham (east of the Property)Taken by:Brandi WilsonDate taken:December 15, 2020

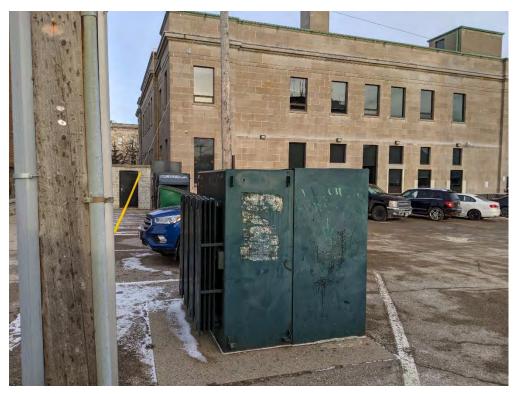
55	Transformer Manufacturing, Processing and Use	14	Transformer - One pad-mounted oil cooled transformer was identified during the Pinchin Site Visit (in 2018) on the west exterior portion of 138 Wyndham Street North. No staining was observed on the concrete slab in the vicinity of the transformer, and no evidence of leakage was observed during the Site reconnaissance.	Behind 138 Wyndham Street North	Offsite	NO		Hydraulically upgradient/ transgradient of the Phase One Property, but nature of PCA is shallow soil contamination	SR					
28	Gasoline and Associated Products Storage in Fixed Tanks	15	Historical Service Station - a former auto servicing and refueling station was located at 145 Woolwich with 4 gasoline USTs located out front, on Woolwich Street. The service station existed from at least 1929 to 1960 based on the FIPs and city directories (Simpson, CT, Service Station).	145 Woolwich Street	Offsite	NO		Hydraulically downgradient of the Phase One Property	FIP, CDL			1929, 1946, 1960		1936 to 1944

Photograph 11: Transformer behind 138 Wyndham Street (behind generator in Photo 1), east of the Property
